# STAGE PROTECTION AGAINST DEGRADATION DUE TO THE USE OF DEICING SALTS OF A STRUCTURE IN ANDORRA

ALBELDA CUADRA, RAÚL  
Construction Projects, Globalvía, Spain

RODRÍGUEZ, JOAN LLUIS; TRIAS PATOUT, CHRISTOPHE  
Túnel d'Envalira Concesion, Andorra

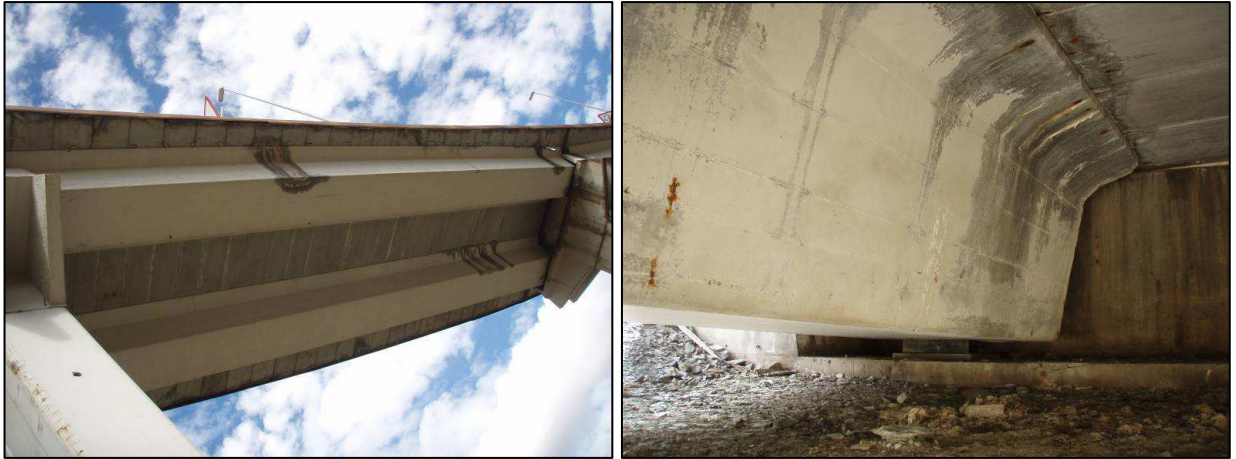
In many paraments of the structure shows the degradation of concrete mass, starting altering cementitious mass itself that becomes micro-cracking and spalling, leaving the aggregates in sight, which then come off, resulting in loss of material. This effect is due to the combined and synergistic action of freeze-thaw and salt crystallization. Both effects are mainly active in the most exposed areas in which water with salts drains. This effect is observed in a particularly intense in the base of the safety barrier system, mainly on the left side, where large areas are totally deteriorated (responsible for maintenance of the Concession reported about recent timely repairs on this element). This has also been observed in concrete abutments.

*Figures nº 10 and nº 11. Concrete beams surface alteration with the presence of punctual reinforcements in sight*

For the beams of the deck, sandblasting of the paraments affected is recommend (in case of reinforcement in sight, it is necessary to discover itching around to clean them up and proceed to pasivante, adding reconstruction mortar type R4, DIN EN 1504). In the repaired paraments is recommended to apply a protective coating with repellent feature, in order to allow evaporation and elimination of possible leakage sites (Principle 2, method 2.1 UNE-EN 1504-9:2011). In abutments, it is recommended in the abutment No. 2 a deep sanitizing, which would be recommended to remove at least 10 cm thick coating, applying reconstruction mortar (type R4, UNE EN 1504) and the use of protective reinforcement and concrete with corrosion inhibitor (follow requirements offered for piers). In the repaired paraments is recommended to apply a protective coating with repellent feature, in order to allow evaporation and elimination of possible leakage sites (Principle 2, method 2.1 UNE-EN 1504-9:2011).

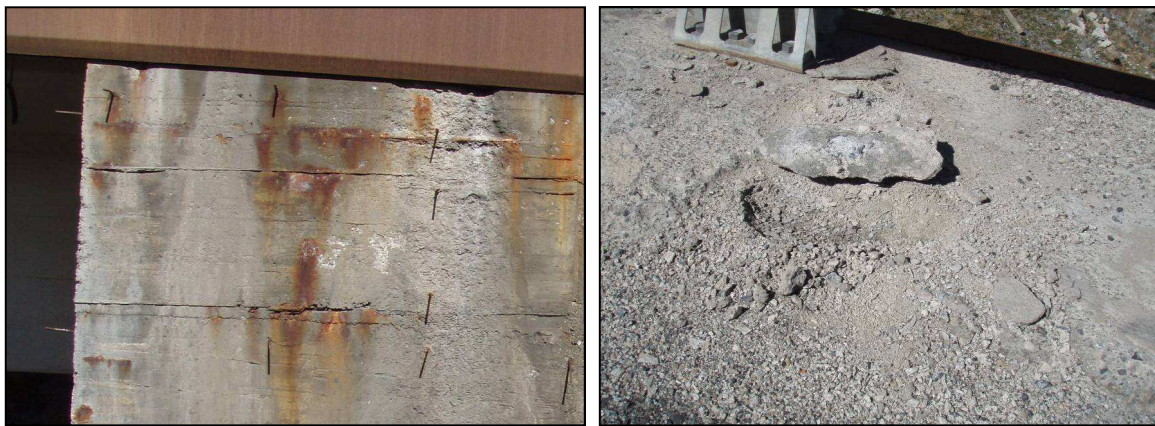
*Figures nº 12 and nº 13. Degradation of concrete abutment No. 2 (left) and surface alteration of concrete base for safety barrier (right)*

As a second stage, to those elements in permanent contact with the water and the snow (mainly concrete bases of safety barrier system), it is recommended to clean up and demolish the concrete, always coming to the reinforcement, cleaning up and passivating it) and reconstruction with mortar (type R2, UNE EN 1504). Prior to concreting, it is recommended that once the reinforcements are clean, they are protected with a product with corrosion inhibitor (active protection for reinforcement, due to Principle 11 11.1, method UNE-EN 1504-9:2011). That product can also act as a union bridge with the mortar.

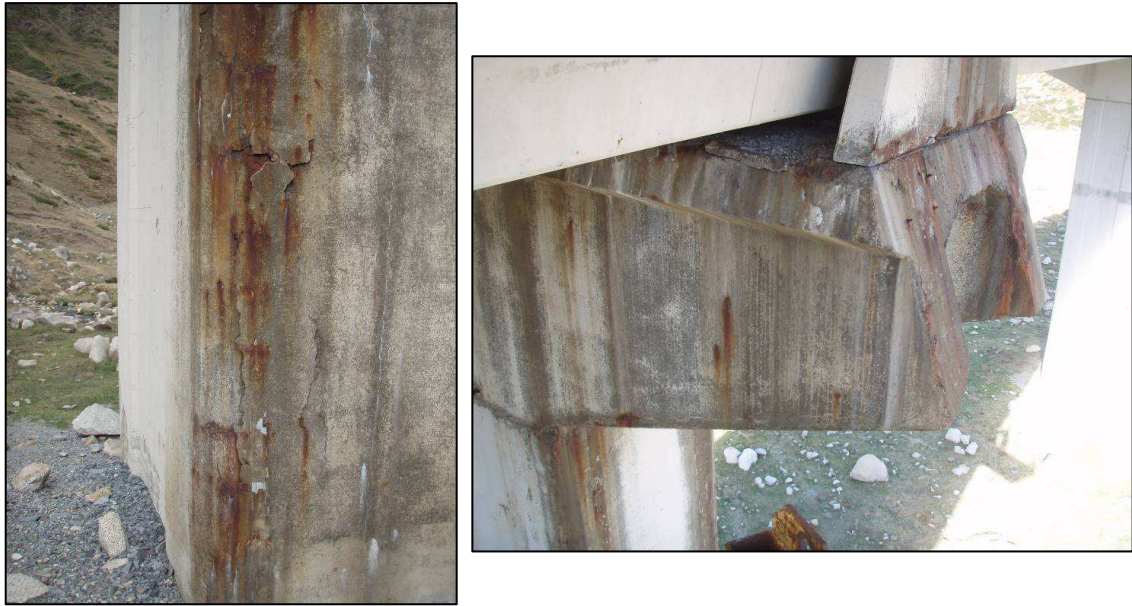
The hardest hit walls in piers are those located on the south side of the structure, since the deck lateral slope causes the water to fall to this side. On the other hand, the prevailing winds are from south to north on the valley under the viaduct, so that the water affects the south-facing paraments. Because water with chlorides filtration (from the molten salts composed primarily of sodium chloride), corrosion processes are triggered very active in the reinforcement, which affect areas with the highest incidence of moisture (facing south); within these are particularly evident in the areas of lower coating thickness. This shortage of coating was recorded especially in the corners of some of the pier shafts; it has been detected on a detailed visual inspection that this covering failure had tried to be alleviated by successive layers of repair mortar. It was found that these layers are undergoing degradation, being one of the most affected areas

*Figures nº 14 and nº 15. Detail views of spalling, stains and alteration of concrete surface at bottom of pier No. 2 (top left) and detail view of the pier cap (top right)*

In those elements on which the water is not going to have a contact as permanent and harmful, it is proposed the sanitizing and reconstruction of damaged concrete paraments, restoring lost materials and reinforcements coatings, to thicknesses according to durable conditions as shown in the EHE-08, considering the characteristics and aggressive environment of the structure. In the piers, more damaged than the other elements, it is proposed to demolish to find sound concrete (due to the tests performed, it is recommended to demolish at least 12 cm, always coming to the reinforcement and removing degraded concrete layers and passivate the reinforcement) and reconstruction with mortar (type R4, UNE EN 1504). Prior to concreting, it is recommended that once the reinforcements bars are clean, they are protected with a product with corrosion inhibitor (active protection reinforcements Principle 11 11.1 method UNE-EN 1504-9:2011), that can also act as a union bridge. It is advisable also to apply a corrosion inhibitor to the concrete mass, in order to establish a multilayer protection system. This migration will be of type inhibitor when applied to existing concrete and aggregating to the new concrete to be used in the reconstruction. In the repaired paraments is recommended to apply a highly waterproof system (Principle 2, method 2.2 UNE-EN 1504-9:2011).

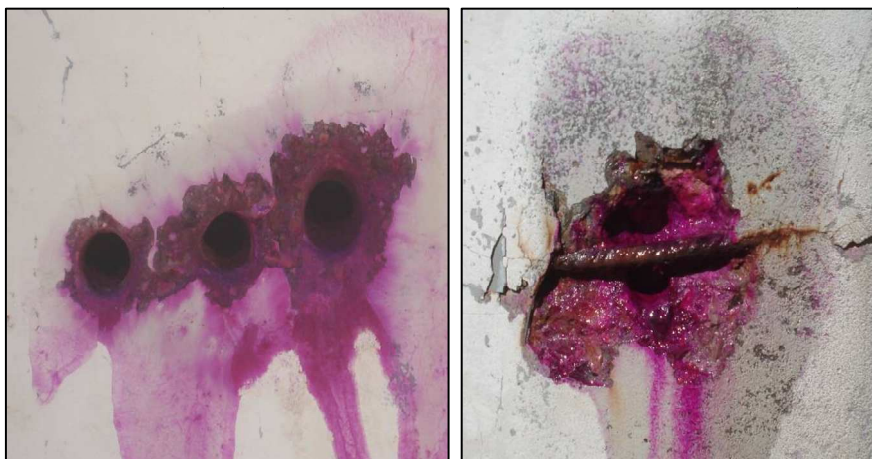
The data obtained indicate that the carbonation is negligible in all sides of the shafts, so this data extrapolated to the rest of the structure, is considered that the carbonation is not the trigger of corrosion processes logged.

Figures nº 17 and nº 18. Advance of carbonation front in piers No. 2 and No. 3 respectively

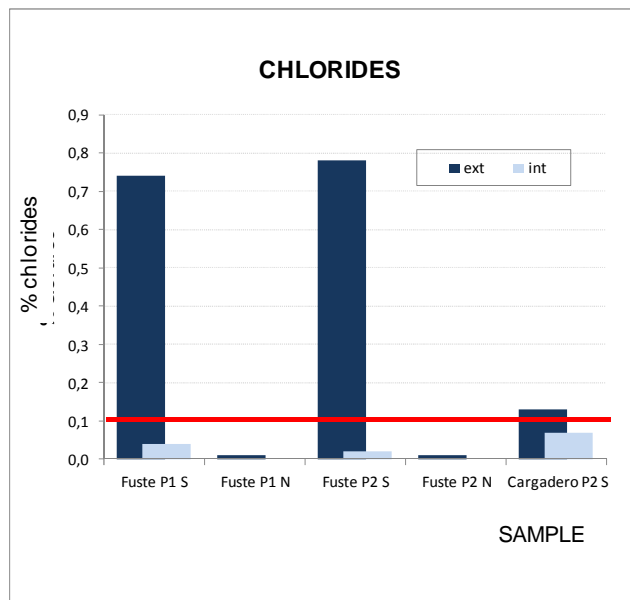
- South facing paraments in the shafts of all piers
- Pier caps No. 1, No. 2 and No. 5, in the south paraments and east and west half paraments
- Full abutment No. 2

Figure n° 19. Chlorides concentration data in concrete samples

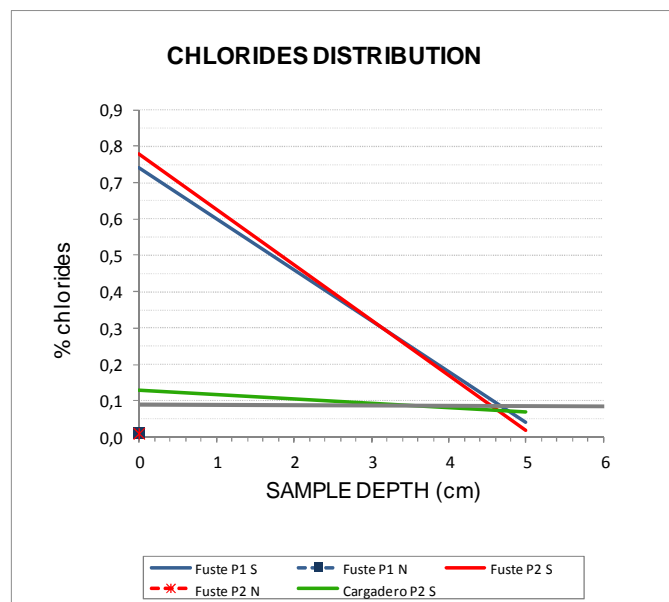
The maximum limit of chlorides currently prescribed in EHE Regulation for concrete is 0.4% relative to the weight of cement (half in the case of prestressed concrete). If it is a good concrete (350-380 kg of cement per cubic meter of concrete), this limit will be approximately 0.05-0.10% by weight relative to the concrete, so has been taken this value as the maximum permissible limit. Figure No. 19 shows the chloride concentration determined for each sample. As can be seen, the chloride content of samples taken on the south side is clearly significant (above 0.1%), dropping to negligible levels inside (samples "interior"). However, none of the samples taken on the north side are contaminated by this aggressive ( $[Cl^-] < 0.01\%$ ). Furthermore, the distribution indicates that this aggressive chlorides derived from the molten salts used, not having been added during casting (or setting regulator contaminating any component). In Figure No. 20, these data are represented in the form of profile.

Figure n° 20. Chloride distribution in samples

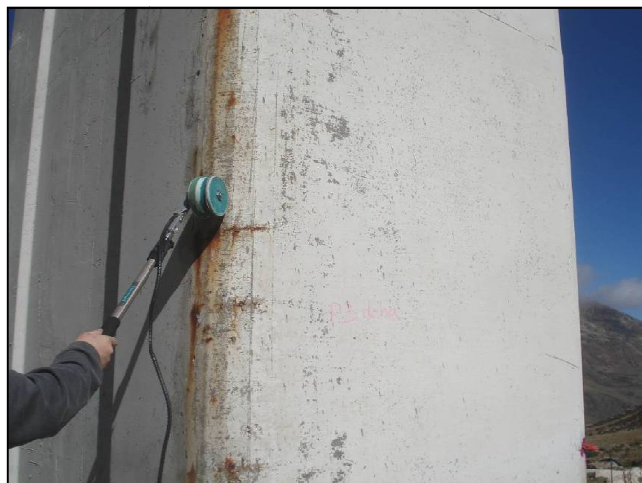
- Searches conducted on the northern paraments indicate passivity of reinforcement (more positive  $E_{corr}$  -275 mV), which is consistent with the absence of aggressive (chlorides and carbonation negligible) to begin the process of corrosion
- Searches conducted on the southern paraments clearly indicate active corrosion visually affected areas, consistent with the high content of chlorides obtained in these area, triggers the oxidation process

Figure nº 21. Corrosion potential record in south parament at pier No. 3

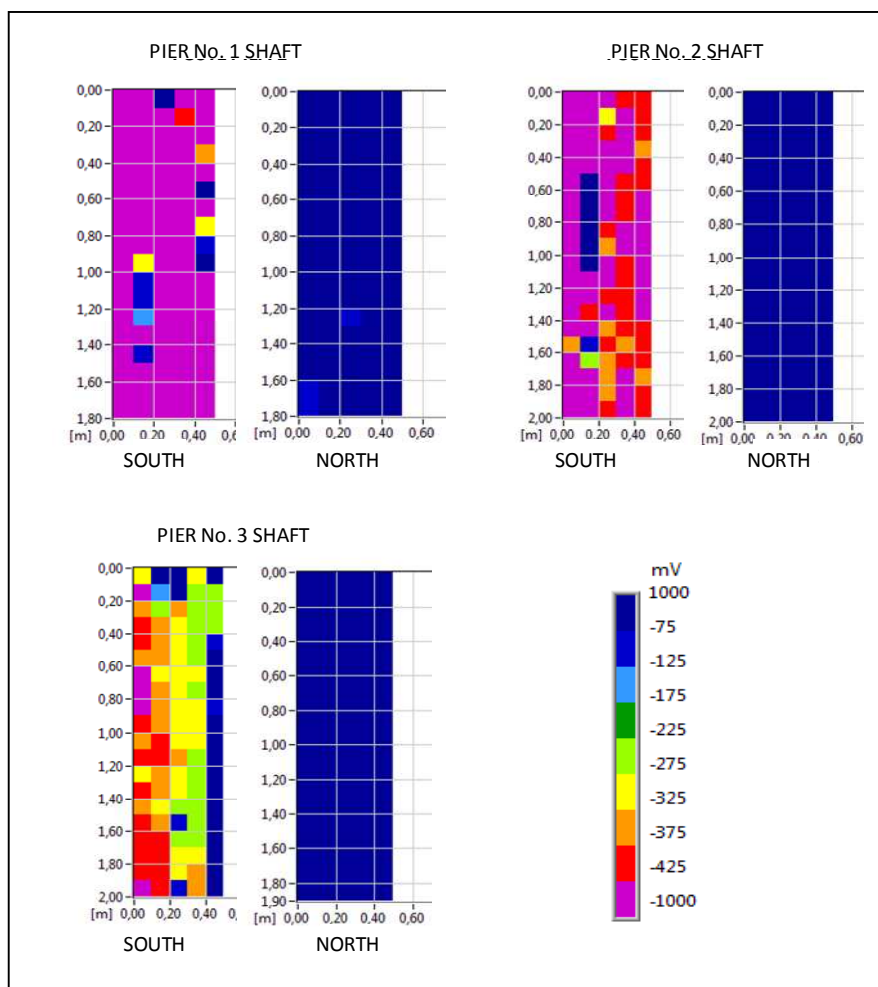
Figure n° 22. Potential maps on north and south paraments at piers No. 1, No. 2 and No. 3
