STUDY INTO THE DAMAGE TO VARIOUS CONCRETE BRIDGES DECKS WITH INTENSIVE WINTER MAINTENANCE

Alvaro Navareño Rojo
General Road Directorate, Ministry of Public Works, Spain
anavareno@fomento.es
Gonzalo Arias Hofman
INES Ingenieros, Spain
gah@inesingenieros.com
Emilio Criado Moran
General Road Directorate, Ministry of Public Works, Spain
jecriado@fomento.es
Marta García Guillot
Chemistry consultant, Spain
martagarciaqui@gmail.com
Ana Belén Menéndez Corral
GEOCISA, SA., Spain
abmenendezc@geocisa.com

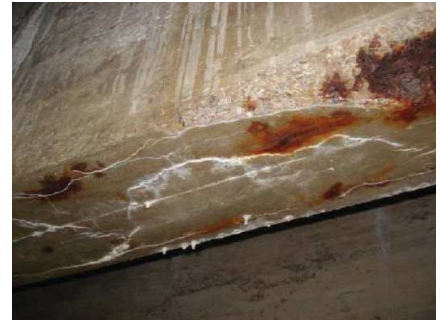
Figure 8. Structure nº 2; N-630, p.k 88

On the right image can be seen concrete of a beam with cracking, spalling, rust staining, and concrete precipitates, indicating about an important pathology.

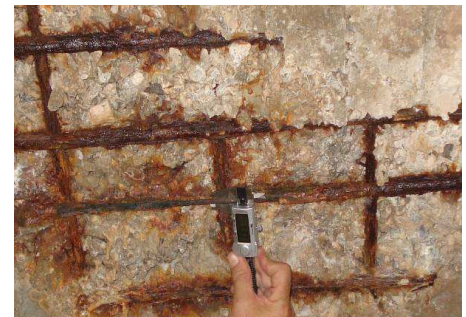
Figure 9. Structure nº 2; N-630, p.k 88

Some of the most important data is to assess the state of passivation protection and reinforcement, since its oxidation leads to loss of bars section (see Figure 9), reducing the structural capacity of the bridge.

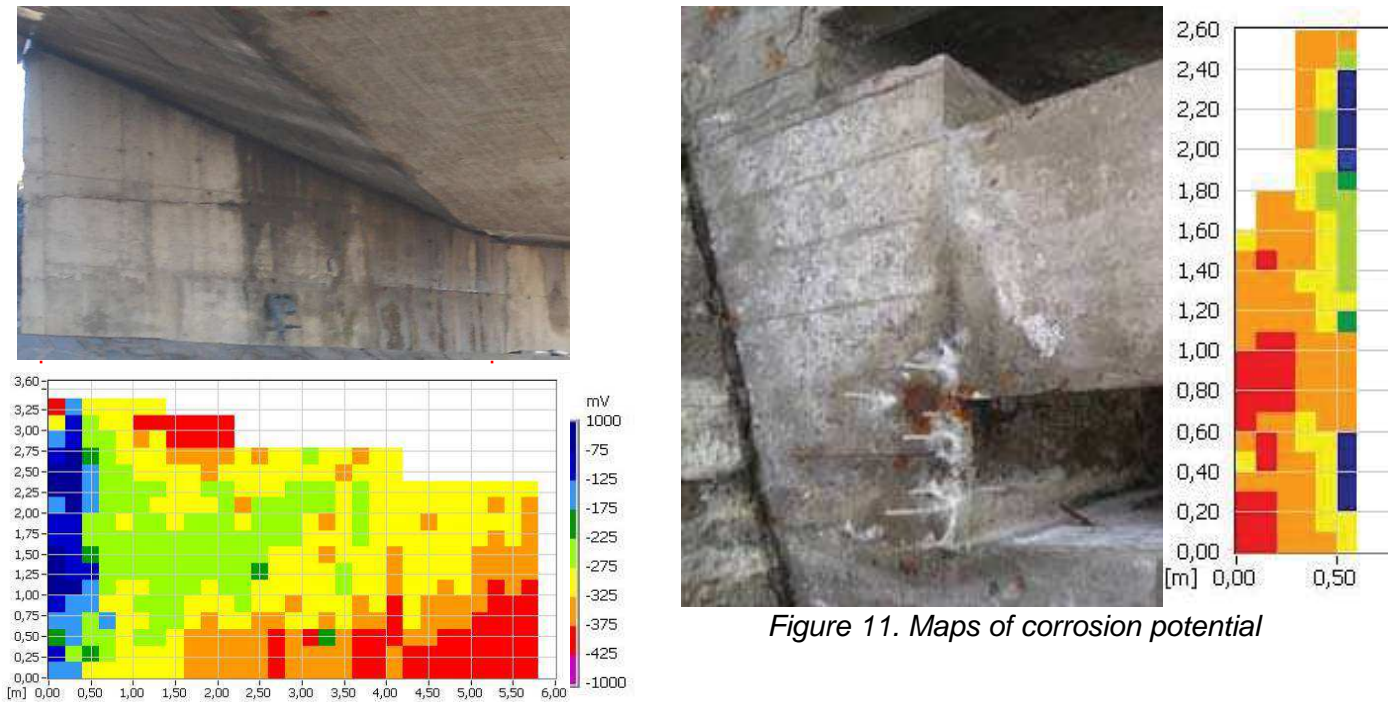
Figure 11. Maps of corrosion potential

As shown in the maps, there are areas with a high degree of corrosion risk even if it cannot be observed from the outside.

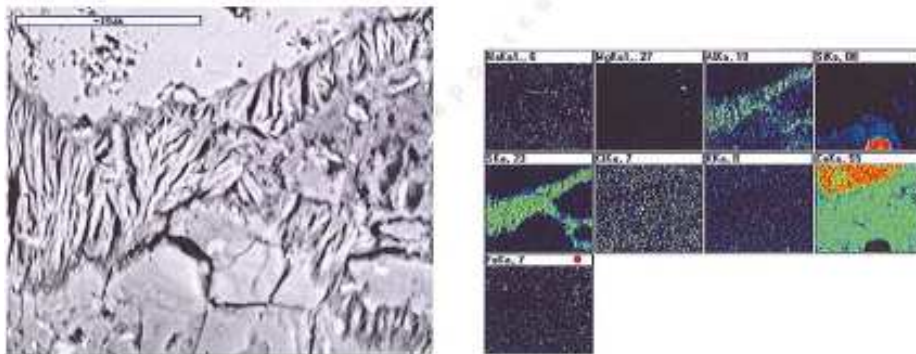
Figure 12. Microscopy: crystallization of ettringite in cracks and map elemental composition

Among the tests performed, it was determined the presence of ettringite and alkali aggregate reactions emerging into some of the structures.

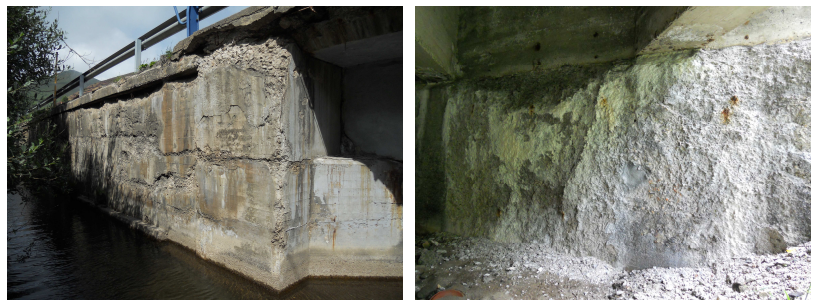
Damages are similar, and focus on the existence of corrosion in localized areas of the deck, movement of water and concrete degradation in edge areas, elevations and localized in some abutments associated with freeze-thaw cycles, exacerbated by the de-icing salts used on the road. (To determine this, the General Road Directorate is carrying out a research in the Institute Eduardo Torroja based on the application of freeze-thaw cycles with and without salts in different conditions). This freeze-thaw damage is extensive, although

Figure 13. Damage at abutment and sidewall due to freeze-thaw cycles

not widespread, and can be seen in areas corresponding to accumulation of snow, or certain elevations (not always on the same side of the road, despite being the same stretch, associated with the same sunlight and shade), so it must have great influence the local microclimate of each bridge, and its implementation in the road.
