# **The influence of anti-freezing agents on the deck of highway bridge, and its countermeasures**

Nasu administration office, East Nippon Expressway Company Limited, Japan

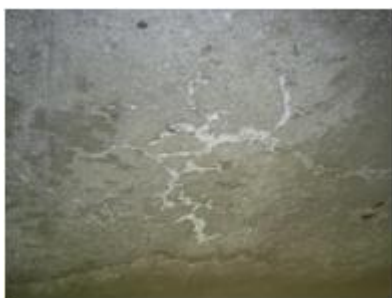
Picture 1-Free lime on the primary plate

We conducted research for the occurrence status of free lime from the bottom of the deck. Table 3 shows the results and Picture 1 is a photograph of the inspection work. Compared with the primary plate of the other bridges, there were more Assessment A free limes on the primary plate of Michinoku Bridge. Inspections of each panel revealed, free lime had

(assessment A3)

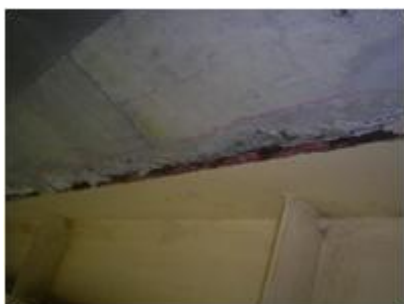
Picture2-Exfoliation on the primary plate

We conducted research for the occurrence status of exfoliation, floating, exposure of reinforcing bars, cavity, and honey comb on the primary plate. Table 4 shows the results. And Picture 2 is a photograph of the research work. Compared with the primary plates of other bridges, there was more exfoliation and floating on the primary plate of Michinoku Bridge. Concerning the reasons, we considered that the anti-freezing agents got in the cracks, which occurred because of the curbstone above the G4 girder, and brought on salt damage.

(assessment A3)

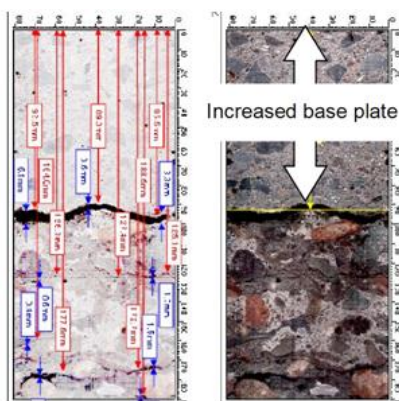
Picture 3-A photograph of the core(P2-3)

cruising lane of P3-P4, which are evaluated as “having damaged areas” in the impact echo inspection mentioned above. In Picture 3, which was taken by the stick scanner, we found a 6.1mm horizontal crack at 92.8mm from the surface and a 1.7mm horizontal crack at 126.3mm from the surface. Since the thickness of the increased deck is 93mm, it turned out that the horizontal crack on the surface side occurred on the boundary of the increased deck and the established deck. Concerning the horizontal crack on the bottom side, since it is located at about 180mm from the deck surface, it can be considered that it exfoliated somewhere around the reinforcing bars on the bottom side. Also, there was a horizontal crack in the idle of the established deck at 126.3m from the surface of the deck. From Picture 4 which was taken by the stick scanner, we found a 5.2mm horizontal crack at 89.4mm from the surface side, and a 10.4 horizontal crack at 104.6mm from the surface side. Since the thickness of the increased deck is 62mm, it turns out that the upper horizontal crack occurred on the upper reinforcing bars in the established deck. Also, we found out there is a cavity in the deck. As well as in the results of other observations, we found horizontal cracks around the boundary of the increased deck and the established deck in 5 spots out of 22 spots. The reason can be considered that the increased deck and the established deck didn't unite properly because of the grinding, cleaning, and compaction were not good enough when the increased deck was positioned in 1996. Also, there are 10 spots out of 22 spots in which we found horizontal cracks in the established deck. The reason for these cracks can be considered that micro cracks occurred in the established deck because of the concrete breaker when the increased deck was positioned in 1996, or erosion of the reinforcing bars because of salt damage. Also, we found a water effusion in the deck, though we performed water proof processing when the increased deck was positioned. The reason could be that water entered from the damaged curbstone and joints of the road surface and remained. Also, the infelicity of the selection of water proof processing for the deck or the methods of surface processing, and the malfunction of water proofing in the deck because of external influences such as the aggregate and the weight of the traffic etc, could be another reason to find stagnant water inside.

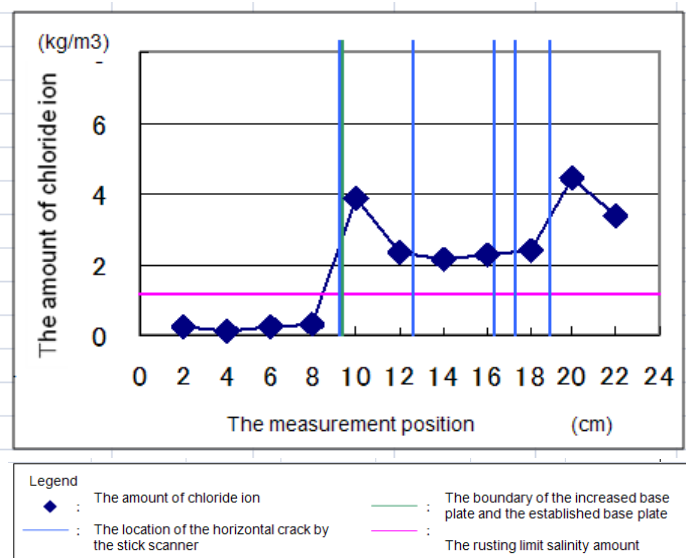
Figure 6-The results of salinity measurements

Figure 6 shows the results of the salinity measurement with a portable fluorescent X-ray in P2-P3 of the cruising lane. Since we added the data for horizontal cracks which were obtained from the inspection with a stick scanner, the relevancy of the salinity can be observed in the graph. The results of the salinity measurement show that the salinity is high on the boundary of the increased deck and the established deck and around the horizontal cracks. It is because the water which includes anti-freezing agents entered from the damaged parts of curbstones and wheel guards, and spread to the boundary of the increased deck and the established deck, and the horizontal cracks in the deck, we concluded. Also, the horizontal cracks which occurred in the spots with high salinity have a high possibility that the reason is an erosion of the reinforcing bars because of salt damage.

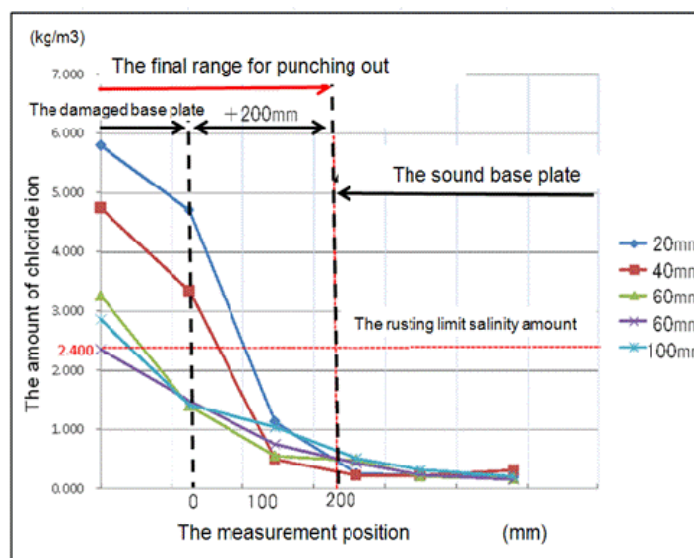
Figure 7-The results of salinity measurements (P5)

Figure 7 shows the results of the salinity measurement research. From the damaged area to the sound area, the concentration of salinity tends to decrease. Also, it is clarified that if we decide the punching out range for +200mm from the damaged area toward the sound area, the Chloride ion concentration goes below  $2.4\text{kg/m}^3$  (this standard is the occurrence limit line which is referred from the bridge repair construction which NEXCO East has conducted thus far). The same results were obtained in the other inspection spots, too. Seeing the salinity concentration at each depth, revealed that the salinity concentration in the damaged area is higher in the bottom area, and it goes lower toward the middle of the deck. Before this research we set the punching out range on the deck of Michinoku Bridge for  $184\text{ m}^2$ , but we decided to set it for  $283\text{ m}^2$ , which is  $100\text{ m}^2$  more than the original plan, according to the results of this research. (Figure 8)

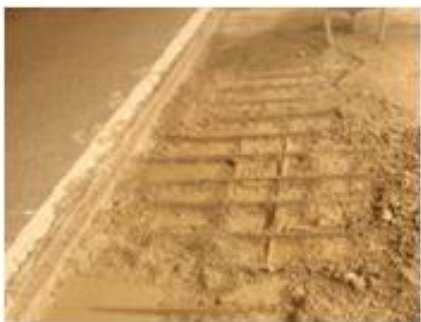
Picture 6-Stagnant water in the established base plate

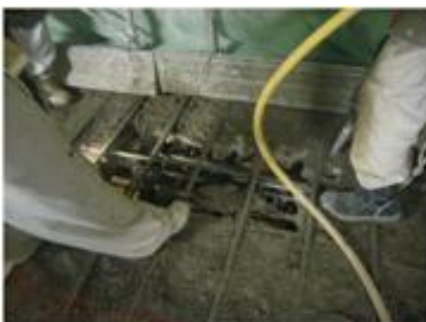
Picture 7-Base plate goes into sand state

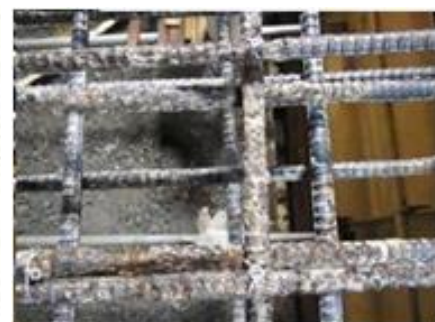
Picture 8- Defect of reinforcing bars

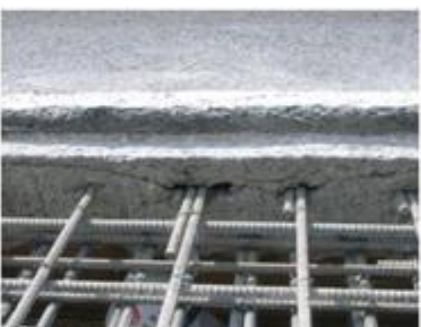
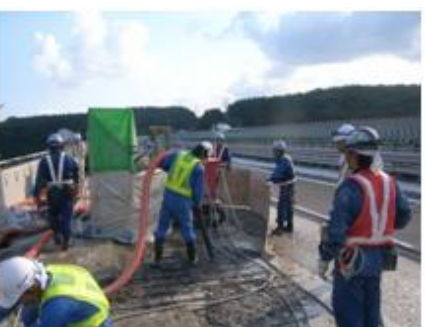
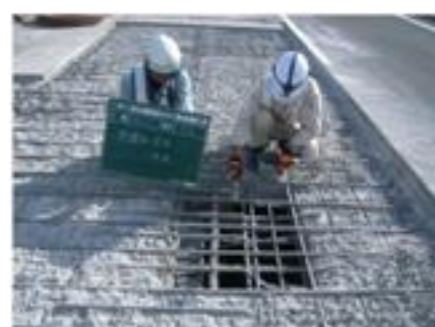
Picture 9-Horizontal crack
