# SNOW FENCES PINO HACHADO INTERNATIONAL PASS

F. AGUIRRE  
Dirección Nacional de Vialidad, Argentina  
aguirre.ing@gmail.com

## ABSTRACT

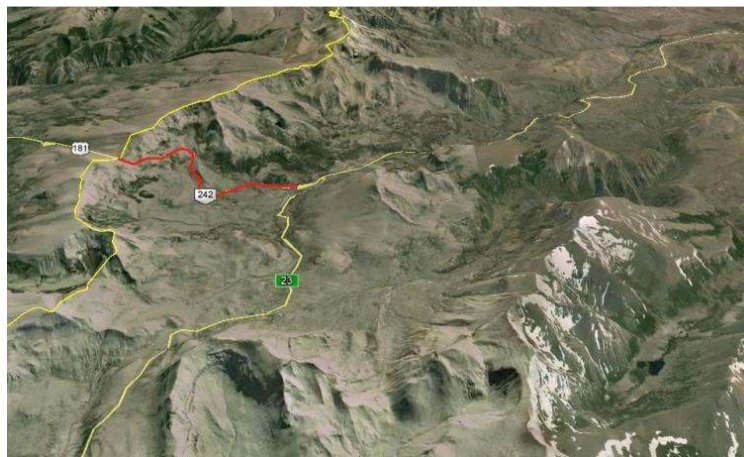
National Route No 242, located on the Argentine side, has a sinuous trace inside a volcanic caldera, presents sectors with cross sections on hillside or over trough cut, with an average longitudinal gradient of 5%.

Figure 1 - Trace of Route No 242

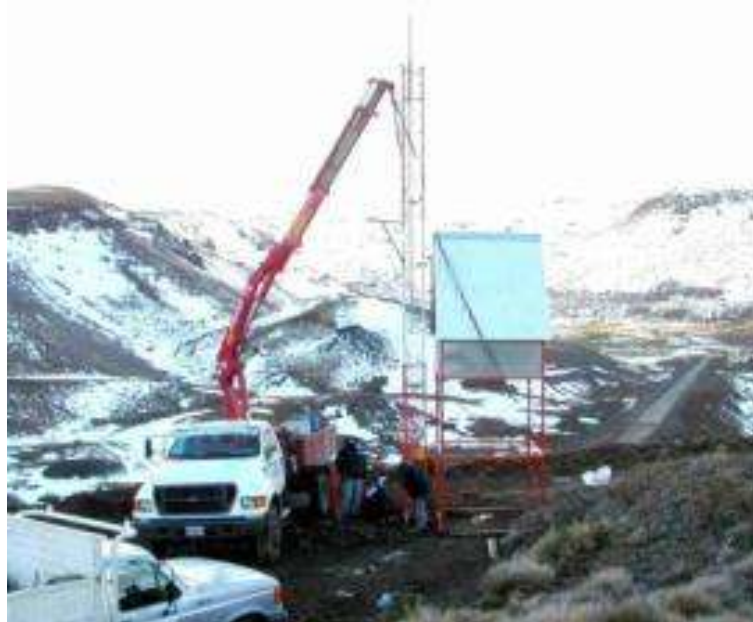
In 2005 was installed a weather station, giving meteorological parameters quantified the site, especially the speed and wind direction.

Figure 2 - Weather station

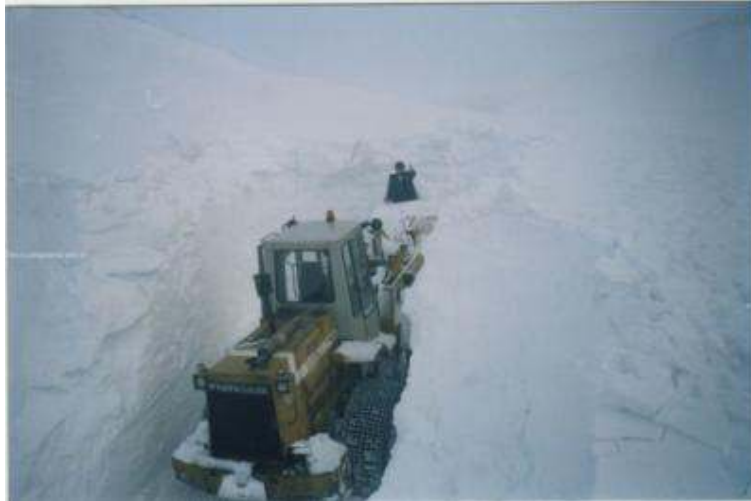
Figure 3 – Maintenance after drifting snow

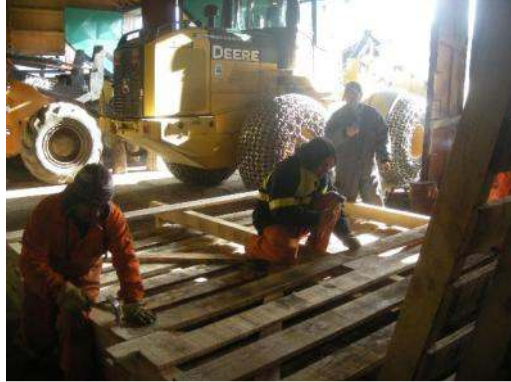
The panels are built with tables whose width is 4 "to 6", The panels are built with tables whose width is 4 "to 6", with a porosity between 35% to 50%, the pieces are held together with spiral nails, forming panels of 3 m / 10 ft high and a width varying from 2.40 m / 8ft to 3.00 m / 10 ft, according the tables that the supplier has available.

Figure 10 - Construction of panels

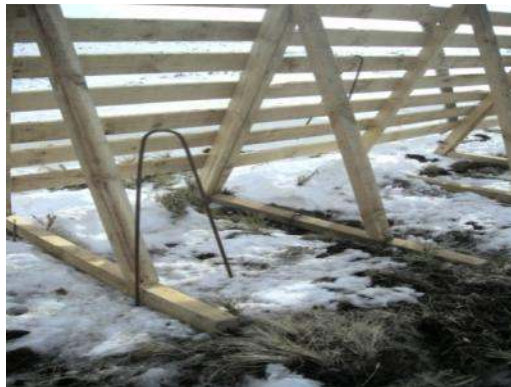
The anchors are made with a reinforcement steel ribbed bar  $\varnothing$  12 mm / N # 4 (1/2"), inverted U-shaped.

Figure 11 - Anchors

Therefore adopts the model of Figure 2, which replaces bar  $\varnothing 19$  mm / No. 6 (3/4 ") with a No. 4 (1/2") to be put into the ground as inverted U.

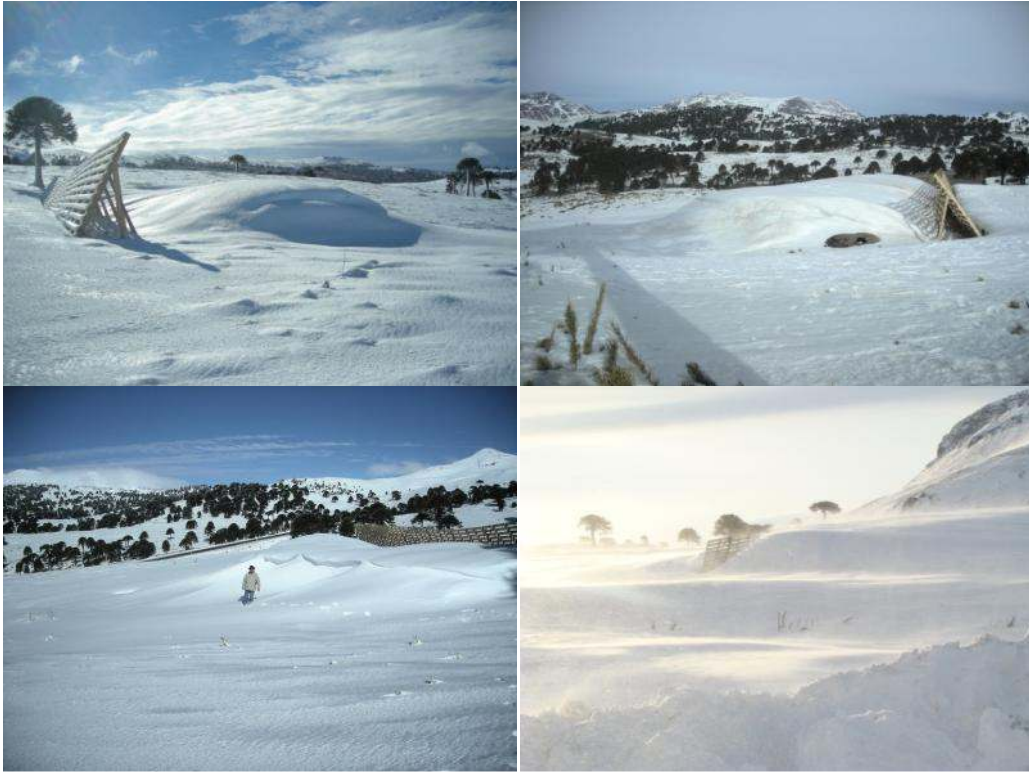
Accumulation stages predicted by the theory of Tabler [1] are verified, in all cases the snow accumulation downwind is less than expected and varies according to the slope of the land where it is located.

Figure 12 - Stages of snow accumulation

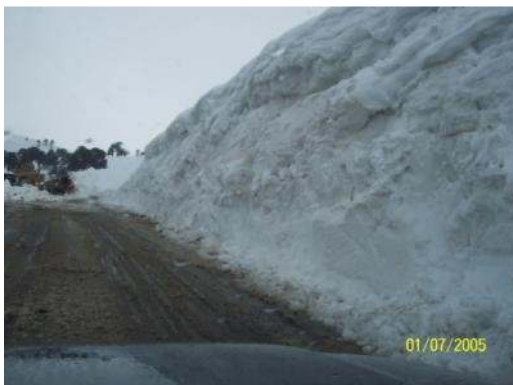
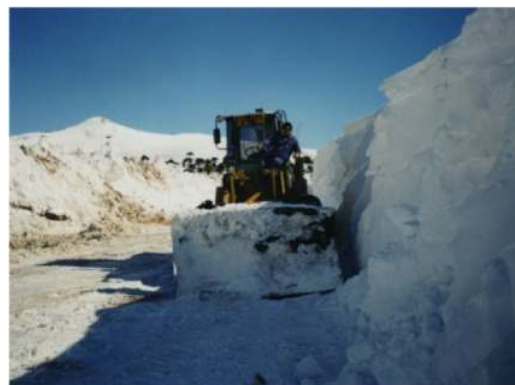
Figure 15 - Images prior to fencing

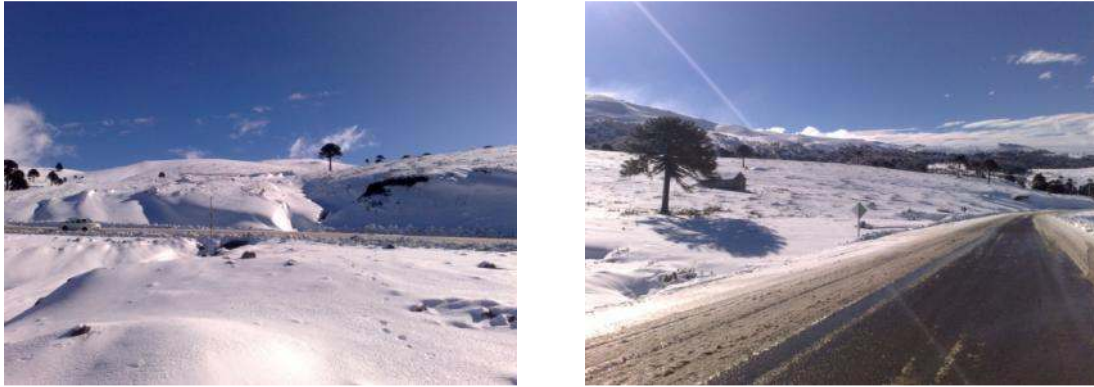
The sectors where fences have been placed accuse significant changes in relation to the accumulation of snow on the road, the workers who keep road say that the sites where tasks previously performed with bulldozer and front loader can now keep with motor grader. Consequently causes a reduced rehabilitation times and less operating costs of equipment.

When the wind speed reaches the maximum, the visibility is very low and stops traffic for safety reasons, in these snowy conditions accumulation on fences is very important and on the road the deposition is reduced by approximately 80%.

Figure 16 - Images post fencing
