MEASURES FOR PREVENTING DROPPING SNOW FROM ROAD ACCESSORIES ON EXPRESSWAYS

ABSTRACT

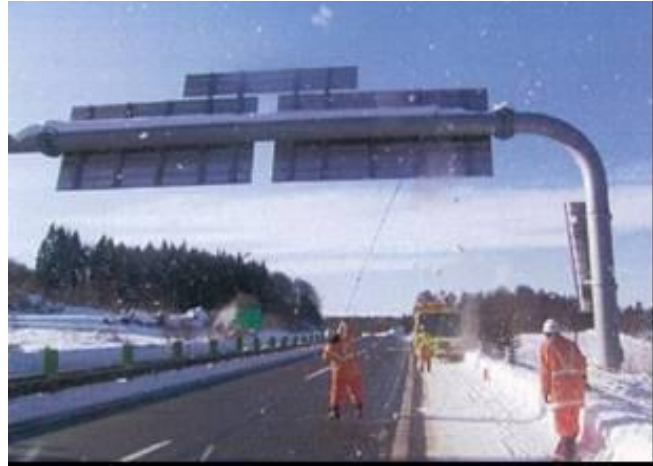
Photo 3: Snow Removal Work for Preventing Snow Drop

Snow accretion occurs on the top of gate type post of road signs. Currently, snow is removed from the post manually using an extendable pole (Photo 3). The problem with this work is that the worker conducts the work while standing under the gate post and takes significant time. There is also a concern that snow may slide and fall onto the worker and may cause an accident. Further, because work is carried out with lane regulations in place on the expressway, work is limited to keep traffic safe, avoiding snow fallen on the road surface or causing poor driving visibility. It is difficult to carry out work properly.

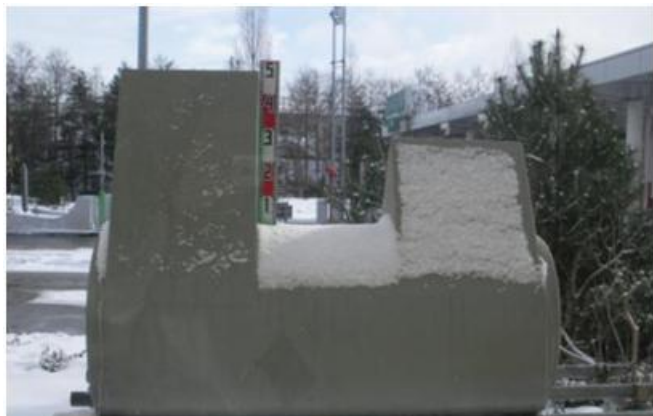
Photo 5.: Test construction conditions

incline of 67.5°, we verified that the amount of snow accretion was little due to the steep incline. Lumps of snow that formed fell to the ground early in the morning due to solar radiation, because of the heat insulation effect of the Styrofoam (Photo 5).

According to the experimental construction results and camera images, there were 15 occurrences of snow accretion. With regards to the test piece without an inclined panel, it was verified that snow accretion continued for six hours from sunrise and it remained likely that lumps of snow would develop. With regards to the two test pieces with an inclined panel, it was verified that there was snow falling from the post with little snow accretion and that the effectiveness of the snow accretion prevention methods was clear. Moreover, in the case of the test piece with the delta-shaped inclined panel with a sharp

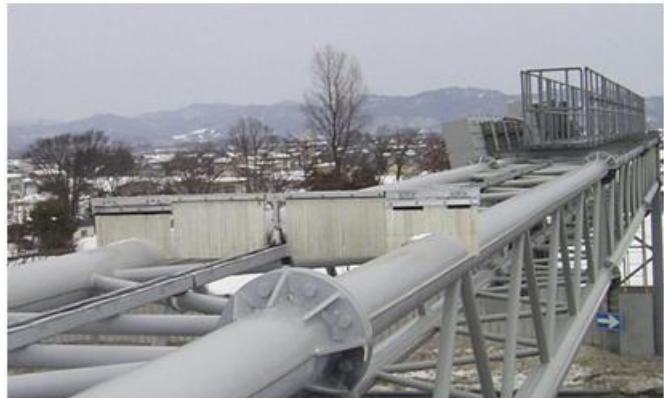
Photo 6: Installation conditions for Snow Clearing Device

A rail parallel to the beam was installed at the center of the beam of the lattice section and then a pulley with a brush attached was installed. The pulley was fixed with a wire, like a cable car, and a hand-operated winch installed, so that the brush can move in both directions parallel to the beam. The winch was installed to the supporting column of the gate type road sign to enable manual operation (photo 6). Galvanized steel was used and a movable plate was attached to the base of the brush to allow it to ride over the beam joining sections.

We installed a movable brush to the road sign and forcibly removed the snow accretion by moving the brush using a winch and rail.
