PIARC INTERNATIONAL WINTER ROAD CONGRESS

Assessment and repair of bridges subjected to de-icing salts

Mr. Ulrik Sloth Andersen
Project Director, MSc
Ramboll Denmark
Hannemanns Alle 53
2300 Copenhagen S
Denmark
ulsa@ramboll.dk

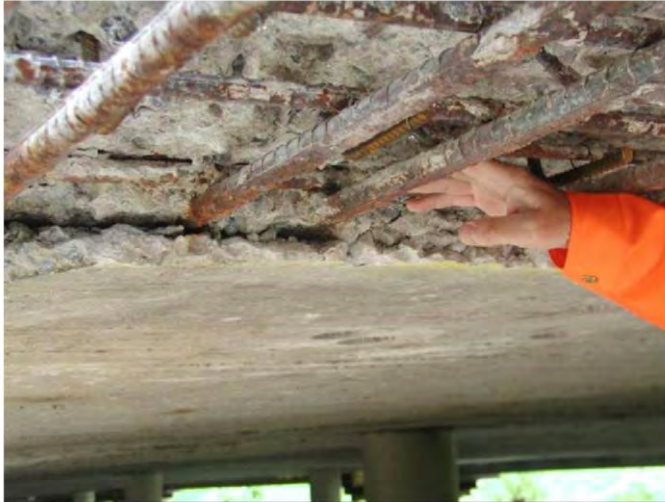
The photo below shows the soffit of a RC bridge deck exposed to chlorides, alkali-silica reactions (ASR) and frost-thaw:

Fig. 1. A bridge deck subjected to de-icing salts.

One of the effects of ASR is a significant expansion of the concrete. The expansion takes place in the direction where a minimum of energy is required to cause the expansion. Hence, a slab with minor stirrups will often form a horizontal crack pattern as indicated in the photo above.

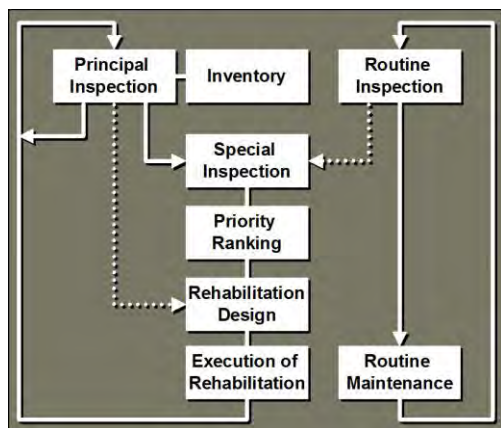
Operation and maintenance of bridges usually follow the processes indicated on figure 3 below:

Fig. 3. Operation and maintenance flow.

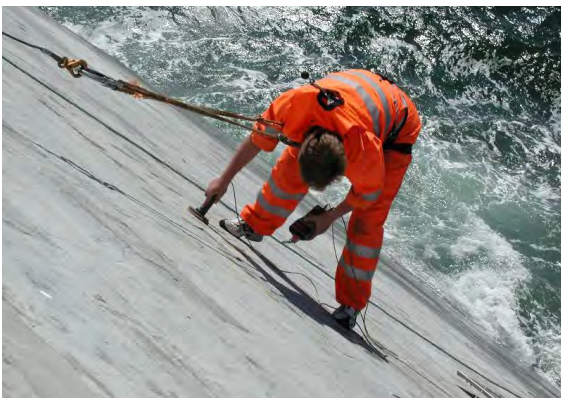
NDT testing with s'MASH is shown in Fig. 4 below:

Fig. 4. NDT testing using s'MASH

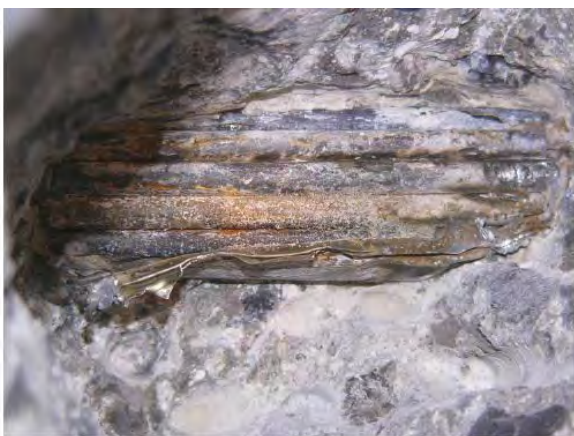
The photo below shows an example of corroded prestressed reinforcement due to chlorides:

Fig 6. Corroded prestressed reinforcement due to chlorides.

Corrosion of prestressed strands is critical since the strands consist of several wires with a small diameter. Hence, a minor degree of corrosion can cause a high reduction of the cross section of each wire.

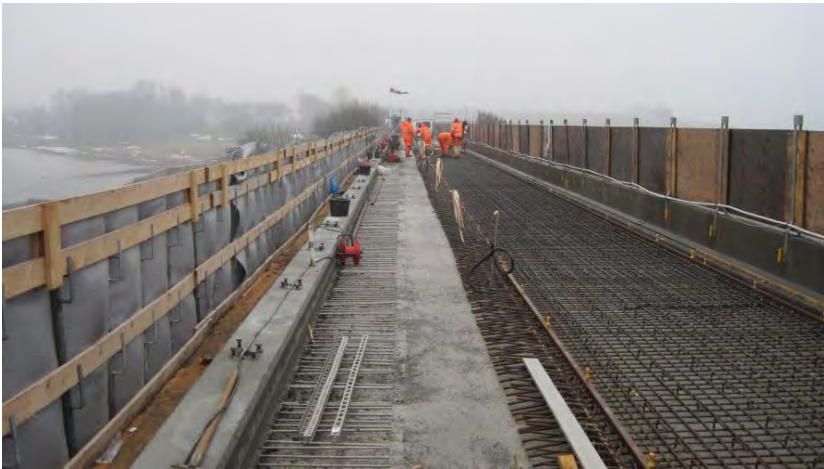
The method is also indicated on the photo below:

Fig. 8. Bridge deck with reinforcement for concrete overlayer

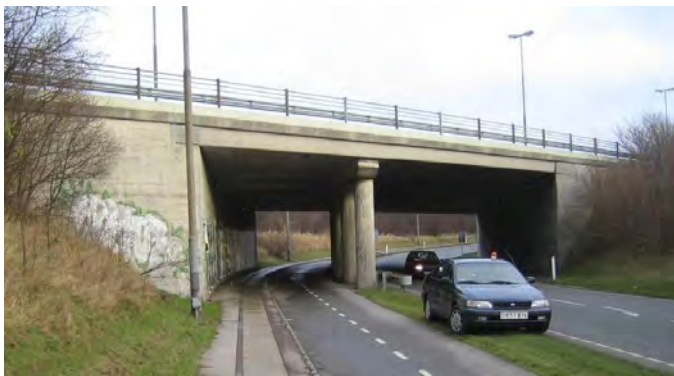
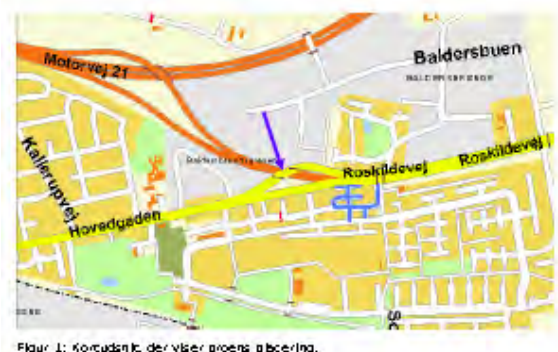
Fig. 9. Elevation of bridge

This project comprises a complete rehabilitation and strengthening of a two-span post-tensioned motorway bridge situated in Roskilde approximately 30 km east of Copenhagen.

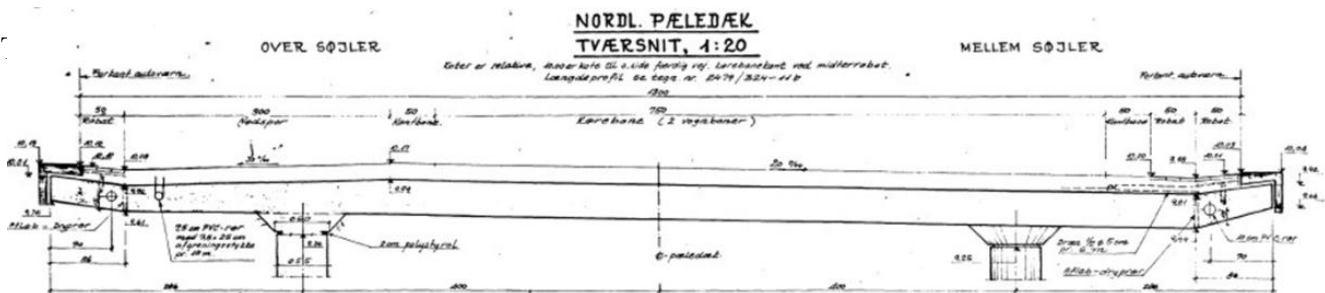
The bridge was constructed in 1972 with a RC slab of a total length of 114 m with a width of 13.7 m thus a total area of 1560 m².

The cross section appears below.

Fig. 13. Cross section of the slab.

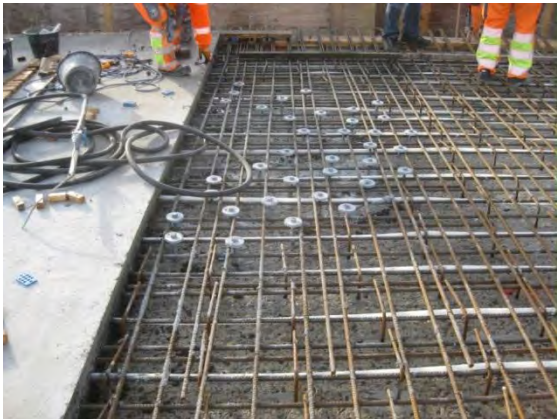
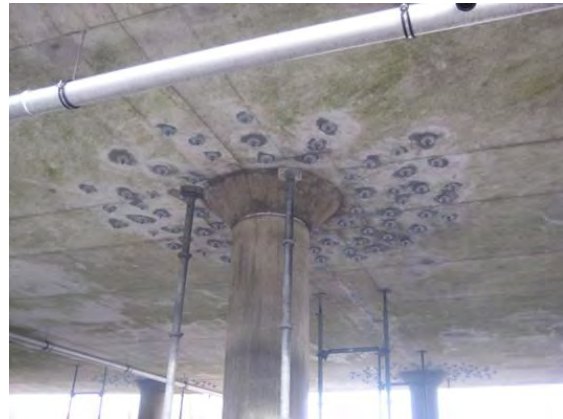
The rehabilitation comprises a new reinforced concrete overlayer. The chloride infected and damaged concrete was removed before the reinforcement (drilled and horizontal reinforcement) was installed. In addition vertical bars (quality M30 8.8) were drilled through the slab around each column with a steel plate on top and soffit of the slab as indicated below:

Fig. 14. Repair and strengthening

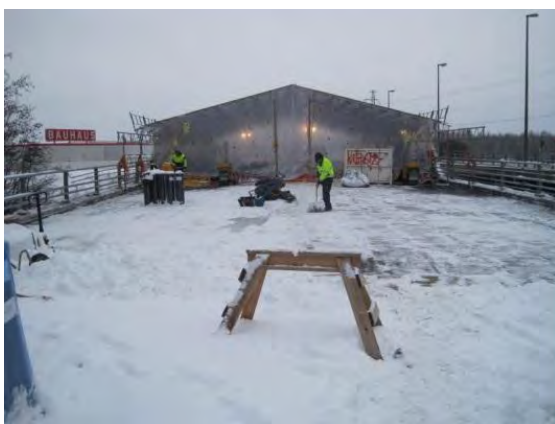
Fig. 15. Tent placed on a similar bridge

The traditional way to ensure the needed climate to continue the work would be a tent combined with hot air provided from oil burners.

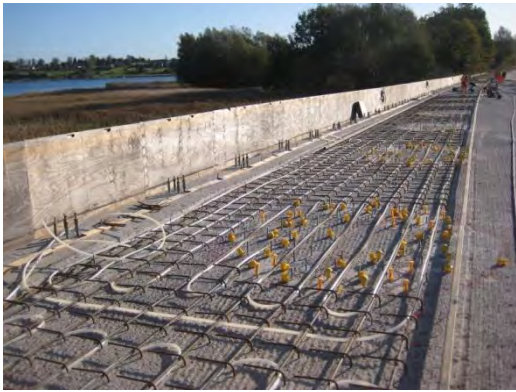
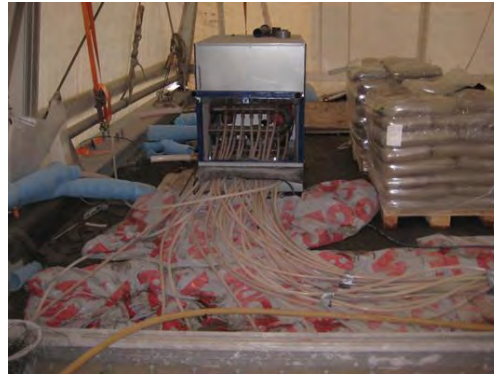
However, in this case a system with hoses containing hot water was installed in the concrete overlayer. The heating system was utilized when the concrete overlayer was cast and subsequent when the water proofing (comprising a primer and two layers of bitumen sheets) and surfacing were carried out:

Fig. 16. Bridge deck with hoses for hot water.
