CRITERIA FOR CLOSING MOUNTAIN PASSES BASED ON FRICTION MEASUREMENT AND CROSSWIND

B.NONSTAD & P.BRANDLI
Norwegian Public Roads Administration, Norway
BARD.NONSTAD@VEGVESEN.NO
PER.BRANDLI@VEGVESEN.NO

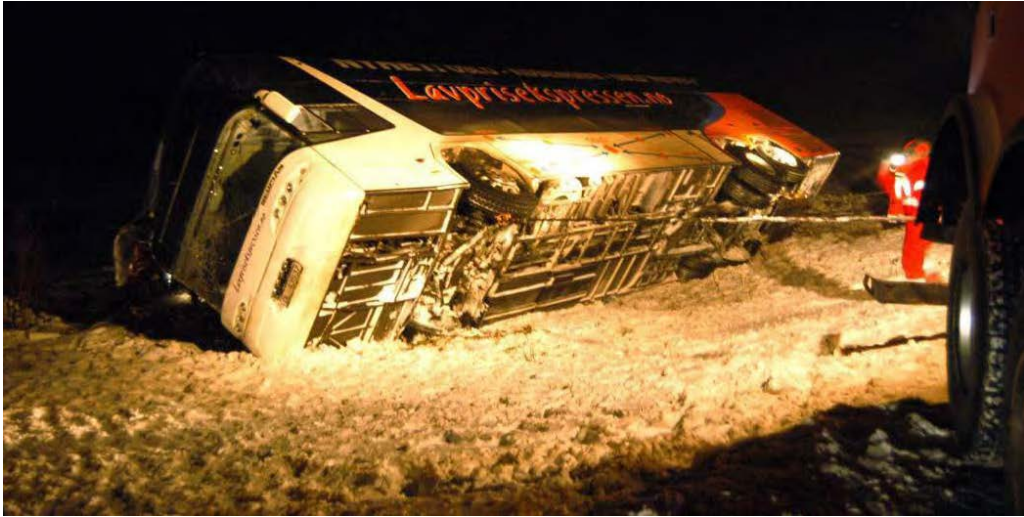
Figure 1 - The recovery operation after the accident. (Source: The Accident Investigation Board Norway).

During the night of November 24th, the coach “Lavprisekspressen” was heading south from Trondheim to Oslo on the E6 highway. The coach was a double-decker MAN Neoplan Skyliner. There were 53 passengers on board on the bus. When the bus was reaching the highest point on the route, the mountain pass Dovrefjell, there was strong wind combined with ice covered road. As a result of this very strong crosswind and the slippery conditions the bus lost the grip on the front wheels and the driver couldn't control the bus. The bus went into the ditch and turned over and landed on it's right side when reaching the flat ground. [1]

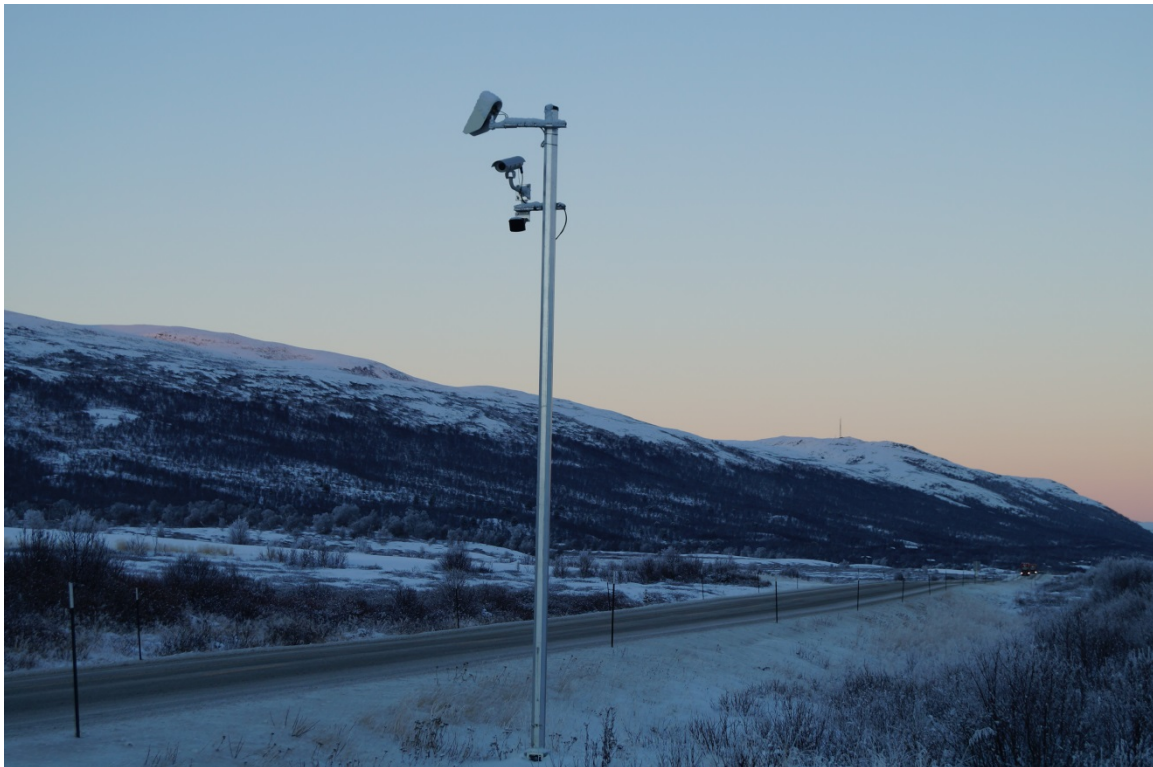
Figure 3 - Weather station with wind sensor, web camera, surface- and air temperature and a road surface state sensor.

There are installed three weather stations in this section of the road. The weather stations give data about the temperature (road surface and air), wind (speed and direction), air humidity and precipitation. On two of this station there are also road surface state sensors which give us a friction index based on registration of the road condition in a little area on the road.

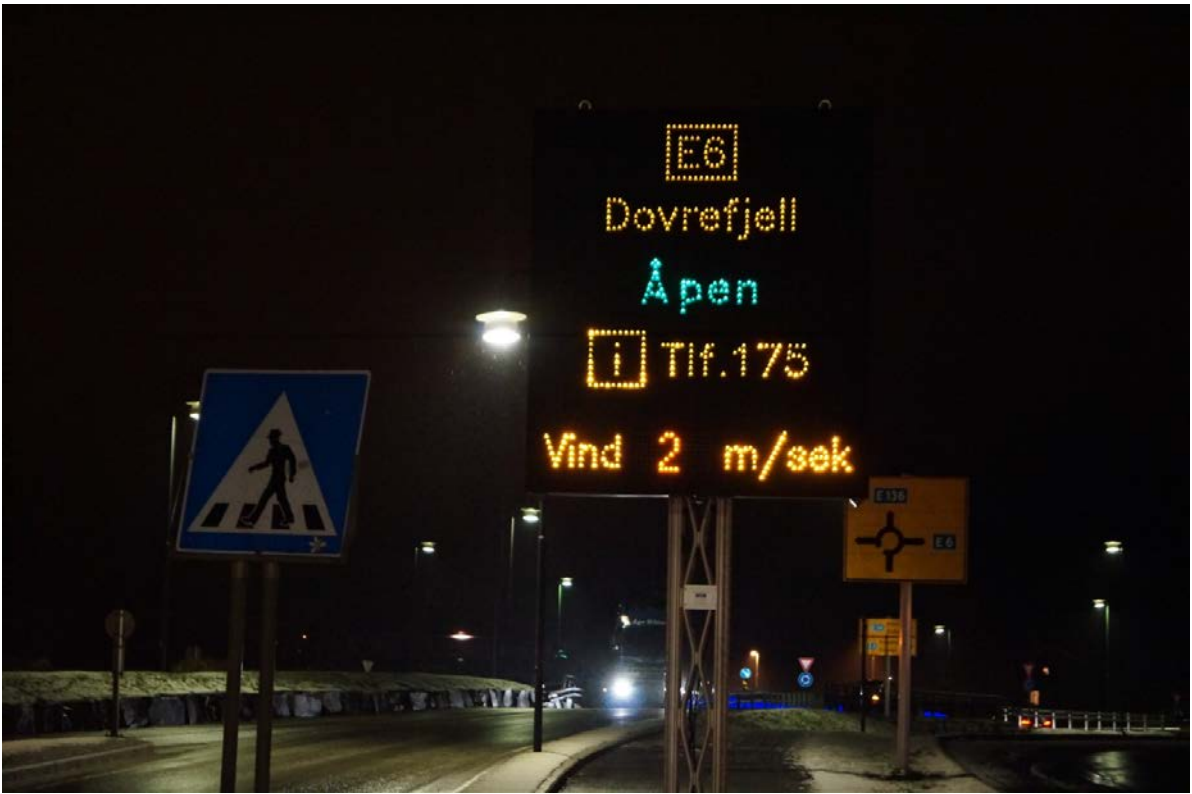
Figure 4 - Variable signpost in Dombaas. The sign says that the road is open and the wind strength is 2 m/sec.

These weather stations are connected to variable signpost located in two small villages (Dombaas and Oppdal) on both side of the mountain pass. Here the road-users get information about the strength of the wind on the mountain and also information if the mountain pass is open, closed or if it is introduced convoy driving.

After the accident in 2006 a new weather station was installed and also variable signpost showing the strength of the wind on the mountain pass (see Figure 4). There is information about the driving conditions on the internet together with “online” web cameras. The winter season 2012/2013 a new service was opened with a SMS-warning informing the road users about the driving conditions on this specific section.

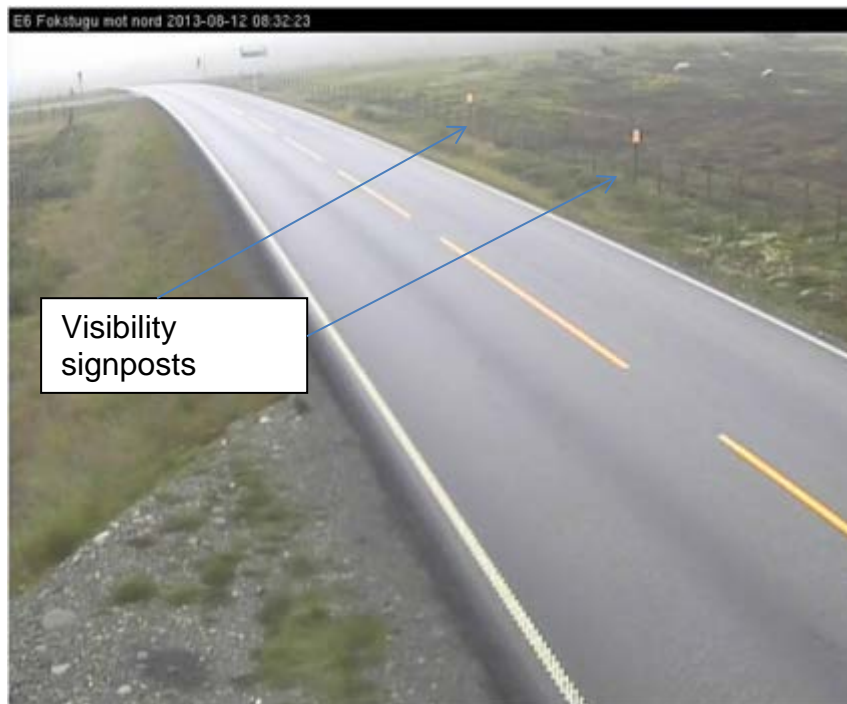
Figure 5 - Webcam on E6 Fokstugu with visibility signposts.

There are now installed three cameras on the mountain pass and “home-made” signpost so the operators can consider the visibility for the road-users from the office. An example of this you can see in Figure 5. The contractor can then consider the visibility based on how many signpost he can see. The webcams are open for public and can be seen at www.vegvesen.no/webkamera. The pictures are updated every 5 minutes.

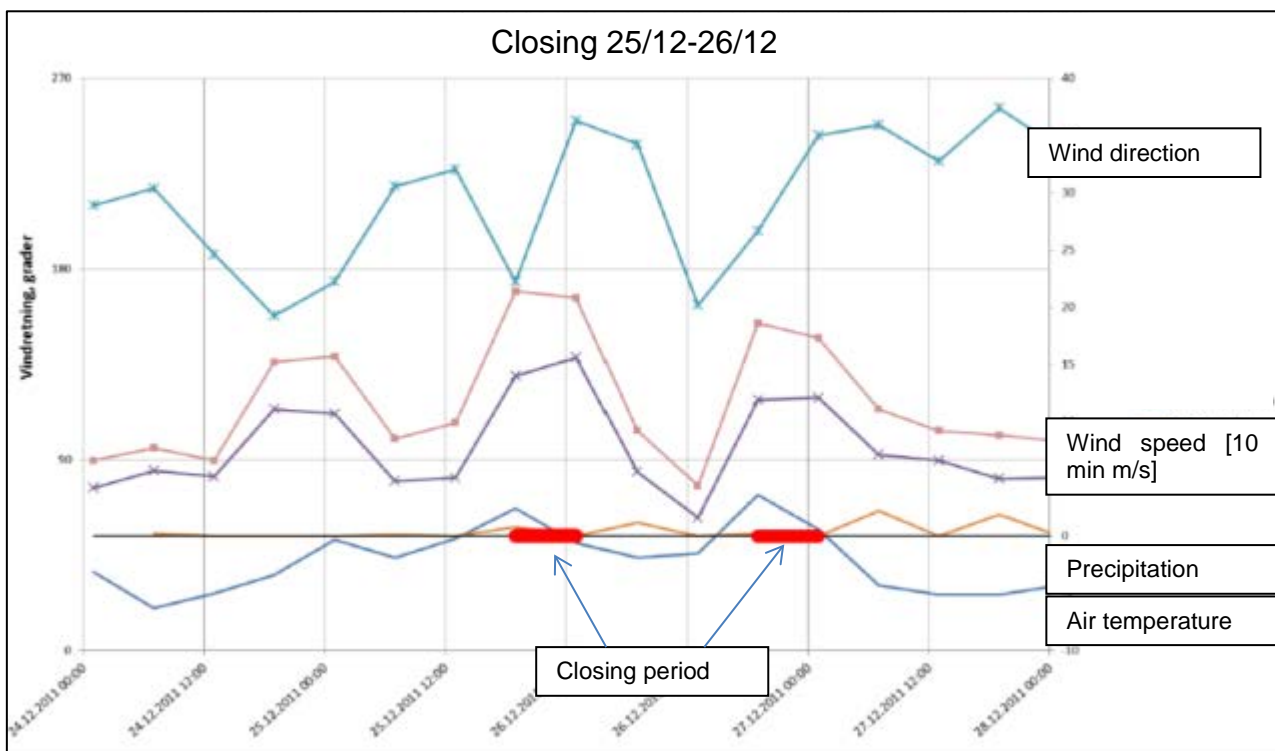
Figure 8 - Weather data from Fokstugu weather station during a storm.

Figure 8 shows the weather data from one snowstorm which led to a closing of the road this winter season. The reason for closing was strong crosswind (over 20 m/sec, values over 10 min average), and the friction was also low with ice- and snow covered road.
