#### MANAGING MOUNTAIN PASSES EXPOSED TO AVALANCHES

T. Vaa Norwegian Public Roads Administration, Trondheim, Norway <u>torgeir.vaa@vegvesen.no</u> I. Hol Norwegian Public Roads Administration, Molde, Norway ivar.hol@vegvesen.no

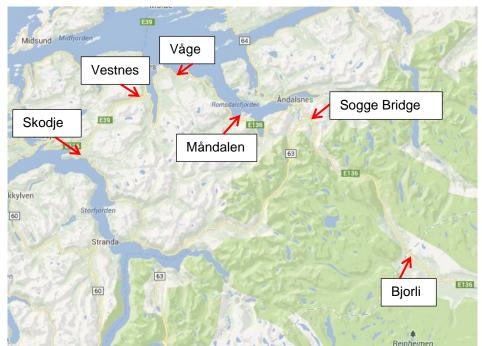
Figure 1 – Road closures on E136/E39 due to risk of avalanches

Based on the weather situation on Monday 15 March the road owner, in consultation with geological experts and the contractor decided that it was necessary to initiate closure of the following sections of trunk roads in the county, see Figure 1:

- E136, Bjorli Sogge bridge
- E136, Måndalen Våge
- E39, Ørskogfjellet

The closures at Bjorli (540 metres above sea level) and Sogge bridge (50 metres above sea level) were manually operated, see Figure 1. The other closures were implemented using only signs as shown in Figure 5. The picture in Figure 5 is from Måndalen, indicating that the road is closed and a trailer can be seen waiting. One of the challenges of using only signs is to maintain respect for the signs during a long period of closure, and some road users ignored the signs.

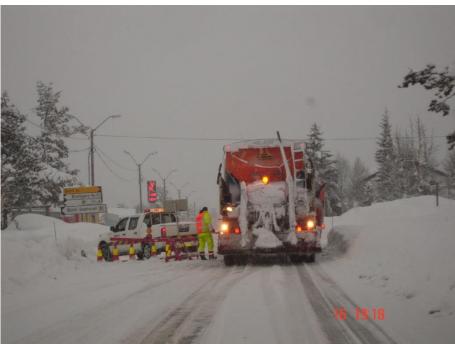
Figure 4 – Manually operated closure at Bjorli

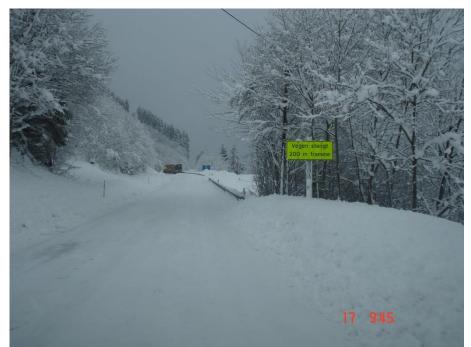
Figure 5 – Road closure on E136 at Måndalen – "Road closed 200 metres ahead"

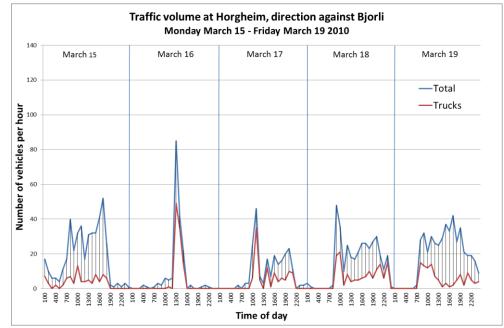
Figure 7 – Traffic volume at Horgheim, direction towards Bjorli, Monday 15 March – Friday 19 March 2010

Figure 7 and Figure 8 show the variation in total traffic volume and the number of trailer trucks at Horgheim between Bjorli and Sogge Bridge from 15–19 March.

It can be seen that the most stringent restrictions were implemented on Tuesday 16 March, allowing for traffic only between noon and 3 p.m. Romsdalen was closed to traffic again on the night of Wednesday 17, Thursday 18 and Friday 19 March with slightly varying opening hours in daytime.

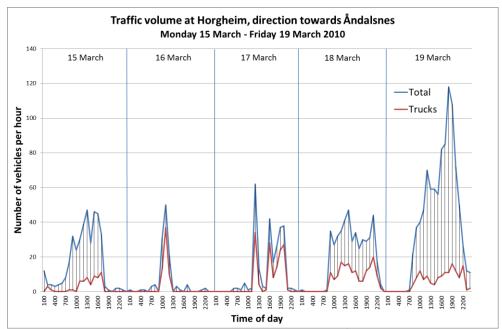
Figure 8 – Traffic volume at Horgheim, direction towards Åndalsnes, Monday 15 March – Friday 19 March 2010

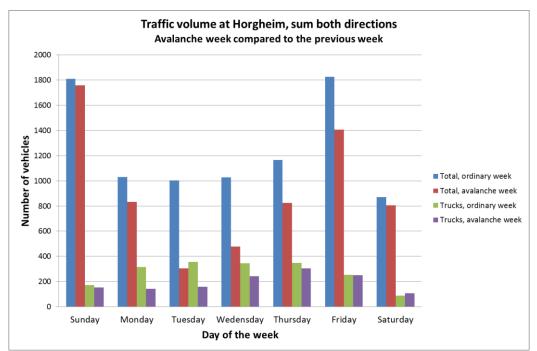
Figure 9 – Traffic volume at Horgheim, sum both directions, avalanche week compared to the previous week

Figure 9 shows the daily traffic volume in the avalanche week compared to the previous week, which was categorized as an "ordinary week". Table 1 shows the daily change in traffic and for the avalanche week as a total.

Figure 9 illustrates that the greatest total traffic reduction was on Tuesday 16 March with the most extensive restrictions. It can also be seen that the variation in total traffic differs from the variation for trucks. The heavy traffic was affected earlier but also normalized earlier than the total traffic.

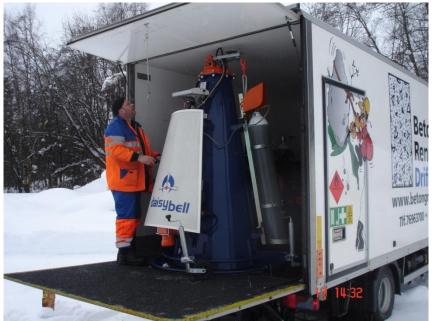
Figure 11 – Preparing Daisy Bell for operation

In the Avalanche week the road owner and the contractor were in contact with people with local knowledge. This was a challenging position and responsibility was determined in a tangible way, but it was also revealed that there is a need to improve practices and routines in several areas. First and foremost, procedures should be established in order to better support local knowledge through actual observations/records of snow conditions and danger of avalanche. This can be done by combining instrumentation and inspections by helicopter. It is also recommended that controlled release of avalanches be attempted using an air cannon such as the Daisy Bell. It is recommended that equipment of this type, see Figure 11, should be stationed within such a radius that it can be available within a few hours.

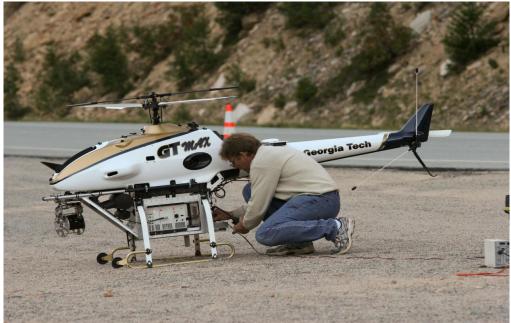
Figure 12 - The rotary wing RMAX

As an example, WSDOT has evaluated the use of (UASs) under severe mountain weather conditions in cooperation with the University of Washington (UW) [3]. Two small UASs have been tested, a fixed wing and a rotary wing (helicopter), see Figure 12, to evaluate their advantages for avalanche control.

The project found that unmanned aircraft hold considerable promise for WSDOT's avalanche control operations. This was especially true for rotary wing aircraft. One of the main benefits of this technology is the ability to provide real-time aerial surveillance of snow conditions and avalanche terrain. UASs also could potentially be used to deliver control explosives in pre-selected, inaccessible avalanche paths. With enhanced optical or non-optical sensor technology such as LiDAR, UASs might also be used to detect people in areas that are targeted for the release of avalanche control explosives or to effectively assess snowpack properties.
