Sudden winter disorders on pavements and behaviour of bituminous materials under frost/thaw conditions

C. Mauduit, S. Liandrat, E. Crégut, G. Bertuit*
Laboratoire des Ponts et Chaussées de Clermont-Ferrand, France
* Université de Clermont-Ferrand, stage de Master
Caroline.Mauduit@developpement-durable.gouv.fr

O. Chupin, F. Hammoum, J.-M. Piau
IFSTTAR, France
olivier.chupin@ifsttar.fr

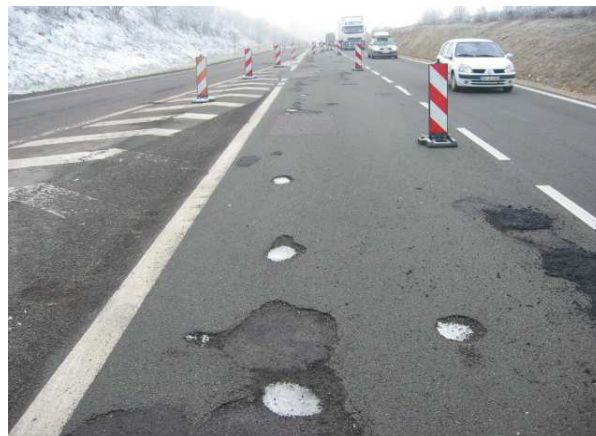
Figure 1: Series of potholes which appeared in a few hours

Since winter 2002/2003, a peculiar mode of degradation of pavements has sometimes been observed in the northern and eastern parts of France and borderlands (south of England, Belgium, west of Germany...). This one occurs without specific early signs and in short time duration of about a few hours [1]. These degradations usually take the form of scabbing of the surface of the asphalt layer with formation of series of potholes and appear essentially in the wheel tracks. They may cause the closure in emergency of roads to traffic (figure 1). The extent of areas affected by such degradation events seems to coincide with that of areas undergoing in the same period similar climatic conditions, characterized by cold temperatures (below -10°C) preceded by periods of positive temperatures with rainfall episodes.

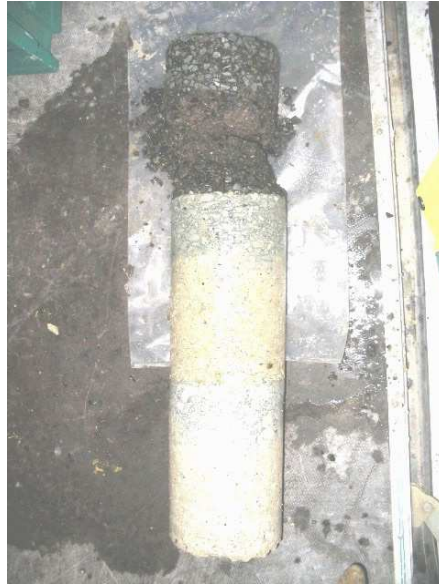
*Figure 2: Core drilled near a pothole
Disintegration of the old surface layers*

Roads that went through maintenance consisting of the superimposition of old and new surface layers are often the worst affected roads. In this case, core drilled shows that the source of degradation is located at the old surface layers which are almost fully disintegrated (fig. 2). It also reveals the presence of water within the porosity of the asphalt surface layers.

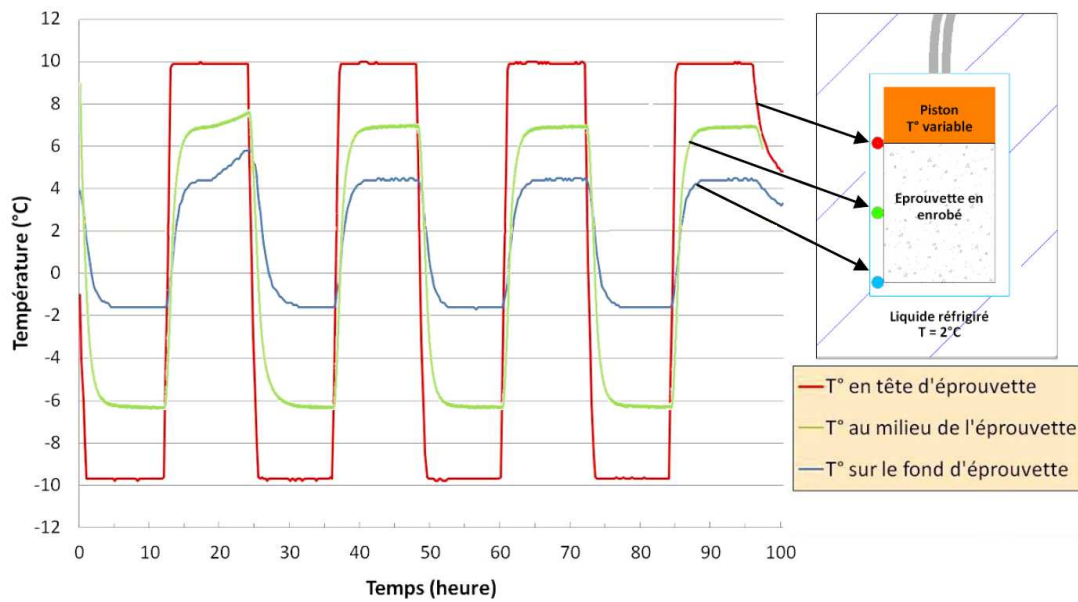
Preliminary tests were performed to appraise the temperature reached at the heart of samples when frost/thaw cycles are applied at the top surface. The purpose is to determine the amplitude of the thermal cycle and its duration to avoid surfusion inside the sample. The figure below shows the variation of temperature at different heights of the sample when cycles of 24 hours varying between +10°C and -10°C are applied at the top surface. The extreme values of temperature go from +6.5°C to -4.5°C at mid-height of the sample, from +5°C to -3°C at the bottom and from 0°C to 1.8°C at 20mm under the sample bottom surface (air temperature at this location). The variation of temperature measured by this sensor is very small showing the control of the temperature by the refrigerated liquid. The configuration of the experimental device thus generates non-homogeneous thermal gradients in the vertical direction, varying with time.

Figure 4: Temperature measurement at different heights of a sample during a test

Indeed the measurements performed in the horizontal directions of any section show only small differences of temperature between the edge and the heart of the specimen. In the following, the temperature measured on the outer lateral surface of the sample is taken as reference.

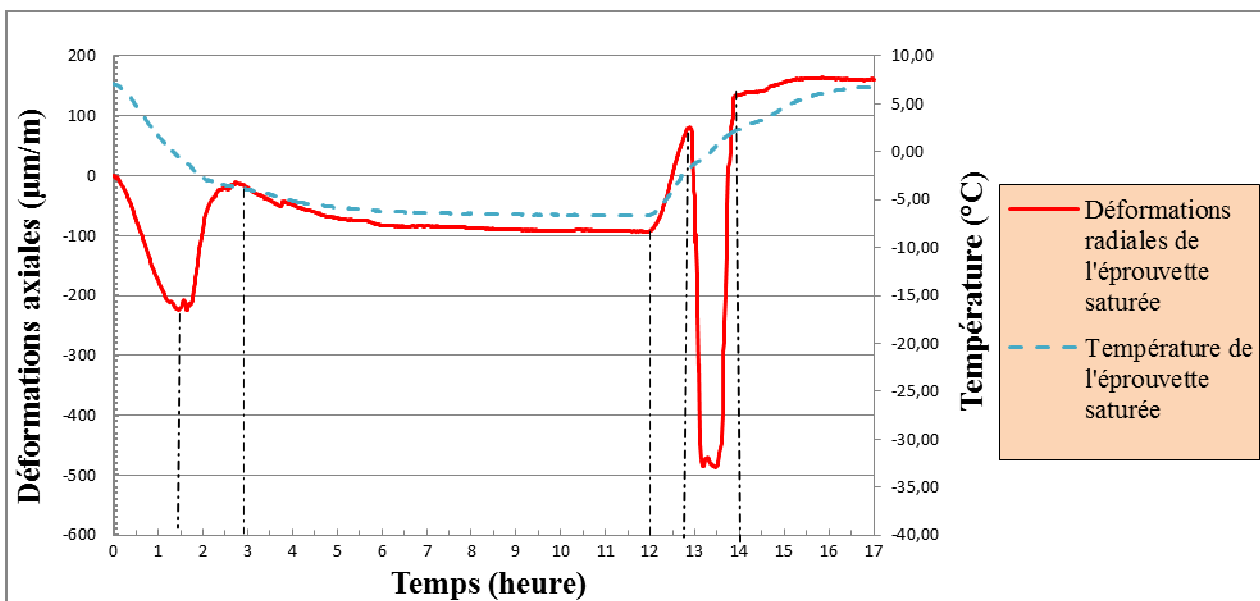
A zoom in of a time period of 17h is represented in Figure 7. This representation makes easier the visualization and interpretation, at the scale of a single frost/thaw cycle, of the history of the local deformation of the material near the instrumented section. Between 0 and 1h30, the temperature decreases but remains positive and the material undergoes thermal contraction as for the dry sample.

Between 1h30 and 3h, the temperature becomes negative and the freezing front goes through the location of the gauge in the downward direction. The material undergoes a relative extension of about 200 micro strain. This is definitely due to the dilatation of the volume of water saturating the porosity of the asphalt concrete during the phase change from liquid to solid (for recall the volume expansion of liquid water to ice is 9%).

Figure 7: Zoom in of the radial strain measured on the sample during a frost/thaw cycle

Between 3 and 12h, the material contracts as the temperature decreases. The water within the pore volume is largely or totally frozen; the grains, the binder and the ice contract according to the classical thermo-mechanical process.

After 12h, the freezing front goes up to the top surface of the sample. The material and the ice start warming up in the domain of negative temperatures; as expected an expansion is observed.

The freezing front goes through the vicinity of the gauge in the time interval between 13 and 14h. The material then undergoes a large phase of contraction (600 micro strain) followed by a phase of expansion of similar amplitude. These fluctuations are probably due to the inverse transformation of the water present in the pore volume from solid to liquid, which is associated with a decrease of volume. The fact of having alternatively contraction and expansion may result from a negative pressure effect (as compared to the atmospheric pressure) of the newly melt water, followed by a balancing of the air/liquid water pressures. Finally, the last portion of the curve (14-17h) at positive temperatures reflects the thermal dilatation expected when a material is warming up.
