THE EFFECT OF SILANE-TYPE SURFACE PENETRANTS TO CONTROL SCALING AND SALT DAMAGE OF HIGHWAY BRIDGE WHEEL GUARD CONCRETE IN COLD REGION

H. ENDOH & F. TAGUCHI

Materials Research Team, Civil Engineering Research Institute for Cold Region, Japan
96199@ceri.go.jp

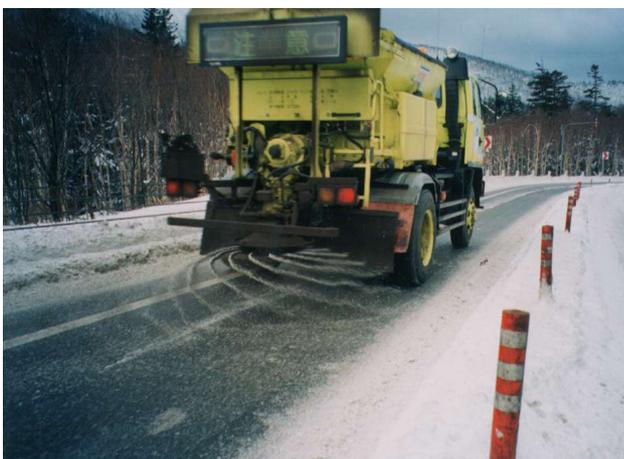
Photo 1 - Deicing salt spraying

To ensure the safety of winter roads, road administrators apply chloride-based deicers to the road surface (Photo 1). However, such application exposes many highway bridges in cold regions to the freezing and thawing as well as to deicing salt, leading to severe deterioration of concrete (Photo 2). The combination of freeze-thaw action and deicing salt is known to accelerate scaling (local peeling) of the concrete surface and reinforcing bar corrosion (Photo 3), which raises the concern about the durability decrease of concrete materials. Given that the budgets necessary for maintaining such highway bridges are expected to increase, effective measures to ensure the structures' durability are essential. One potential method for control frost and salt damage is to prevent the external supply of water and chloride ions. Effective agents for this are silane-type surface penetrants [1].

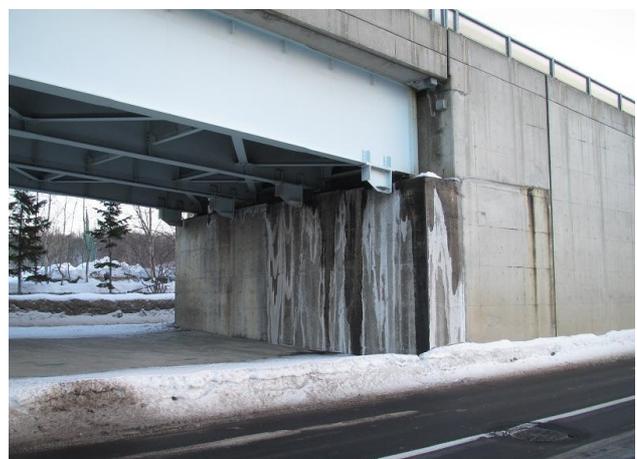
Photo 2 - Deicing salt supplied to a concrete structure

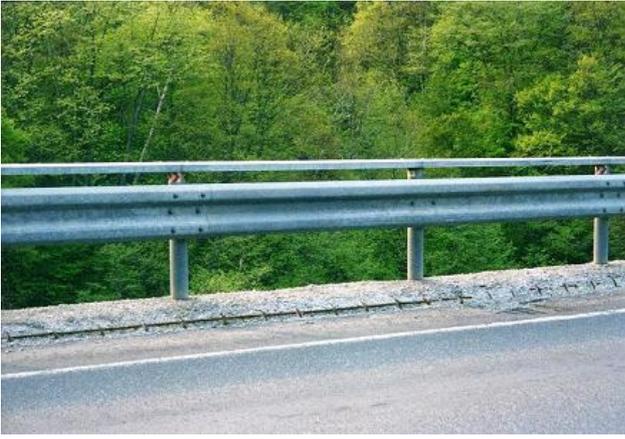
Photo 3 - Scaling deterioration and reinforcing bar corrosion

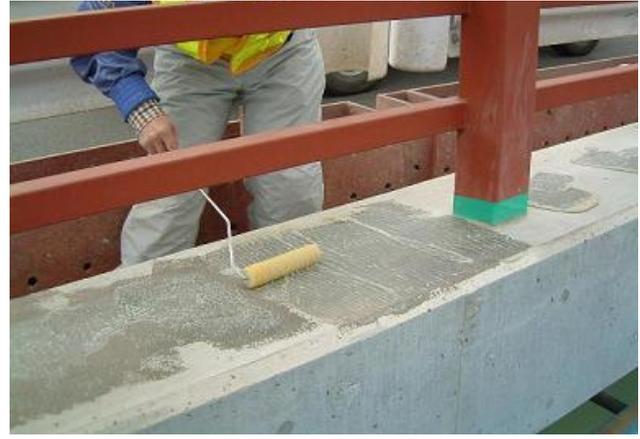
Photo 4 – A coating of silane surface penetrants is applied.

Silane-type surface penetrants are permeating surface-coating materials that are used to control the water absorbability of concrete surfaces. When coated on the concrete surface (Photo 4), water repellence function is shown when the hydrophobic (Alkyl) groups stick to the surface and void walls (Figure 1), and the permeated area turns into hydrophobic area ("water repellent layer").

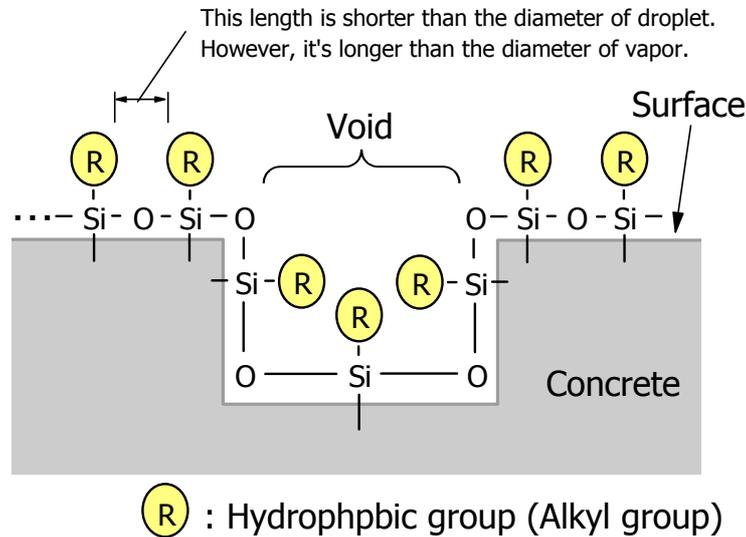
Figure 1 – Structure of water repellence

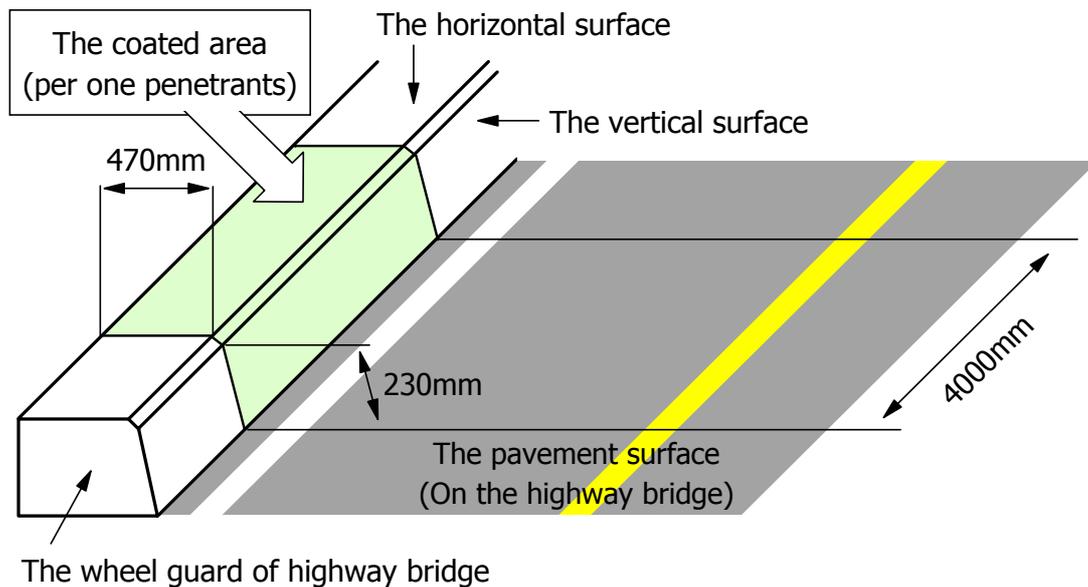
Figure 3 - The size of the wheel guard and the coated area

Figure 3 shows the shape and coated area of the wheel guard, Table 1 shows the mix proportion of the wheel guard concrete and Table 2 shows the outline of the five commercial silane-type surface penetrants used for the test (No.1, No.2, No.3, No.4 and No.5). The highway bridge is designed with a 4% cross-slope from the center-line to the

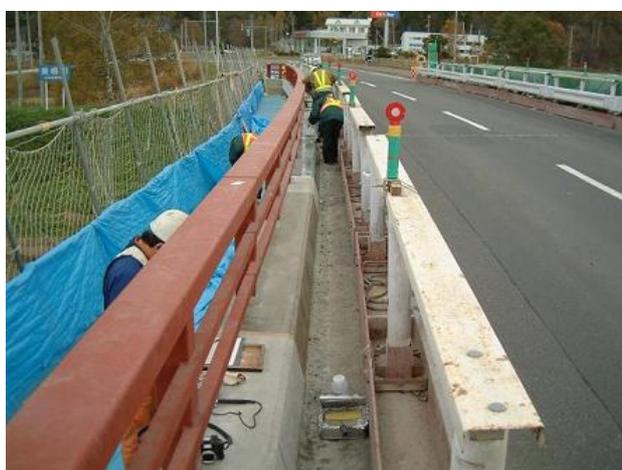
Photo 5 – Coating work (28 October 2004)

wheel guard. Coating work was performed in October 2004 using penetrants Nos.1 through 5. On site, concrete was placed two months before the coating work so that it was never affected by freeze-thaw action. A 20-meter-long wheel guard was divided into five areas (four meters per area). Each area was coated with one penetrants. One representative from each penetrants manufacturer participated and coated the assigned area in accordance with their original specifications. Photo 5 shows how the coating work was performed. Rollers or paintbrushes were used. Some manufacturers made prior surface treatment.

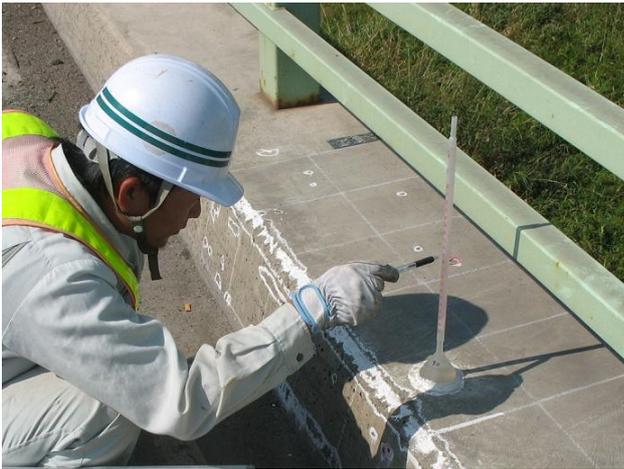
Photo 6 - Measurement of the water permeation ratio

Photo 6 shows measurement of water permeation ratio. In measuring, water was poured into plastic funnels of 75 mm in diameter and then placed on the horizontal surface of the wheel guard until the water reached 250 mm in height (Figure 4). Twenty-four hours later, the heights of water in the funnels were measured individually to determine water absorption, and water permeation ratios were calculated for each by using Equation (1):

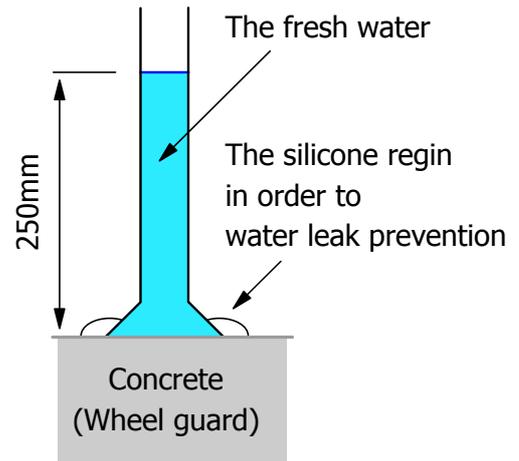
Figure 4 – Method for measuring the water permeation ratio

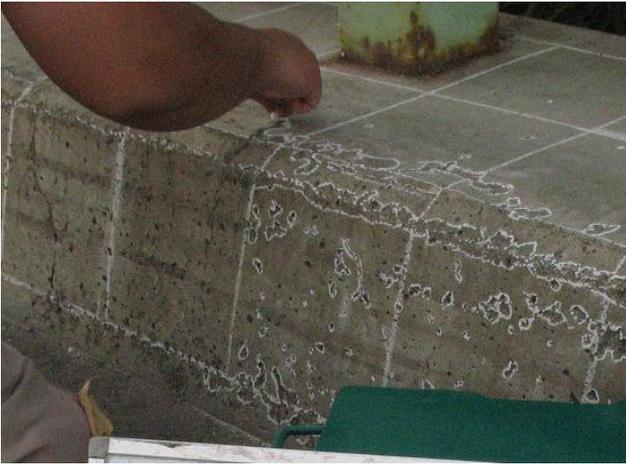
Photo 7 - Investigation of scaling area:
chalk sketch

Photo 7 shows measurement prior to calculation of the scaling area ratios. In the measurement, spots on which scaling developed were marked and then photographed digitally. Sketches of the scaling based on the photos were processed on the computer to calculate the scaled area. Finally, scaling area ratios of each area were calculated by Equation (2):

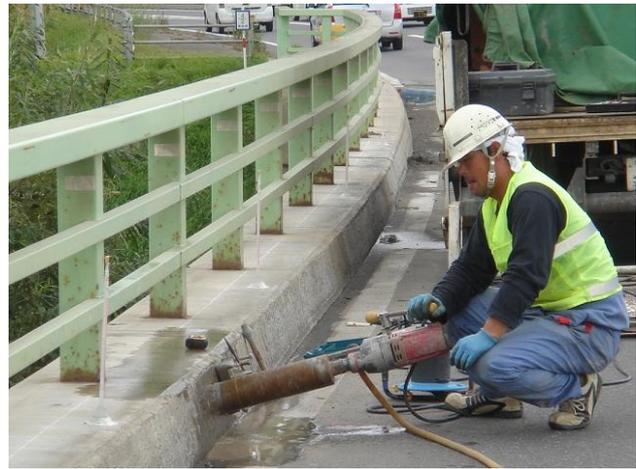
Photo 8 - Core sampling

The thickness of the water-repellent layers and chloride ion penetration content were examined at the spots that had presented relatively favorable results from the previous two calculations (i.e., ratios of water permeation and of scale area). For assessment of the thickness of the water repellent layers, concrete cores were extracted from the vertical surface of the wheel guard (Photo 8). Individual cores cut, and water was sprayed on the chopped areas. The area that immediately dried was considered to be the water repellent layer. Measurement was made using a vernier caliper. A final value for each core was presented as the average of five measurements.

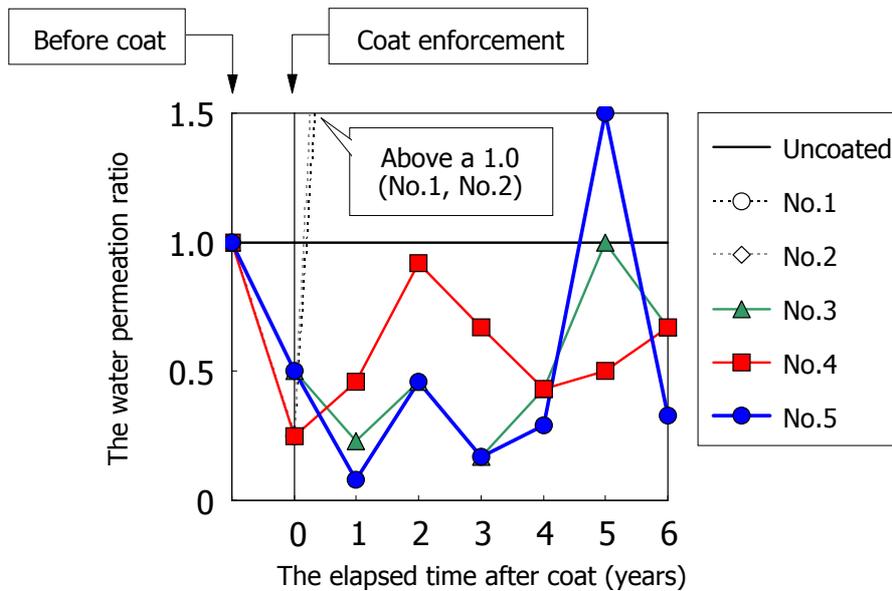
Figure 5 - Change in the water permeation ratio with time

Figure 5 shows the water permeation ratios of tested penetrants over six years. The permeation ratios for all penetrants are 1 or lower in the first year of coating, but greater than 1 for Nos.1 and 2 after a winter had elapsed, which means that the ability of control water absorbability was lost. Values for Nos.3, 4 and 5 remained 1 or lower in general, except minor fluctuations. Thus, it was confirmed that the persistence of control water absorbability varies by penetrants type.

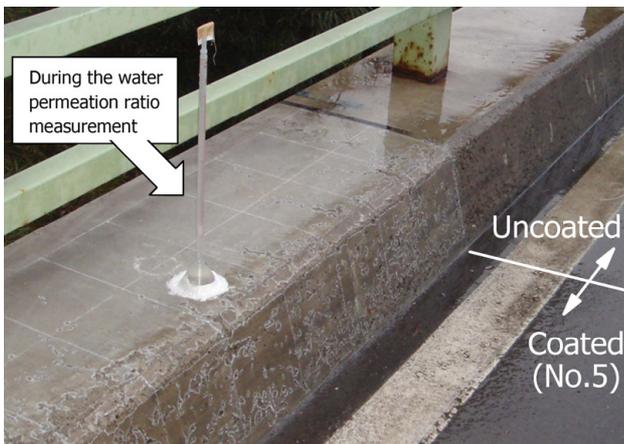
Photo 9 - The condition at the time of rainy weather (6 years elapsed)

Photo 9 shows a wheel guard photographed on a rainy day between an uncoated area and the No.5-coated area. In the uncoated area, the concrete surface looks darkly wet; in the No.5-coated area, the concrete surface looks wet but does not look as apparently water-absorbing as the uncoated area.

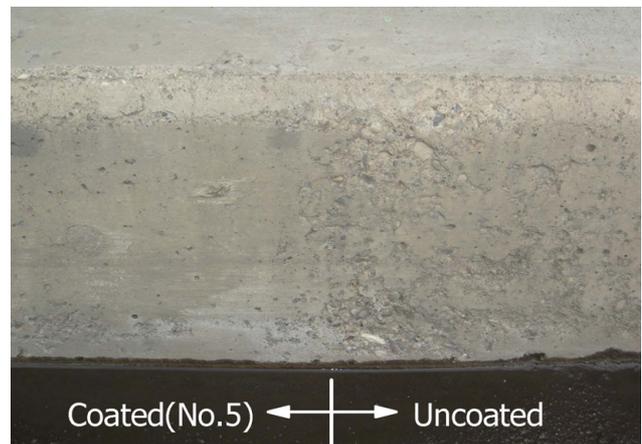
Photo 10 – Condition of the wheel guard (4 years elapsed)

Photo 10 shows scaling of the wheel guard in the fourth year after coating, and Figure 6 shows sketches of the scaling area of the wheel guard in the third and sixth years. From the sketches of the third year, it can be seen that the coating effect was significant given that less scaling was recognized in the coated area than in the uncoated area, and given that the scaling was more recognizable on the vertical surface than on the horizontal surface. This may be because the horizontal surface is highly likely to be covered with grit and snow, which may prevent freeze-thaw action (Photo 11).

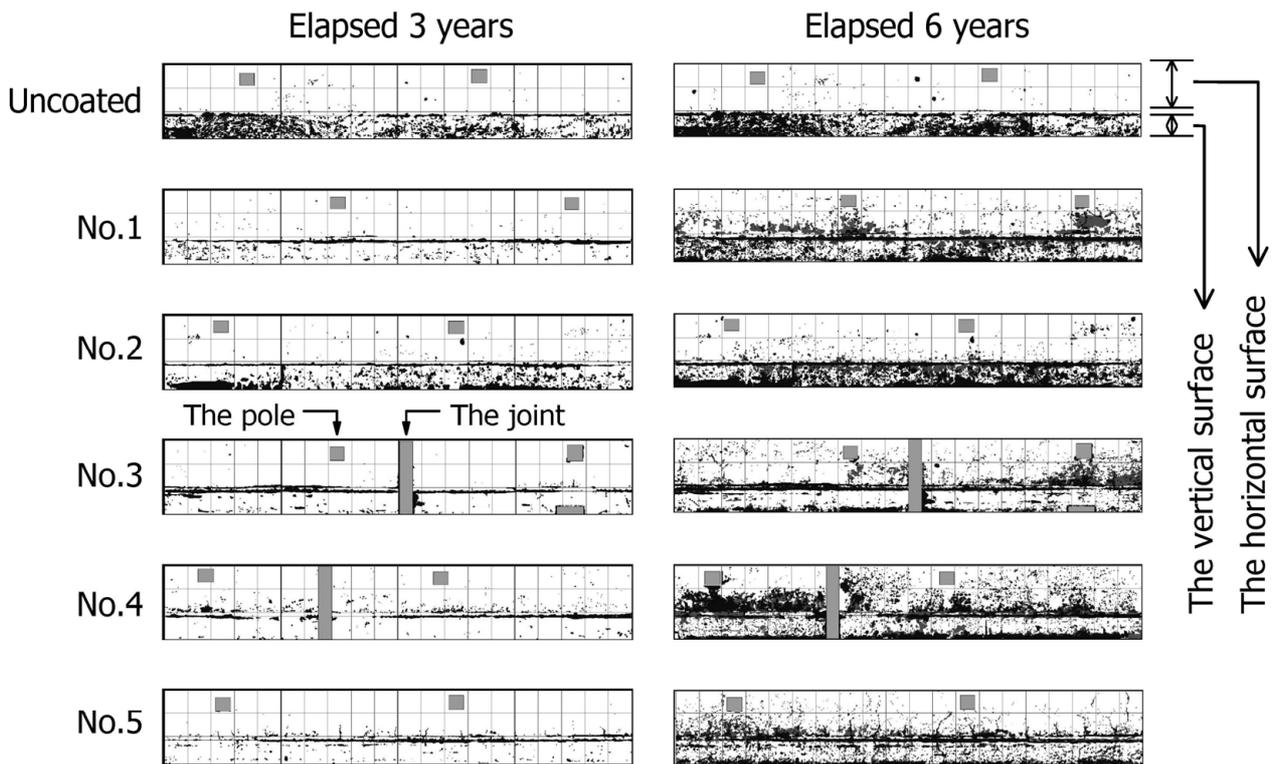
Figure 6 - The scaling area (black)

From the sketches of the sixth year, it can be seen that local scaling developed relatively intensively in the coated area. As Photo 12 shows, the scaling on the horizontal surface was especially clearly at the site near the passing-through cracks which had developed when the concrete was placed. Such cracks are generally known to absorb snowmelt water, and, in concrete matrix, non-freeze water moves to around ice crystal due to osmotic pressure when cooled [8]. In the concrete coated with silane-type surface penetrants, however, movement of non-freeze water was blocked by a hydrophobic group;

that the scaling develops overall at the uncoated area but is uneven at areas coated with No.3, No.4 and No.5. On those areas, scaling develops more intensively at the bottom of the vertical surface, near the pavement, than at the middle part. This seems to be because the highway cross-slope causes water to converge at the bottom of the vertical surface. We examined scaling area ratios for the middle part of the vertical surface in particular, since this part looked the most affected by water splashed by cars. Scaling area ratios of No.3, No.4 and No.5 in the sixth year after coating (Figure 8) indicate that the scaled areas were 50% to 80% smaller than that of the uncoated area. From this point, it is reasonable to conclude that a selection of appropriate silane-type surface penetrants will delays scaling progress for more than six years after coating. It is noted, however, that the penetrants ability may vary by concrete condition and road drainability.

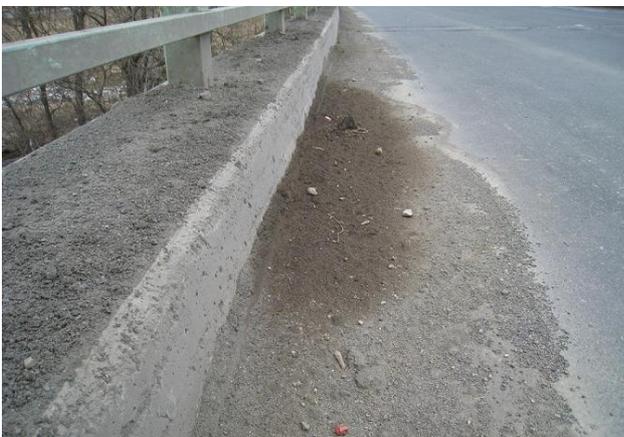
Photo 11 – The wheel guard in spring

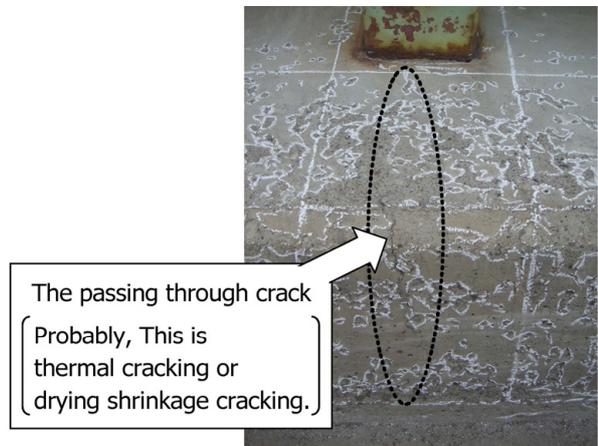
Photo 12 – The condition of wheel guard surface adjacent to passing-through cracks (area No.5)

thus, high water pressure occurred locally, which led to tangible scaling. This suggests that it is essential to repair such cracks prior to applying silane-type surface penetrants as coatings.

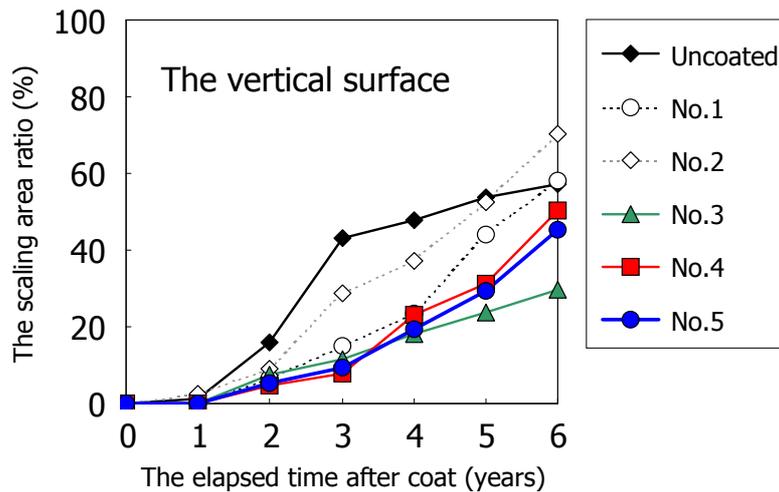
Figure 7 – Secular change in scaling area ratio for the vertical surface

Figure 7 shows the yearly changes in scaling area ratios on the vertical surface. In the sixth year after coating, scaling developed more significantly for the areas coated with No.1 and No.2 than for the uncoated area, but scaling was 10% to 50% lower for the areas coated with No.3, No.4 and No.5. This shows that penetrants No.3, No.4 and No.5 have the ability to delay scaling progress, and these findings agree overall with the results of Figure 5. Sketches of the vertical surfaces in the sixth year after coating (Figure 6) show

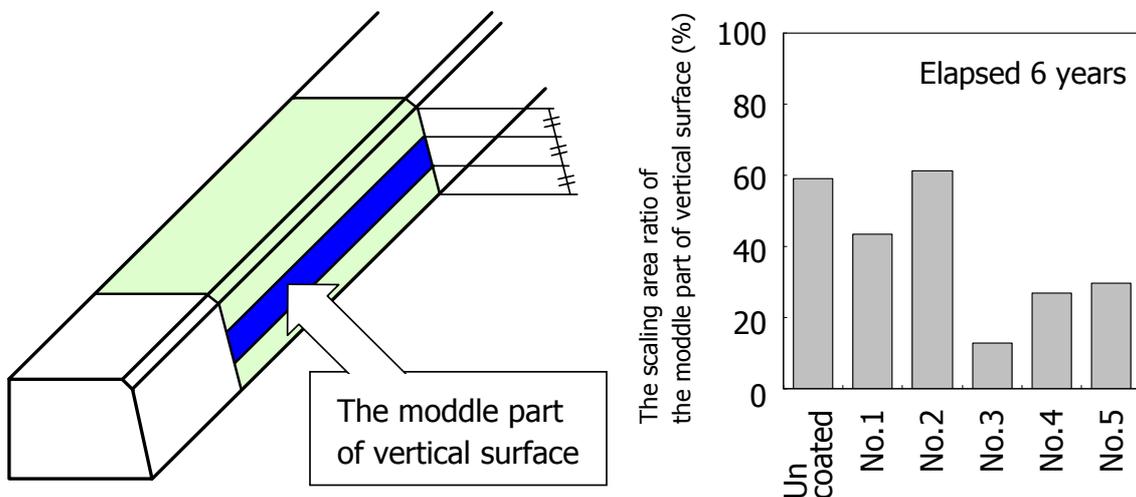
Figure 8 - Scaling area ratio of the middle part of the vertical surface at 6 years elapsed

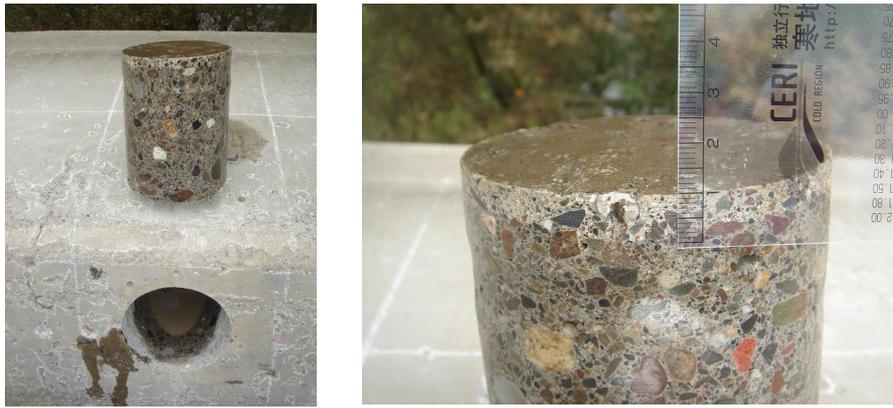
Photo 13 – The wetted core (The layer near the upper surface that is not wet is the water-repellent layer.)

Areas coated with Nos.3, 4 and 5 showed favorable results with respect to water permeation ratio (3.1) and scaling control (3.2). Cores were extracted from the vertical surfaces coated with those penetrants (Photo 13) to further examine their water repellent layers. Figure 9 shows the water repellent layer thicknesses of the cores coated with

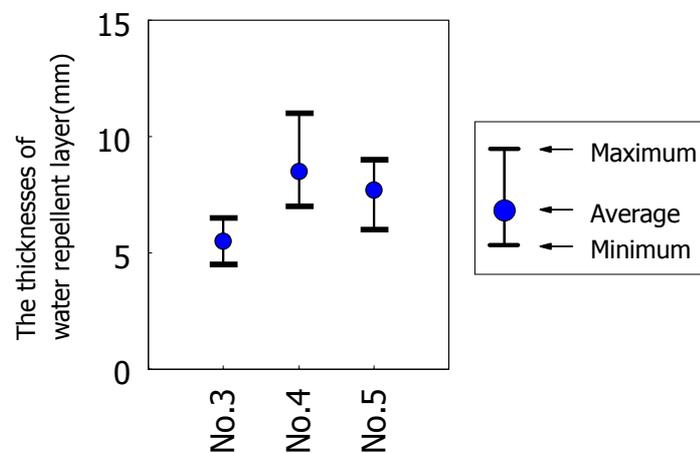
Figure 9 - Measured thicknesses of the water repellent layer at 6 years elapsed

Nos.3, 4 and 5, indicating that 5- to 10-mm-thick water repellent layers formed at the wheel guard of the tested highway bridge. The layers were confirmed to exist even in the sixth year after coating.

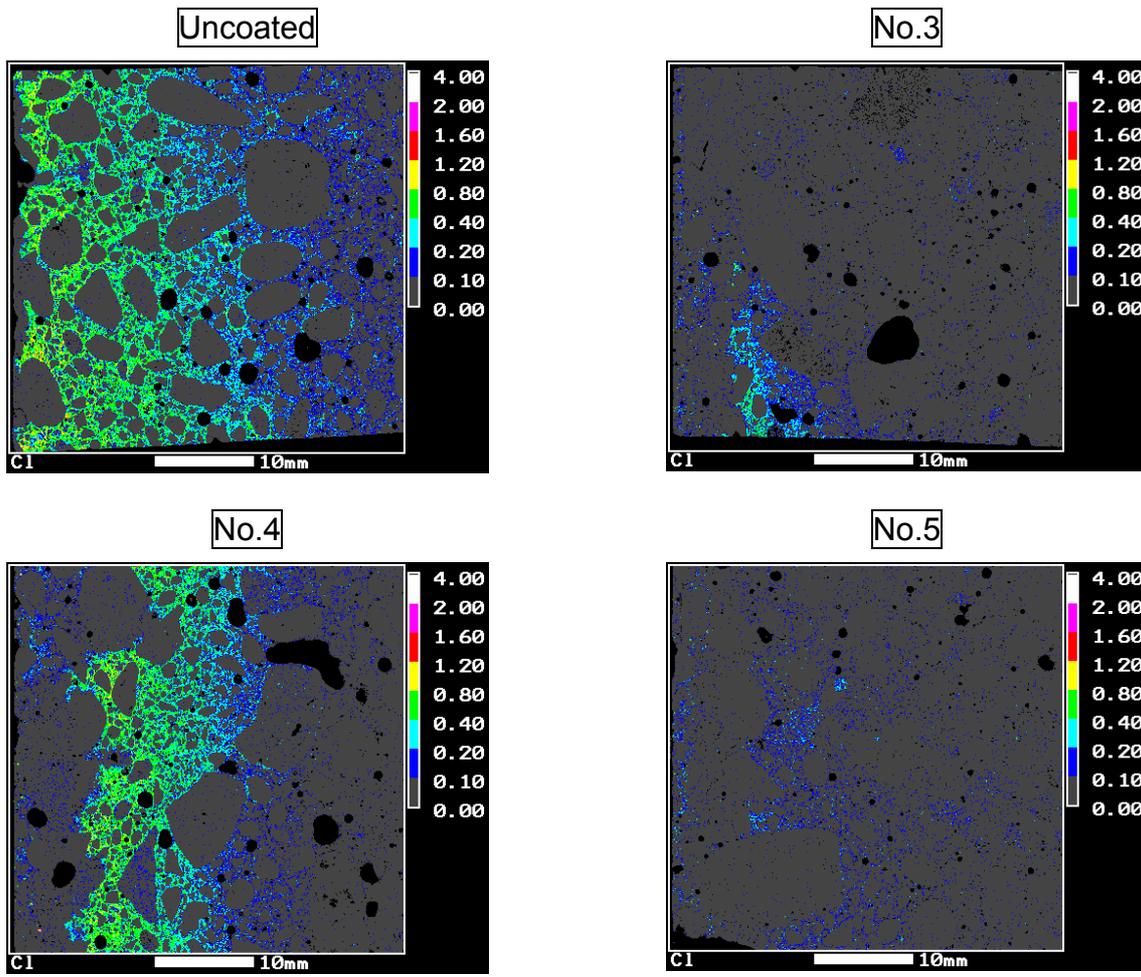
Photo 14 - EPMA analysis of chloride ion concentration distribution at 6 years elapsed. The left side of the image is the surface. Legend: weight ratio (%)

Photo 14 shows the distribution of chloride ion concentrations of the 4-cm concrete cores at the sixth year after coating. Measurement was performed by using an EMPA. The photo legends are the weight ratios of chloride ion masses to concrete masses (expressed as percents). Analyses were conducted on cores coated with Nos.3, 4 and 5. For comparison, a core from the uncoated area was also analyzed.

In the uncoated area, chloride ion concentrations were the greatest on the surface, and chloride ion penetrated well from the surface through the inner part of the concrete. In the areas coated with Nos. 3 and 5, chloride ion concentrations were lower than that of the uncoated area. It confirms that silane-type surface penetrants are effective in controlling chloride ion supply to concrete. The area coated with No.4, however, showed a slightly different result: Chloride ion concentrations were low on the water repellent-layered surface, immediately below which chloride ion was recognized. The thickness of chloride ion penetration was shown to be smaller than that of the uncoated area.

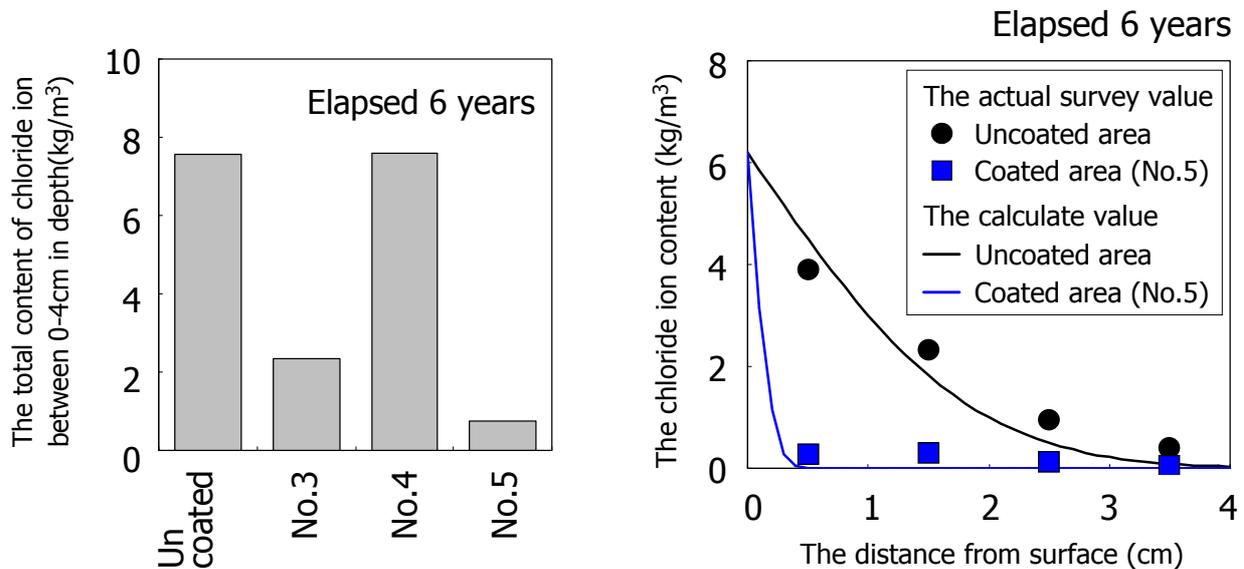
Figure 10 – The total content of chloride ion between 0-4cm in depth at 6 years elapsed

Figure 11 - Chloride ion content distribution of uncoated and No.5 at 6 years elapsed

Figure 10 shows the total content of chloride ion in the extracted concrete cores (for 4 cm from the surface) per cubic meter, calculated by using Mohr's method. No.5 shows the greatest ability to delay chloride ion supply of any penetrants. Accordingly, we looked closely at No.5 to estimate the chloride ion penetrations both at No.5-coated and uncoated areas. For estimation, we used the Fick's second law of diffusion, expressed in Equations (3) and (4):

Figure 11 compares measured and estimated values of chloride ion content in the sixth year after coating. The two values roughly agree. The Standard Specification for Concrete Structures, published by the Japan Society of Civil Engineers, specifies that “the limit chloride ion content for the occurrence of corrosion of reinforcing bar” is $1.2 \text{ kg}/\text{m}^3$ [11]. By using Equations (3) and (4), we estimated the number of years it would take for the chloride ion content to reach $1.2 \text{ kg}/\text{m}^3$ at reinforcing bar of the wheel guard (with 5cm concrete cover). Our calculation found that chloride ion content would outperform the threshold for corrosion in 50 years at the uncoated area, while remaining below $1.2 \text{ kg}/\text{m}^3$ at the No.5-coated area in 100 years.

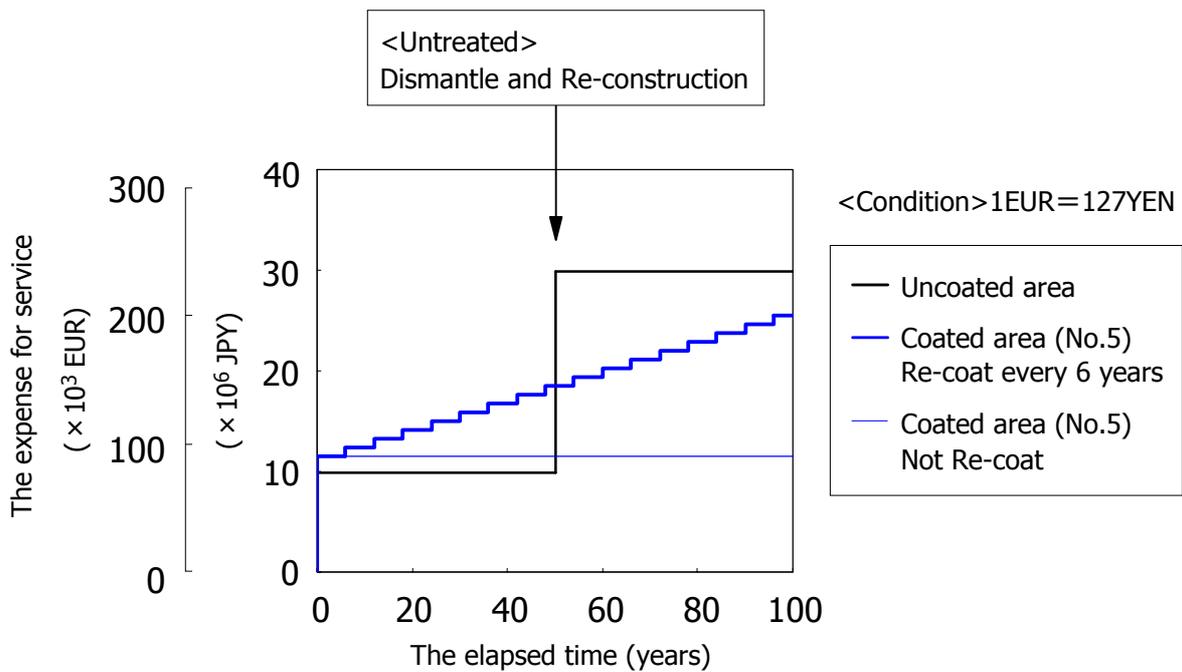
Figure 12 - Trial calculations of wheel guard maintenance costs

Figure 12 shows our expense calculations, which indicate that applying a coat of silane-type surface penetrants reduces the expense for 100-year service of the wheel guard by 15 percent versus no coating (with one replacement). If no re-coating is performed, the expense will be 60% percent.

Actual expenses required for maintaining the wheel guards for 100 years may vary by various factors of road shape (such as alignments, slope gradients, drainability, and so on) and concrete conditions of highway bridges. Based on the findings, we conclude that silane-type surface penetrants may help cut such expenses by between 15% and 60%.
