EXPERIMENTAL STUDY ON DETERIORATION CHARACTERISTICS OF PARTIALLY REPAIRED RC SLABS UNDER FREEZING-THAWING AND FATIGUE COMBINED ACTION

K. KAKUMA, S. OKADA, S. OMOTE & H. NISHI
Civil Engineering Research Institute for Cold Region, Japan
kakuma@ceri.go.jp

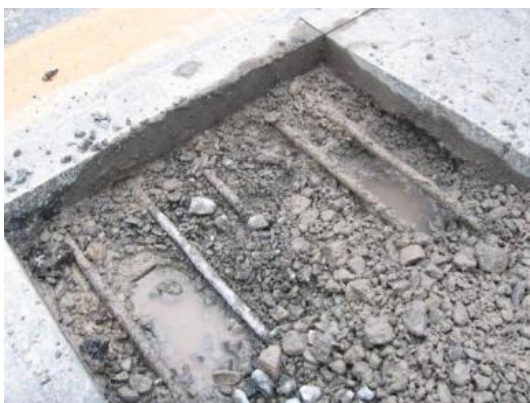
(a) Frost damage of cover concrete

The examples of RC slabs with frost damage of upper concrete in Hokkaido, Japan are shown in Photograph 1. Photograph 1(a) is the case that upper cover concrete separated into mortar and aggregate by frost damage. In this case, water remained on concrete slab in spite of not after rainfall and damage depth exceeded upper cover thickness down to

Photograph 1 - Typical deterioration of RC slabs in Hokkaido

upper reinforcement. Furthermore in Photograph 1(b) showing the subsidence of slabs, concrete around the hole deteriorated and separated into mortar and aggregate similar to the case of Photograph 1(a). From the field investigation of highway bridges in Hokkaido [2], it was reported that such fatigue-frost damage combined deterioration has spread in whole Hokkaido.

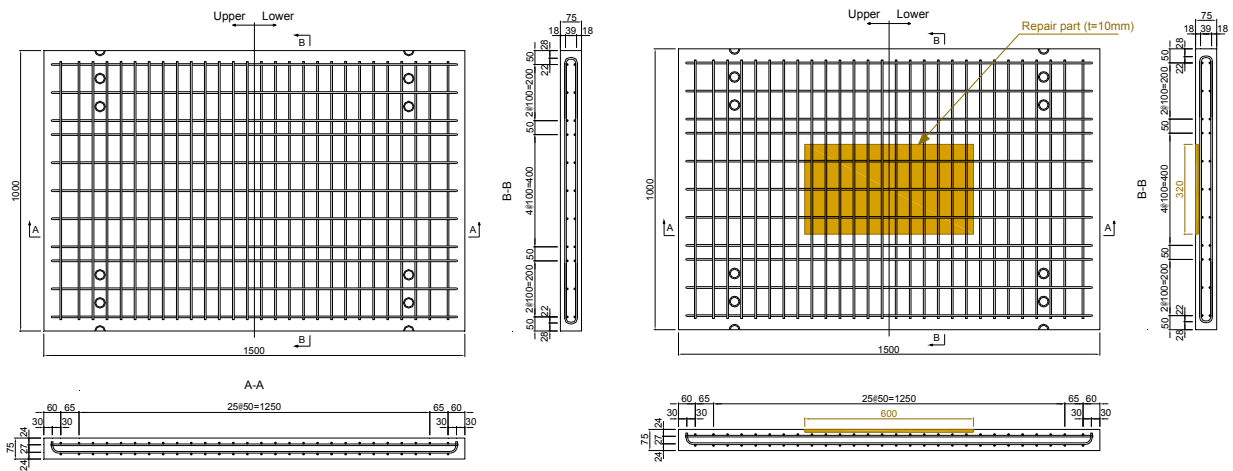
Figure 1 - Dimension and reinforcement arrangement of specimens

Table 1 lists the test specimens; Specimen-1 and Specimen-2 are non-repaired specimens tested under dry and frozen environment respectively, and Specimen-3 is upper-repaired specimen tested under frozen environment. Figure 1 shows the dimensions and the reinforcement arrangement of specimens. The specimens are 1,500mm long and 1,000mm long in longitudinal and transverse directions respectively with slab thickness of 75mm. Specimen-3 has a repair part with area of 600x340mm and thickness of 10mm in centre of specimen as shown in Figure 1(b). Repaired specimen is manufactured by (1)

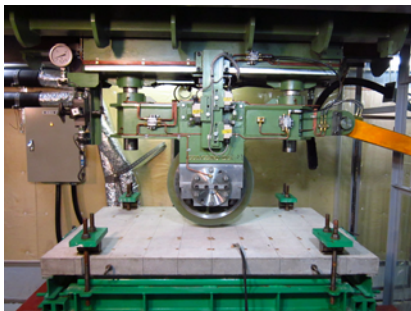
(b) Wheel load running machine

The wheel load running machine is the quarter model of the machine originally developed by Matsui [5] to reproduce fatigue deterioration mechanism and evaluate durability of RC slabs (shown in Figure 2(b)). The specifications of the machine used in this study are shown in Table 4. It is a crank-driven machine and can continuously apply a maximum load of 40kN by hydraulics while running. Wheel can run in 1,000mm distance; 500mm back and 500mm forth from the midspan of specimen in longitudinal direction, with the speed of 24 round trips in a minute under 50Hz of power supply frequency. Wheel is made of urethane with the dimension of 480mm outer diameter and 170mm width.

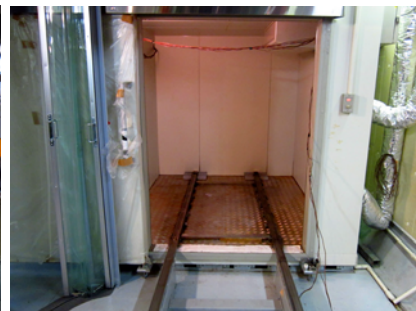
(c) Freezing room

The freezing room of this experimental installation has the inside dimension of 1,190mm width, 1,670mm height and 2,000mm depth and can cool the inside temperature down to -20 degrees. Wheel load running machine is connected with the room by rails to move specimen with supporting frame manually (shown in Figure 2(c)).

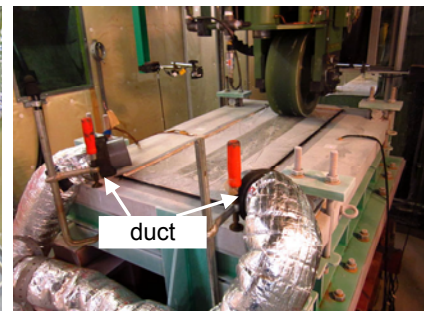
(d) Freezing device

The experimental installation is fabricated in a room with a constant temperature of 20 degrees. Accordingly, to keep specimen at low temperature, cold air in freezing room is sent to specimen via ducts and vinyl made curtains surround the loading machine during wheel load running (shown in Figure 2(d)).

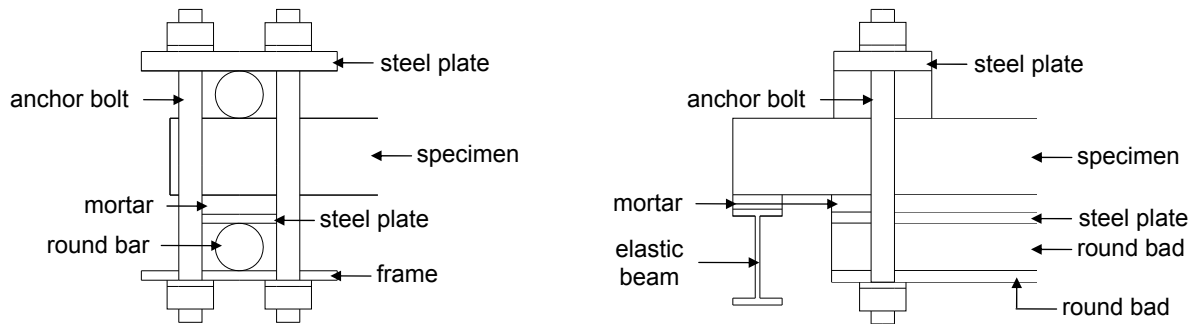
As shown in Figure 3, specimen is simply supported via round bar at the end of transverse direction corresponding to the support by main girder and elastically supported via H-shape steel girder with 100mm height and 50mm width at the end of longitudinal direction considering the continuity of RC slabs in actual road bridges. At four corners of specimen, anchor bolts are set to prevent a specimen from floating.

(a) Simple support (transverse direction) (b) Elastic support (longitudinal direction)

Figure 3 - Support condition

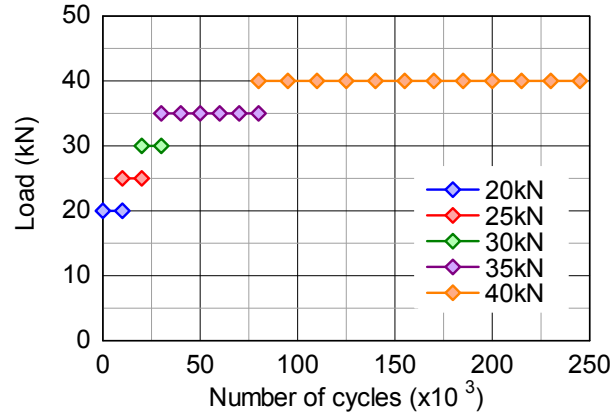
Figure 4 - Fatigue loading program

The fatigue loading program is provided as shown in Figure 4. This test adopts a stepwise increase loading program increasing 5kN each at the specified number of cycles from 20kN to 40kN.

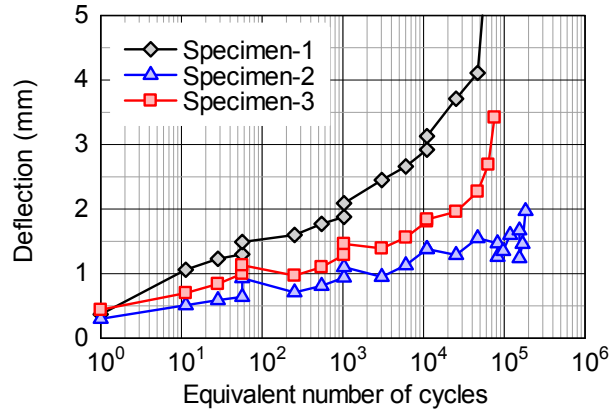
The deflection-equivalent number of cycles relation of Specimen-1 is plotted by black dots in Figure 5.

As to Specimen-1, shear failure occurred at 75,373 running cycles with rapid increase of deflection after showing stepwise deflection change as the slope of deflection change increased gradually with the increase of fatigue load.

Figure 5 - Deflection-Equivalent number of cycles relation

The deflection-equivalent number of cycles relation of Specimen-2 is plotted by blue dots in Figure 5.

As to Specimen-2, deflection changed at almost half degree of Specimen-1 and it showed serrated characteristic behaviour during wheel load running. This was because apparent increase of slab stiffness, while inner temperature of specimen was kept under 0 degrees, prevented fatigue deterioration from developing. Figure 6, the relation between deflection, inner temperature and equivalent number of cycles until 100,000 running cycles, obviously revealed frozen state less than 0 degrees decreased deflection temporarily and the progress of fatigue deterioration resumed under melted state more than degrees.

The deflection-equivalent number of cycles relation of Specimen-3 is plotted by red dots in Figure 5.

As to Specimen-3, fatigue failure occurred with rapid increase of deflection at 75,659 running cycles after the similar serrated deflection change to Specimen-2. Throughout experiment, deflection changed at approximately 1.3 to 1.5 times larger than Specimen-2, since repair material with relatively lower elastic modulus than slab concrete artificially behaved as cushioning, distributed load and brought the increase of crack density. Figure 7 shows the crack density-equivalent number of cycles relation. Here, crack density is

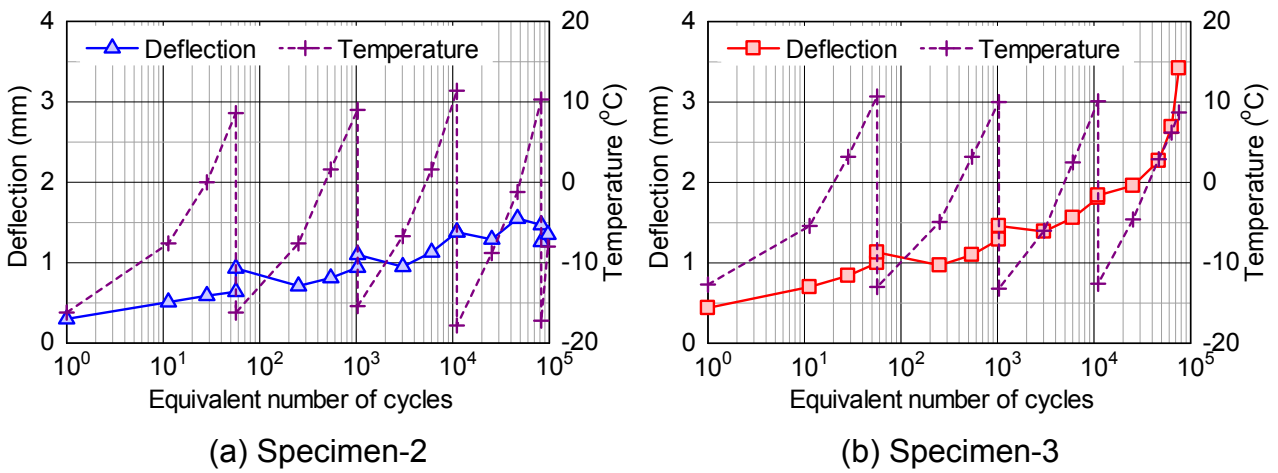
Figure 6 - Deflection-Inner temperature-Equivalent number of cycles relation

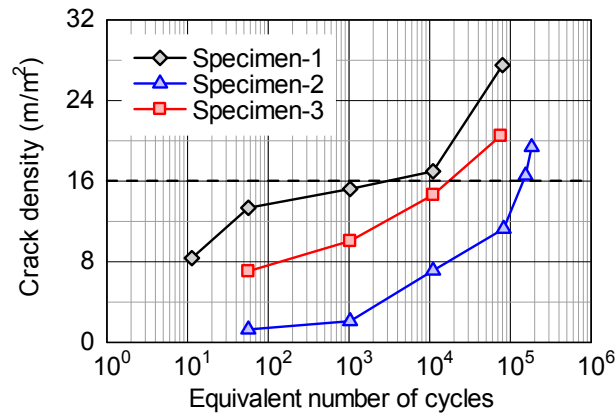
Figure 7 - Deflection-Equivalent number of cycles relation

defined as total crack length measured in the range of central 900x500mm in bottom surface of specimen. From Figure 7, it seems Specimen-3 obviously distributed cracks compared with Specimen-2 just after the start of wheel load running.

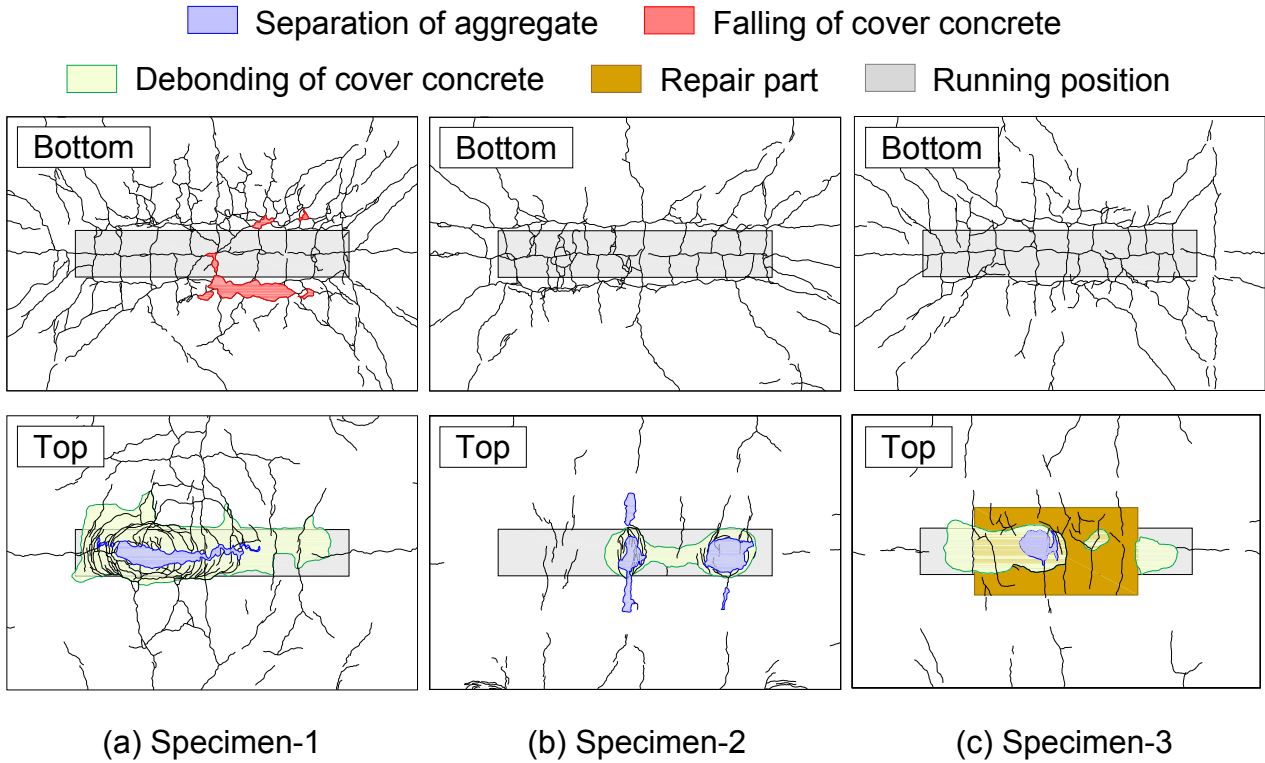
Figure 8 shows the failure condition of bottom and top surfaces of all specimens after experiment finished. In the figure, blue, red and green area show separation of aggregate from concrete, falling of upper cover concrete and debonding of upper cover concrete detected by hammering test, respectively.

Figure 8 - Crack patterns in bottom and top surfaces

Failure condition of Specimen-1 was similar to a typical fatigue failure mode of RC slabs, i.e. hexagonal cracks initiated in bottom surface became dense and developed to cracks penetrating the slab from bottom to top, and finally punching shear failure occurred with falling down of bottom concrete where coloured by red in Figure 8(a). Upper cover concrete seemed to be peeled off from lower section just under wheel load running position after 11,033 running cycles and upper concrete was partially lost along running lane at failure. This was probably caused by abrasion between wheel and specimen and the difference damage type from circular or elliptical shape damage shown from fatigue loading under water environment.

In Specimen-2, initial and midterm damage condition, meaning before the developing of hexagonal cracks and the penetrating toward height direction, were similar to Specimen-1. At 82,522 running cycles, the education of efflorescence was observed at both centre and one end of running lane in bottom surface. Also, debonding of upper cover concrete along wheel load running lane and separation of aggregate in upper concrete just over the position of efflorescence educating occurred at the almost same time, 154,012 running cycles. Finally, the aggregate separation depth in upper concrete deepened to 8mm at the end of experiment, 183,565 running cycles.

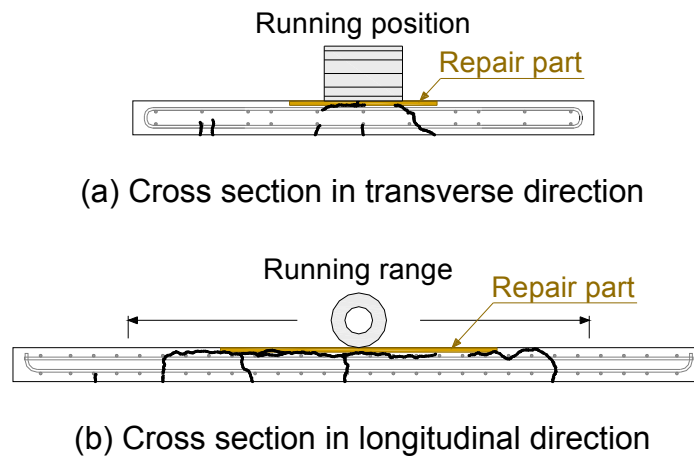
After experiment, for Specimen-3, cut cross section of specimen was observed in order to investigate damage condition, especially about debonding of repair material, in detail. Figure 9 shows the crack patterns of cross sections in transverse and longitudinal direction. From the observation of transverse cross section shown in Figure 9(a), it can be seen that

Figure 9 - Cross sectional crack pattern of Specimen-3

shear crack developed from the end of wheel loading position to bottom surface, indicating punching shear failure of slab concrete was the final failure mode of Specimen-3, while failure mode could not be determined from the surface crack pattern. This failure occurred at centre of specimen where aggregate separation of repair material also occurred. From longitudinal cross section shown in Figure 9(b), it seems that horizontal crack initiated in upper part of specimen along the whole wheel running range, including cracks appeared in both slab concrete and interface between slab concrete and repair material. Although a further investigation might be necessary to evaluate the structural integrity of repaired slabs, it seemed that the adhesion between repair material and slab concrete was sufficient to retain structural performance since no preceded interfacial separation of repair material and slab concrete was observed.

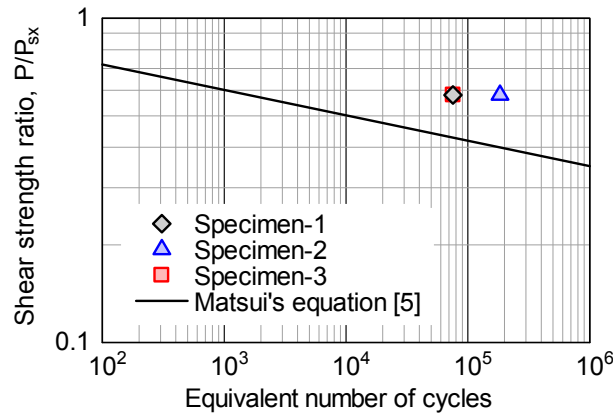
Figure 10 plots the fatigue lives of all specimens with SN diagram of RC slabs proposed by Matsui to clarify upper repair effect under frozen environment. About Specimen-2 before fractured, final equivalent number of cycles is regarded as fatigue life because the change of deflection and crack pattern indicated the symptoms of failure.

Figure 10 - Experimental fatigue lives and S-N diagram

When comparing Specimen-1 and Specimen-2 to evaluate the effect of freezing, the fatigue durability of Specimen-2 was almost 2.5 times of Specimen-1. The experiment under frozen environment in this study allowed temperature to rise and wheel load running proceeded in the state that frozen state and melted state, it was almost the same meaning as in water environment, interchanged alternately. Although it has generally known that water environment shortens fatigue durability of RC slabs to 1/10 times or less of that under dry environment, the restraining effect of the increase in slab stiffness at below 0 degrees exceeded the decreasing effect of water.

As to Specimen-2 and Specimen-3, the fatigue life of upper repair specimen, Specimen-3, resulted in 1/2.5 times of non-repaired one, Specimen-2, under frozen environment. In Specimen-3, the decreasing effect of aggregate separation of repair material on fatigue durability was significant to cancel the fatigue life extension by freezing effect and the fatigue life was almost same degree as that of Specimen-1. Provided that, it is necessary to conduct additional wheel load running tests under perfect frozen environment refusing melted state and perfect or partial submerged environment in order to validate these effects.
