BRIDGE DECK PRESERVATION SYSTEMS FOR EXPRESSWAY NETWORKS

Heungbae Gil
Construction & Environment Research Division,
Korea Expressway Corporation Research Institute, Korea
hgil@ex.co.kr
Gyungja Jung
Future Strategy Research Division,
Korea Expressway Corporation Research Institute, Korea
gjjung@ex.co.kr

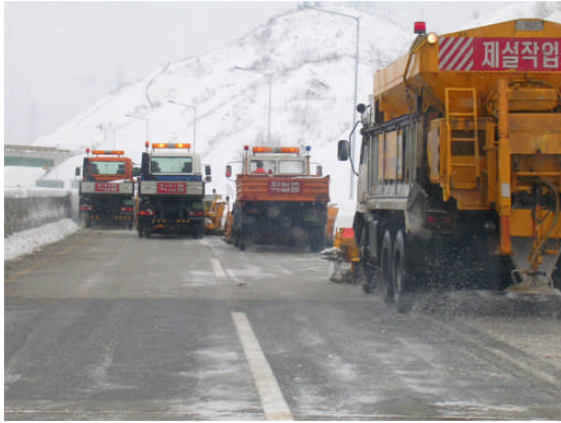
Figure 1 – Spreader trucks

In the past, the Korea Expressway Corporation (KEC) used a mixture of sand/calcium chloride mixture by spreading it on icy road surfaces. The sand provided the required traction, while the calcium chloride helped to melt the frozen snow. However, it was seen that in most cases the sand scattered off the road and had to be cleaned-up. To minimize the use of calcium chloride and its harmful environmental effects, the sand/calcium chloride mixture was replaced with deicing chemicals, namely a mixture of NaCl and CaCl₂. Rock salt, NaCl (70%), is wetted with a 30% calcium chloride solution. The CaCl₂ fosters the melting of snow and ice while the NaCl helps to keep it from refreezing. These deicing chemicals are spread using spreader trucks, as shown in Figure 1. As shown in Figure 2, a number of fixed anti-icing spray systems are also installed at high-risk highway segments and bridges.

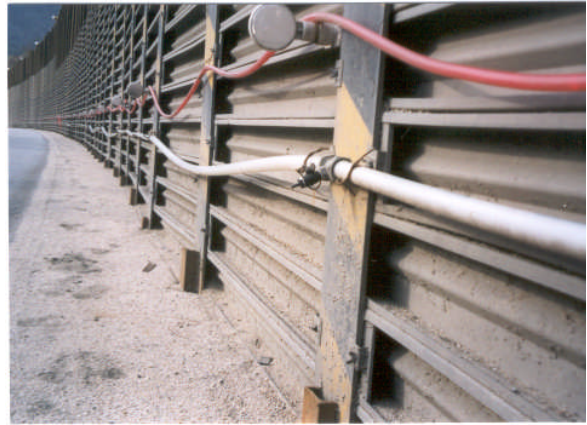
Figure 2 – Fixed de-icing spray system

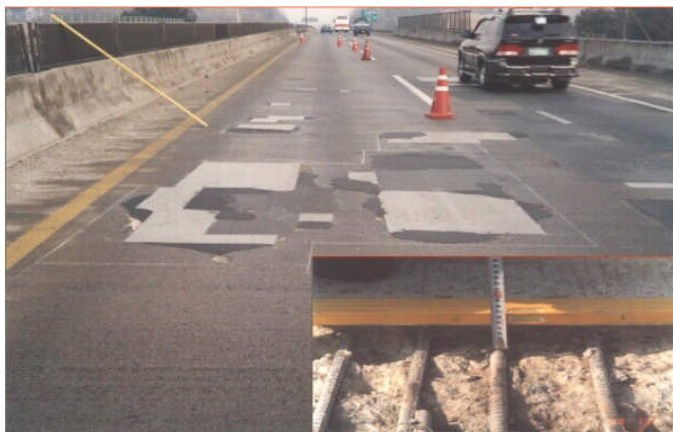
Figure 3 – Deterioration of deck

A few years after the deicing agent was changed from the mixture of sand/ CaCl_2 to the mixture of $\text{NaCl}/\text{CaCl}_2$, a rapid increase in the damage to concrete bridge elements was seen. As shown in Figures 3 and 4, the damage has been especially severe at exposed surfaces such as bridge decks, abutments and barriers. The bridge repair costs to fix these problems have also rapidly increased and now account for almost 50% of the total bridge maintenance budget of KEC. The rapid deterioration of concrete bridge decks is becoming the most serious maintenance problem. Similar deterioration problems with chloride deicers in the USA were reported by Huang et al. [1].

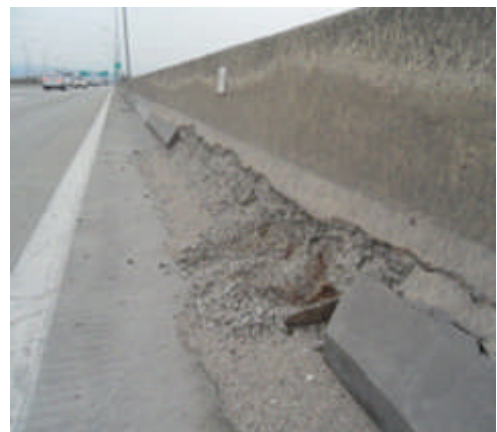
Figure 4 – Deterioration of barrier

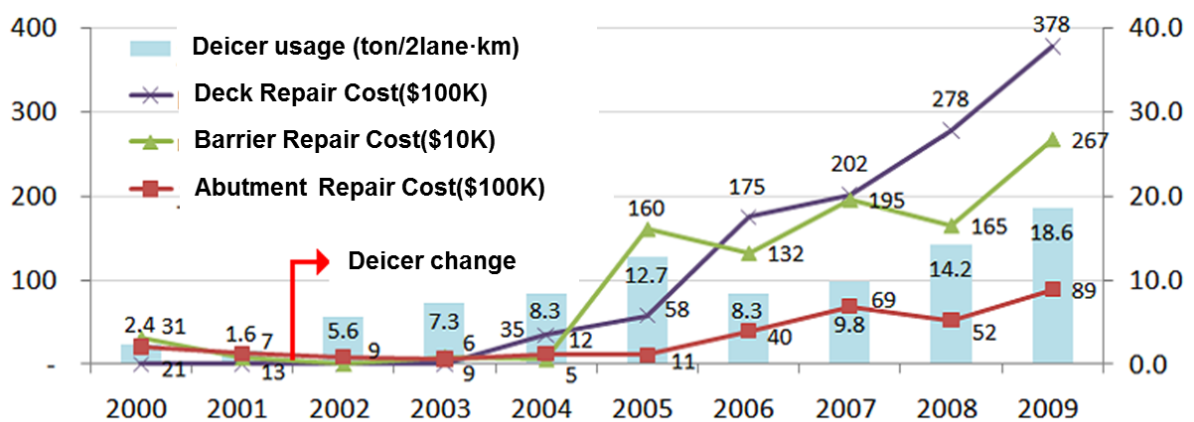
Figure 5 – Yearly deicer usage and repair cost

Global warming and climate change have led to increased snowfall in the Korean Peninsula and unpredictable weather patterns. During the winter season, heavy snowstorms and extended cold waves have become more frequent. Because of the increased snow and icing, the use of deicing/anti-icing chemical use has increased rapidly in recent years and the deterioration of bridges and pavements has worsened. Figure 5 shows the rapid increase in bridge repair costs caused by the increased use of deicing chemicals and the change in deicing materials.

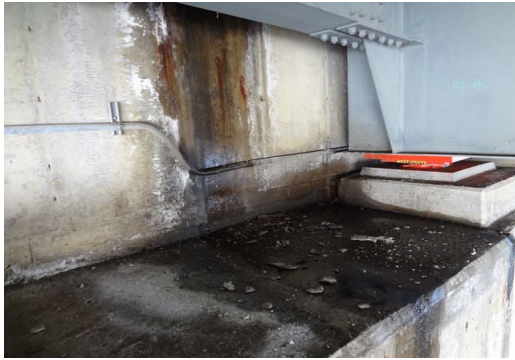
Figure 6 – Leaking expansion joint

Transverse and end expansion joints are installed to accommodate movements caused by traffic, temperature variation, etc. Different types of joints are used, depending on the expansion length of the bridge. To protect the bridge elements under the expansion joints from runoff water and other contaminants, they are designed to be watertight and should be appropriately maintained. However, as shown in Figure 6, these joints are prone to damage and leakage. Deicing chemicals passing through a leaking expansion joints attack girder ends and bearings, as well as the bridge deck. A typical example of a deteriorated deck and abutment is shown in Figure 7.

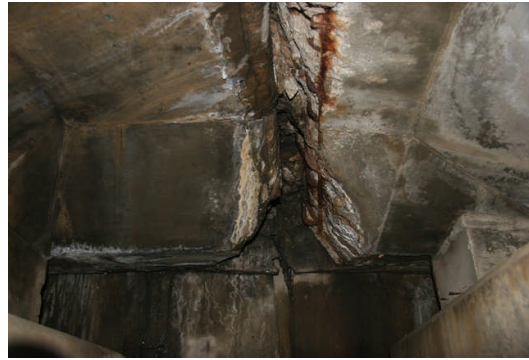
Figure 7 – Deterioration of decks

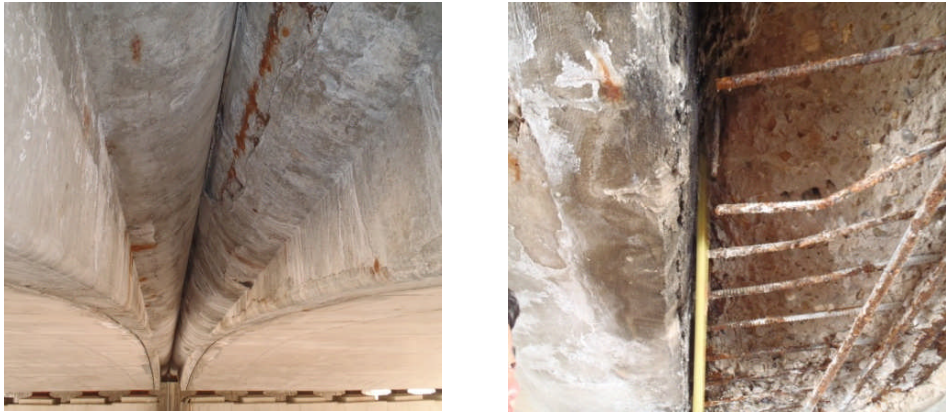
Figure 9 – Deterioration of deck under longitudinal joints

In addition to the expansion joints in the bridge's transverse direction, a large number of KEC bridges have been constructed side-by-side to accommodate two-way traffic. Each bridge carries traffic in one direction. Each bridge has at least two lanes and a shoulder. When two bridges are constructed side-by-side, a concrete median can be constructed on one of the bridges, as shown in Figure 8(a), or on both bridges such that it is divided in half, as shown in Figure 8(b). When the median is installed on only one bridge, the other bridge is separated by approximately 20 mm, and the longitudinal joints between the two bridges are typically filled with filler such as Styrofoam. The median haven been usually installed on one bridge to increase the constructability and save construction costs. However, an internal study of in-service bridges with longitudinal joints showed that the joints have a negative impact on the durability of the bridge deck (Figure 9). Deicing chemicals were found to leak through the longitudinal joints and deteriorate the edge of the deck. Over 150 bridges had been affected by leaked deicing chemicals, and the decks of those bridges were substantially damaged.

To prevent further deck damage due to leakage at longitudinal joints, new joint systems such as a closed cell elastomer joint seal and an asphalt plug joint are being tried for in-service bridges. Water drainage systems to carry away runoff water and deicing chloride are also being installed. After the study, it was also recommended that new bridges be designed with a divided concrete median, as shown in Figure 8(b), with the exception of wider bridges with at least four lanes in one direction or bridges with different span lengths.

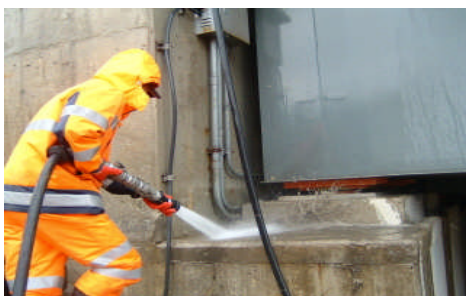
Figure 10 – High-pressure water cleaning

During the winter and early spring, water tanker trucks and high-pressure hoses, as shown in Figures 10 and 11, are used to remove the de-icing agent residue from bridges. It is carried out to prevent the chloride residue from attacking the concrete surface. Abutments, piers, barriers, medians, bearings, and expansion joints are cleaned using high-pressure water. Laboratory tests and a field study showed that the chloride content can be reduced by as much as 30% by cleaning. In regions of heavy snowfall, this cleaning must be carried out twice a month or after a couple of deicing operations.

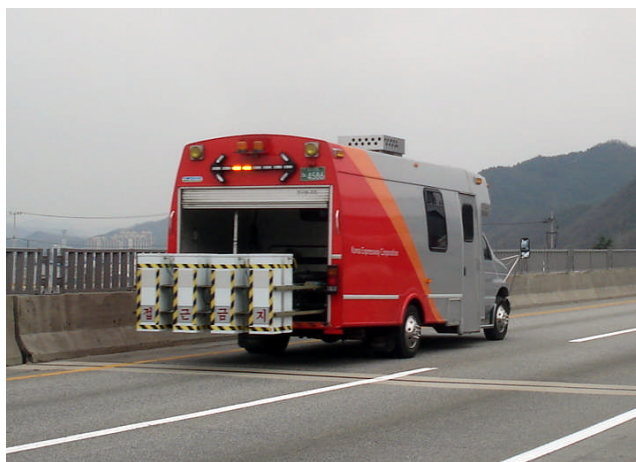
Figure 12 – A vehicle mounted GPR system

The condition of a concrete bridge deck covered with an asphalt overlay can be investigated by either removing the overlay or using non-destructive investigation methods. Though conventional non-destructive investigation methods such as chain dragging have been used earlier, ground-penetrating radar (GPR) has proven to be the most effective deck condition assessment method. GPR uses high-frequency radio waves to detect potential problems under the overlay. The vehicle-mounted GPR system shown in Figure 12 has been used for the condition evaluation of the decks in KEC because it can scan bridge decks rapidly and continuously. The system, which has four ground-penetrating radars, can be driven at speeds between 60 and 80 km/h. Each year about 100 bridge decks are investigated using the GPR system.
