Experimental Study on Deterioration Characteristics of Partially Repaired RC Slabs under Freezing-Thawing and Fatigue Combined Action

S. OKADA, S. OMOTE and H. NISHI
Senior Researcher, Researcher, Team Leader
Civil Engineering Research Institute for Cold Region

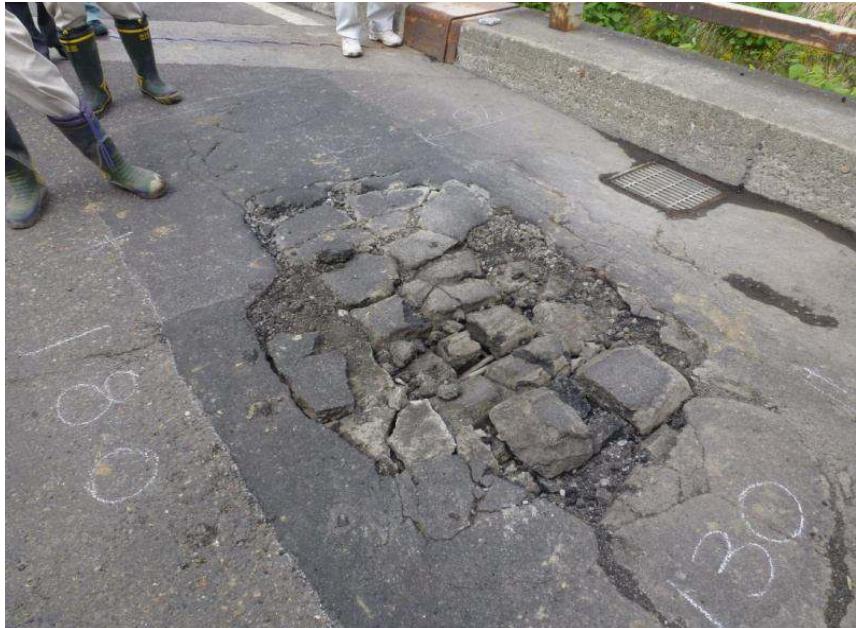
Unpredicted failure

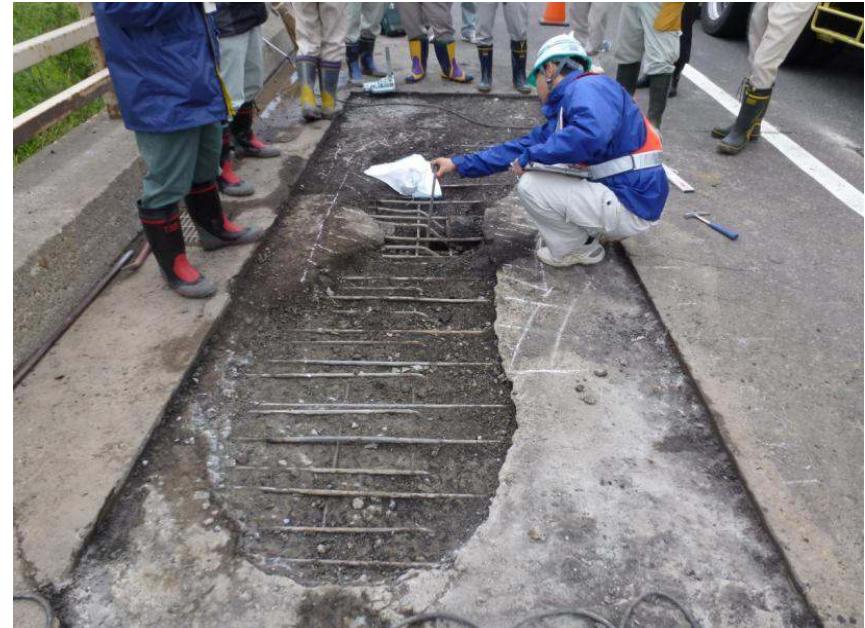
Upper damage

Upper damage is unique damage modes in Hokkaido.

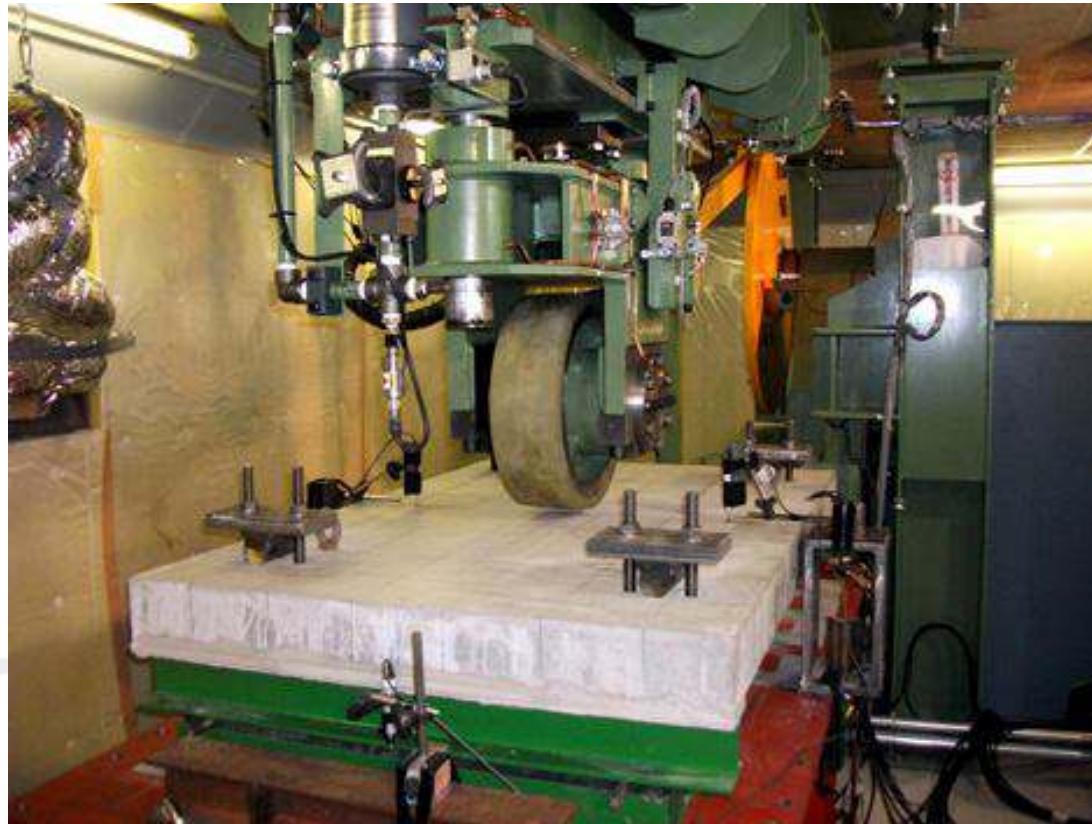
Wheel load running test

FATIGUE TEST
