PIARC INTERNATIONAL WINTER ROAD CONGRESS

TOPIC 8. ROAD BRIDGES IN WINTER CONDITIONS

ASSESSMENT AND REPAIR OF BRIDGES SUBJECTED TO DE-ICING SALTS

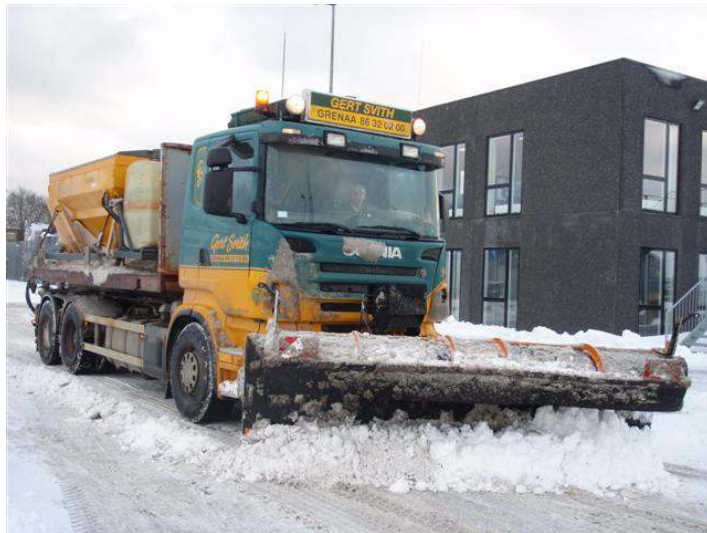
High chloride content leads to corrosion of the reinforcement.

The de-icing salts usually consist of NaCl. The Na⁺ will provide additional alkali that can speed up ASR.

Cracks from ASR will allow additional water ingress that will reinforce the chloride impact and subsequently the deterioration of the structure (corrosion and spalling).

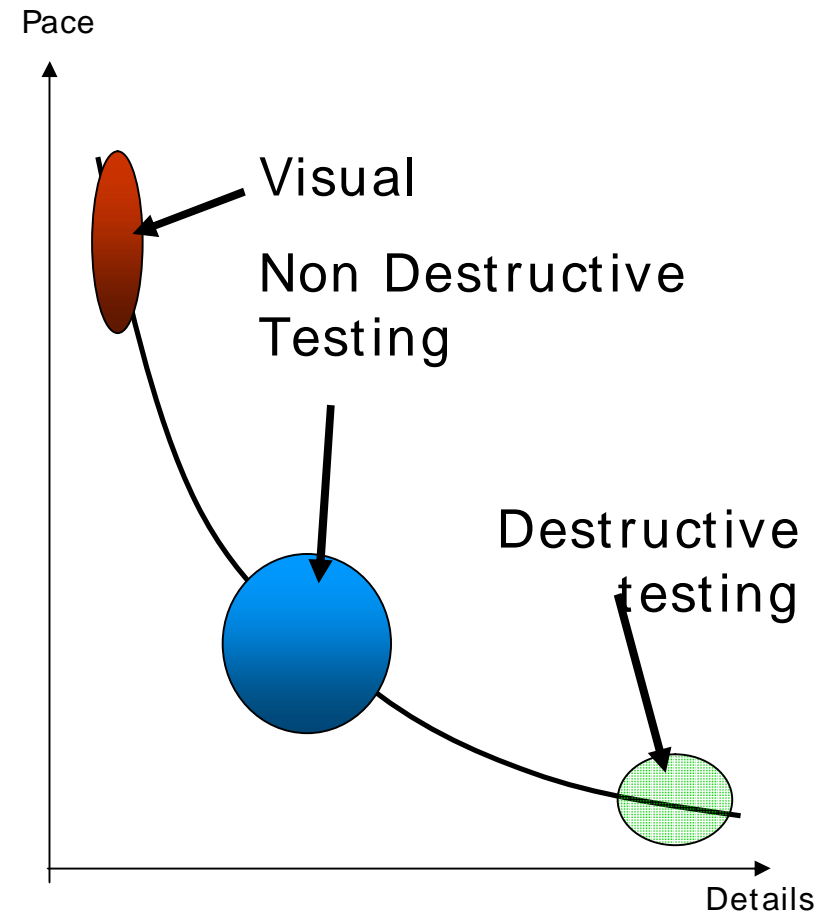
The **visual** inspection provides overview and forms basis for hypothesis regard future development of defects.

NDT testing provides detailed information about extent of defects:

ECP (Half-Cell potential-mapping)

Covermeter

s'MASH (Impulse response) etc.

Destructive testing provides detailed information about small areas:
Breakouts, chloride testing, carbonation testing, cores etc.

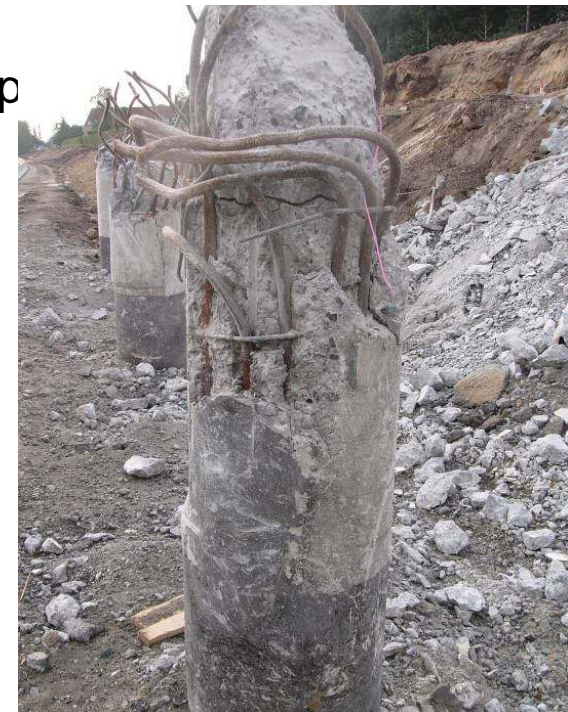
If the chloride content is **high**, more than approximately 0.05% and corrosion of the reinforcement is on-going:

- Repair all areas with high chloride content by removing contaminated concrete and applying sp mortar, concrete or shotcrete. If the area of the reinforcement is reduced it may be necessary to add additional reinforcement.
- Option: Cathodic Protection
- “Surface treatment” (replacement of bitumen sheets for a bridge deck, paint system for other surfaces)

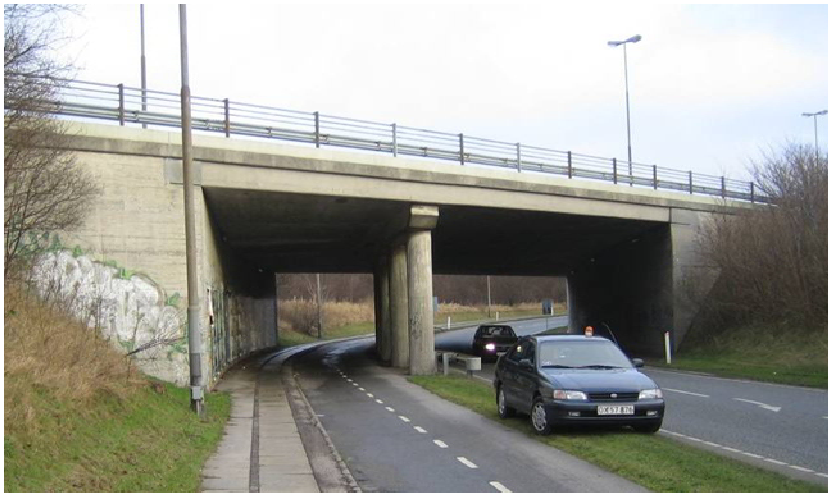
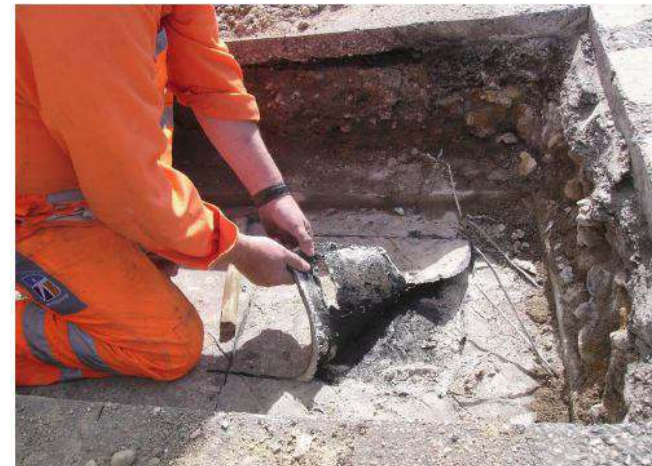
This project comprises a complete rehabilitation and strengthening of a two-span post-tensioned motorway bridge. Prior to the rehabilitation, a special inspection and load capacity rating was undertaken. The bridge is situated near Roskilde approximately 30 km west of Copenhagen.

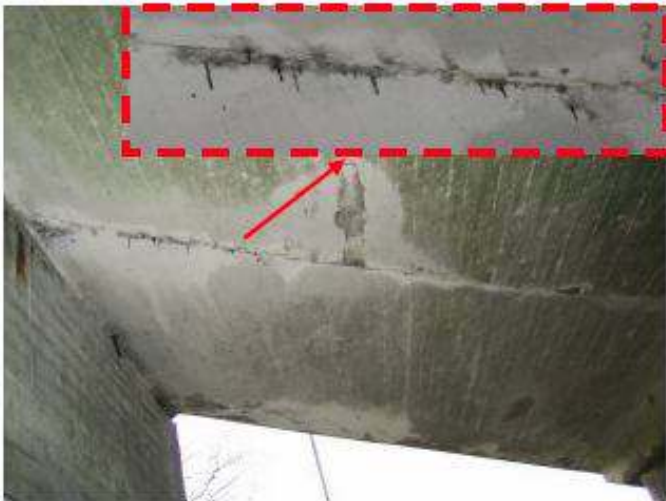
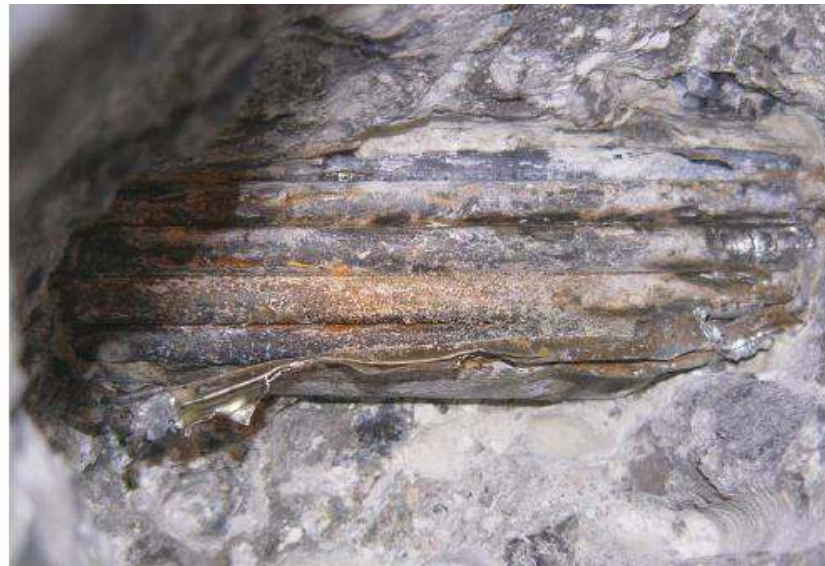
The overall condition of the bridge prior to rehabilitation was as follows:

- Defective waterproofing leading to water leakage through the slab
- Corrosion (minor) of the pre-stressing tendons at a cold joint.
- Insufficient load-carrying capacity (Class 70 (tonnes) while class 100 (t) is required at the location)

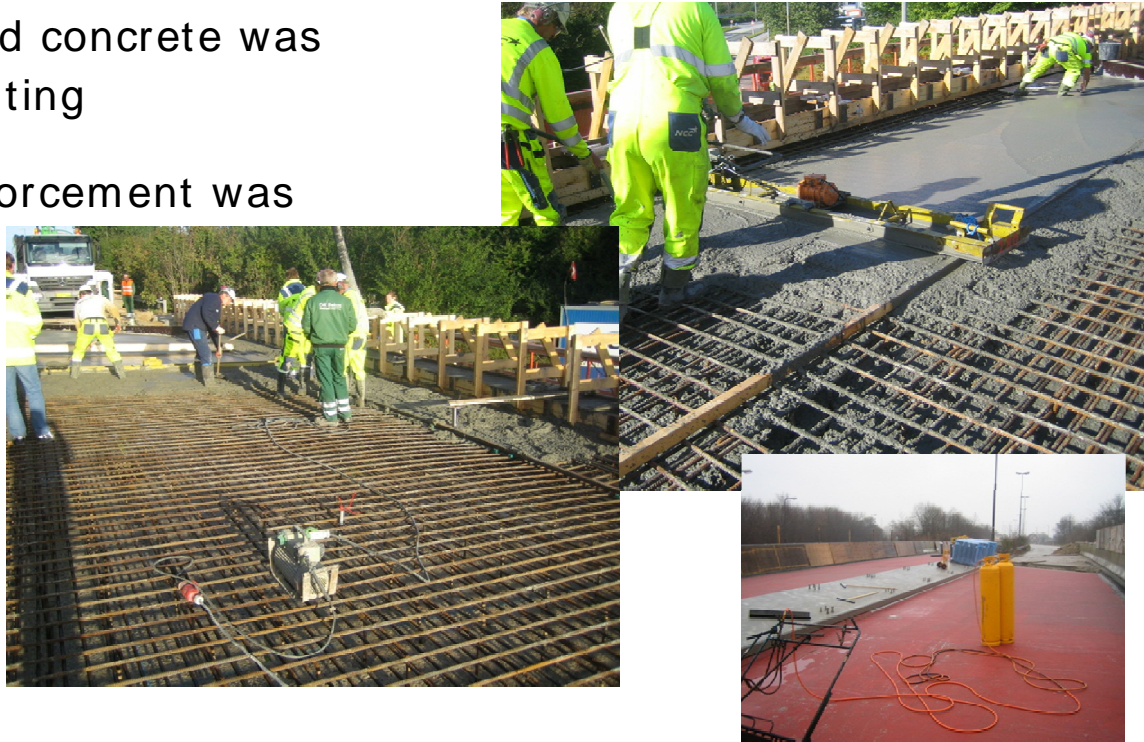
- Conclusions
- The strengthening was successfully integrated with the repair works.
- Chloride contaminated concrete was removed by water jetting
- Since additional reinforcement was only required in a limited area, the strengthening was carried out at an additional cost of only **0.5%** of the total costs.

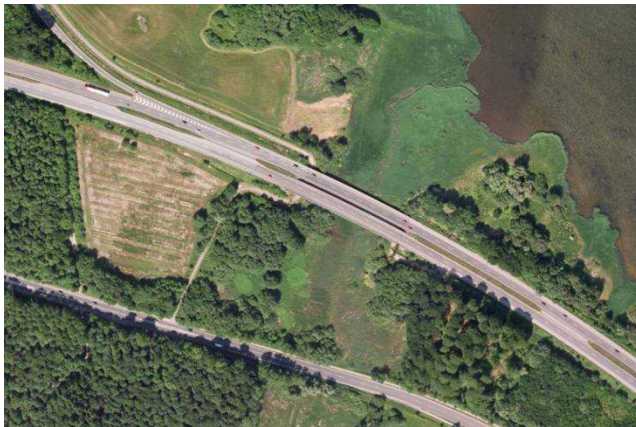
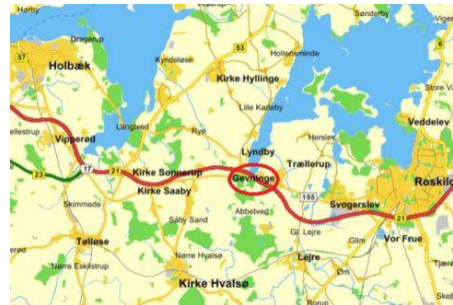
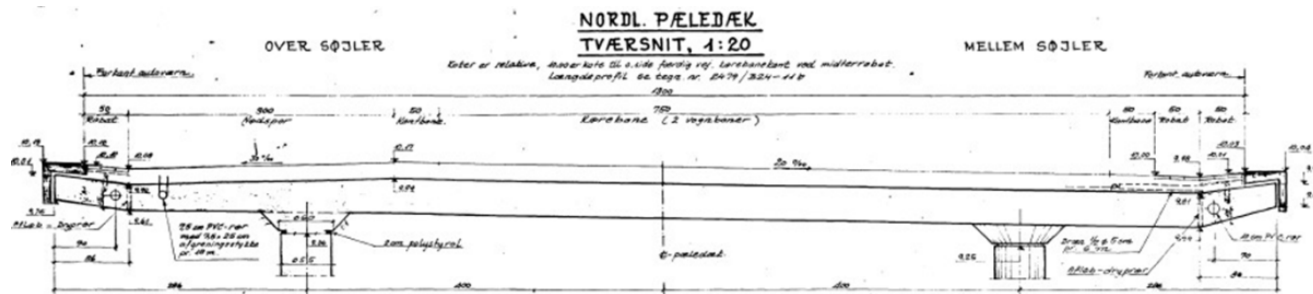
Bridge constructed in 1972 with a RC slab. Total length of 114 m; Width of 13.7 m. Total area of 1560 m².

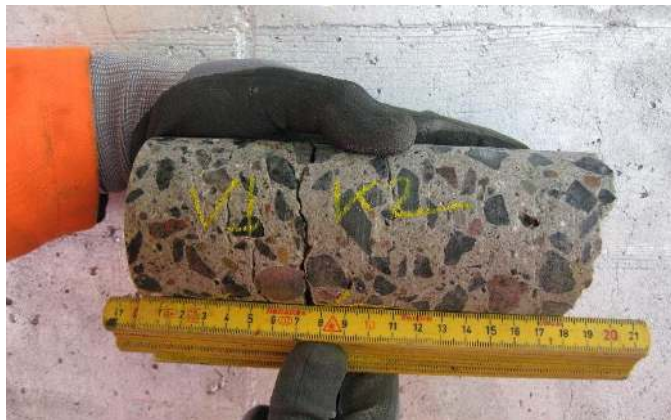
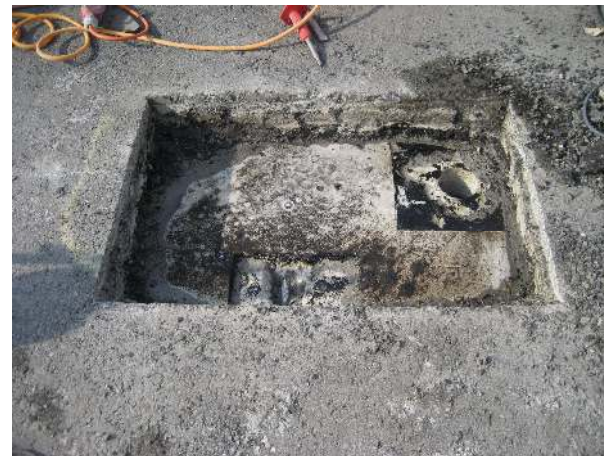
The overall condition of the bridge prior to rehabilitation was:

- Defective waterproofing leading to water leakage through the slab
- Corrosion of the reinforcement due to de-icing salts
- ASR in the slab
- Insufficient load-carrying capacity (lack of shear capacity over columns)

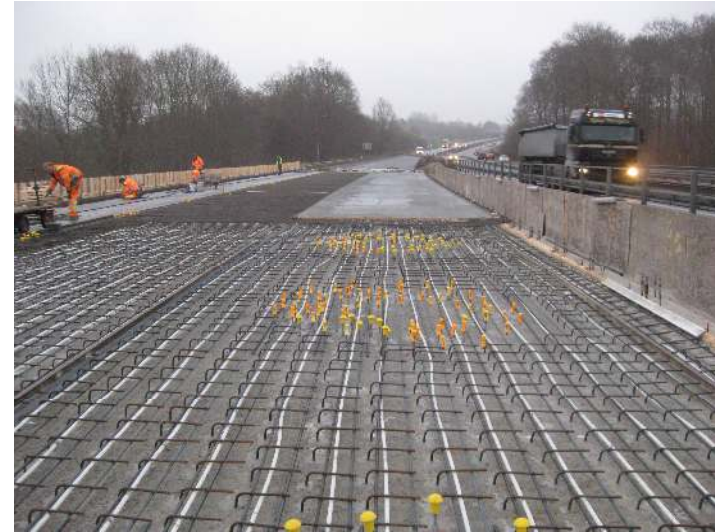
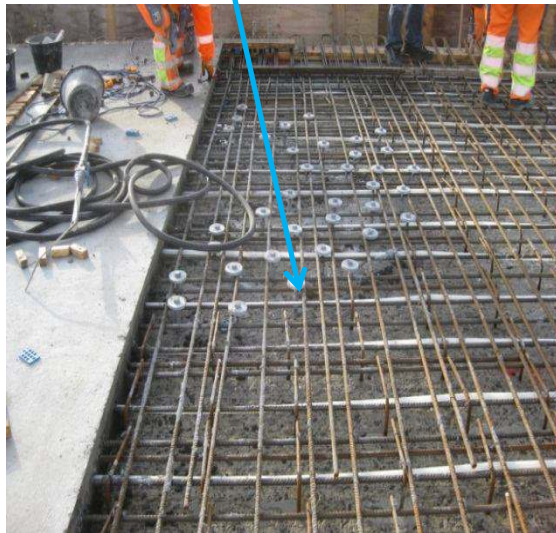
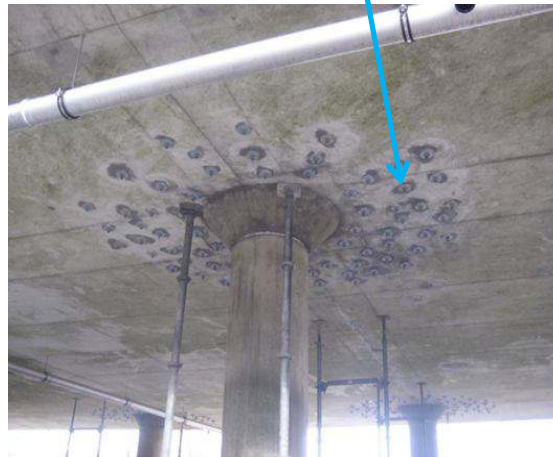
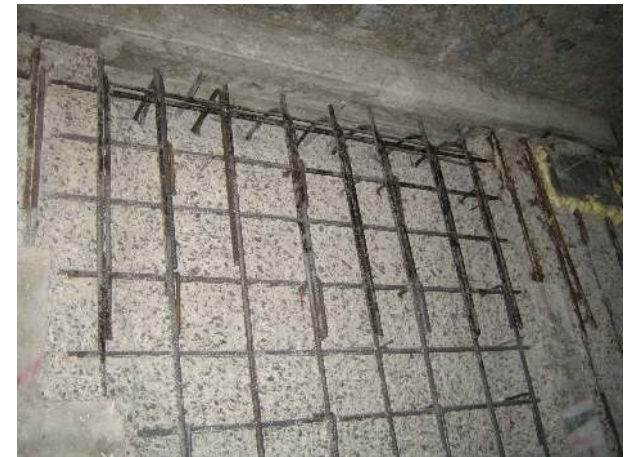
Bars drilled through the slab (shear).
Fixed with steel plates

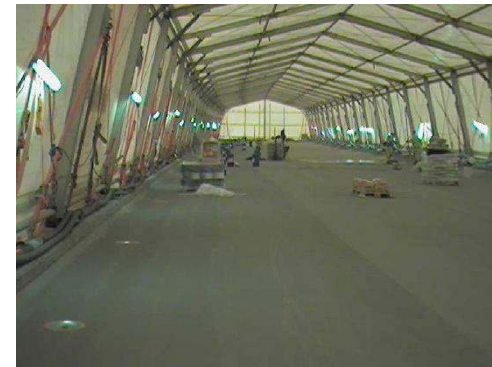
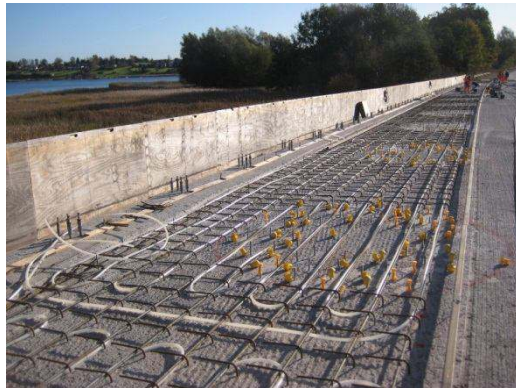
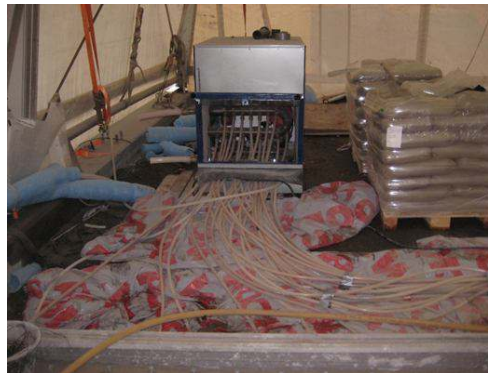
Execution of the rehabilitation during winter period 2010-11.

Concrete over layes with hoses for hot water. The heat is provided where it is needed (cost and CO2 friendly solution)

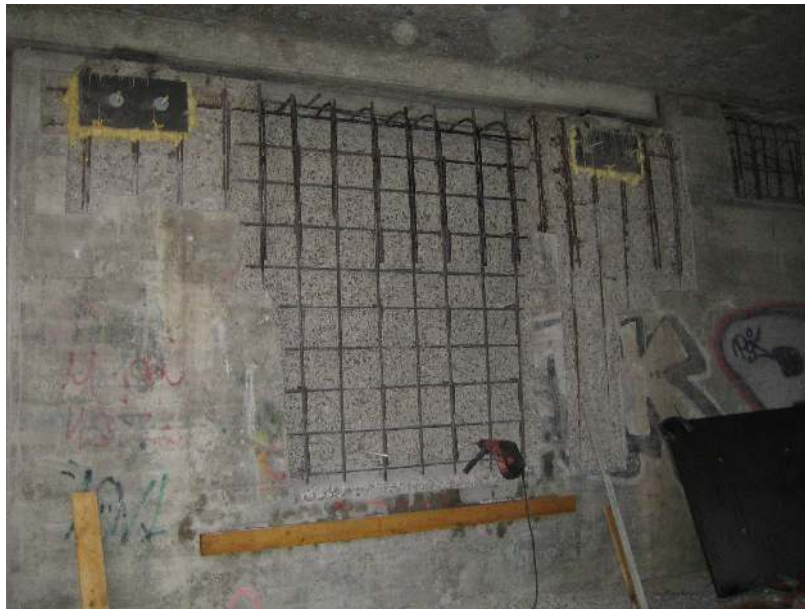
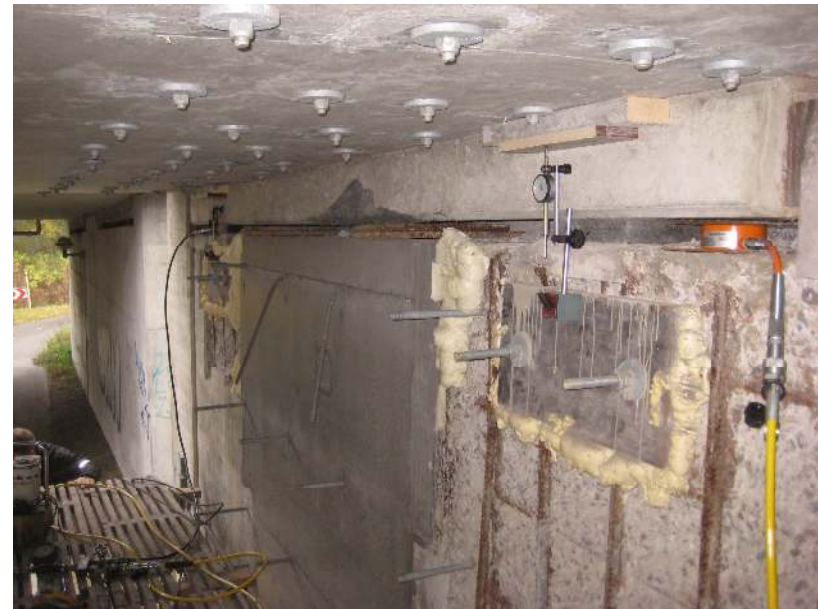
Abutments with spalling concrete and corroded reinforcement due to chlorides. Full concrete repair including replacement of bearings:

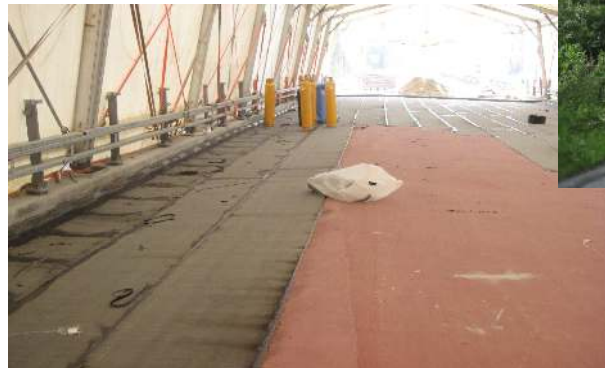
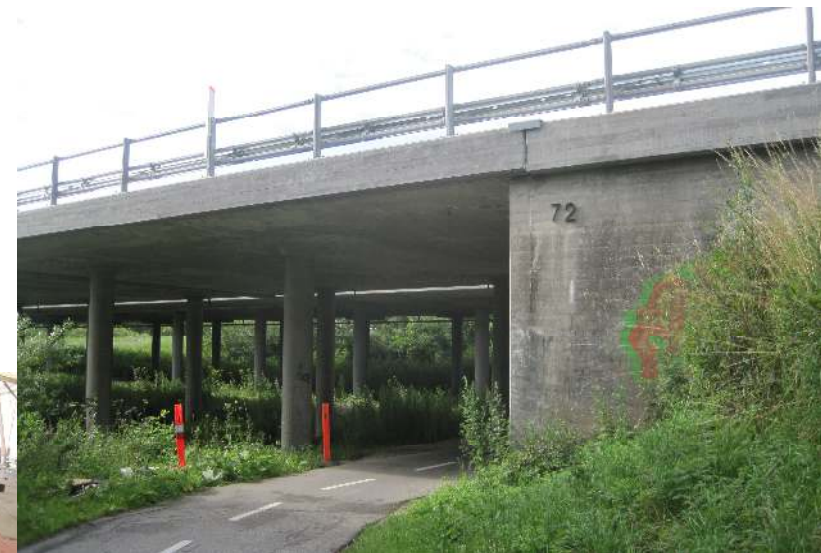
Conclusions after complete rehabilitation of the bridge:

- Corrosion of the reinforcement and the ASR has been halted
- The waterproofing and surfacing has been replaced
- Strengthening was successfully integrated with the repair works.
- The work could be carried out during the winter period at very low additional cost due to the heating system with cast in hoses.
