# STAGE PROTECTION AGAINST DEGRADATION DUE TO THE USE OF DEICING SALTS OF A STRUCTURE IN ANDORRA

ALBELDA CUADRA, RAÚL  
Construction Projects, Globalvía, Spain

RODRÍGUEZ, JOAN LLUIS; TRIAS PATOUT, CHRISTOPHE  
Túnel d'Envalira Concesion, Andorra

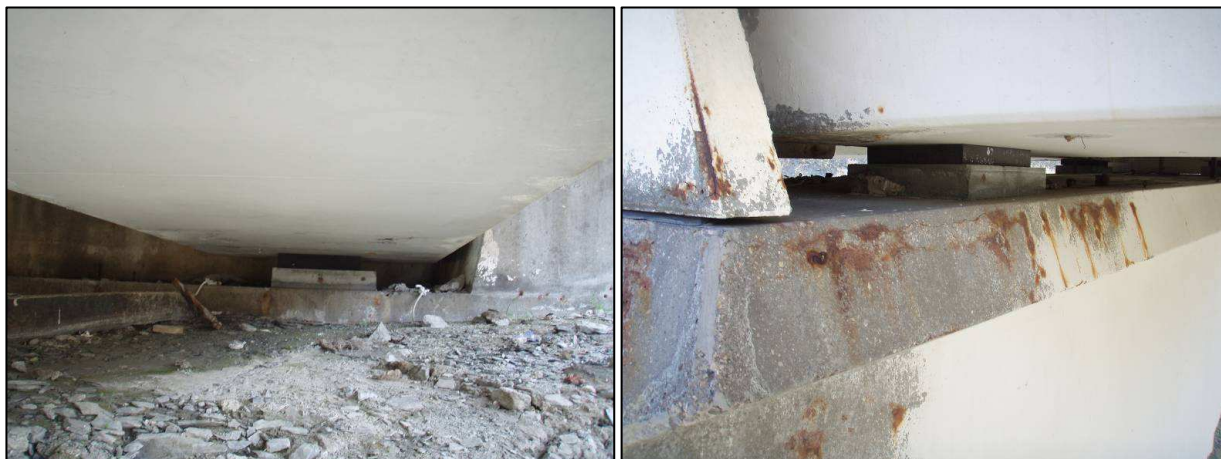
*Figures nº 5 and nº 6. Left beam bearing at No. 1 abutment (left) and right beam bearing at pier No. 2 (right)*

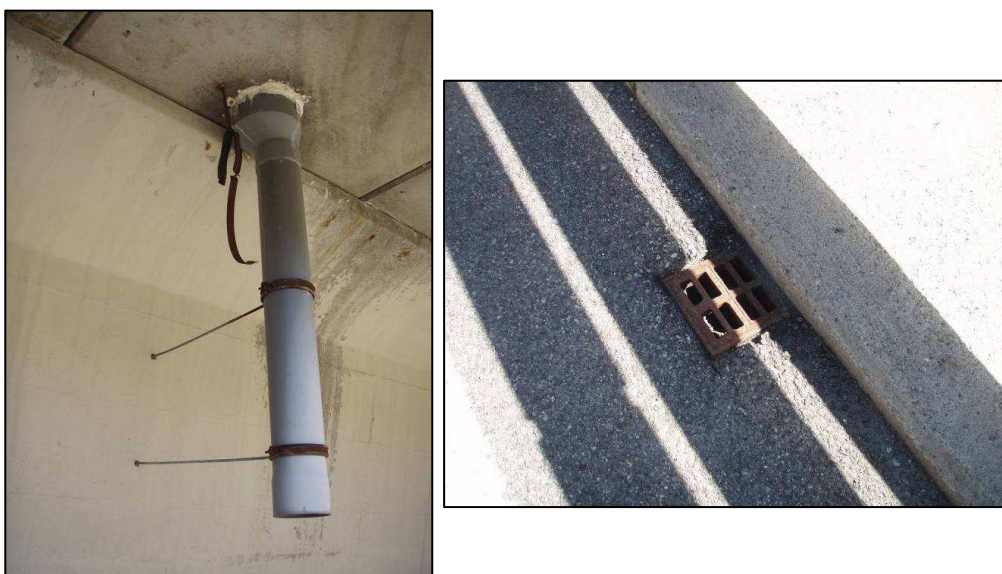
*Figures nº 8 and nº 9. Drainage tube at No. 4 span (left) and sink at No. 2 span (right)*

The safety barrier system is a metal guardrail (safety level H3, according to UNE 1317) anchored to the slab of the deck. The concrete longitudinal beam to which it is anchored forms a sort of lateral sidewalk. The drainage system consists of sinks topped protected and newly implemented inferior drain tubes (originally there was a longitudinal manifold whose anchors still be seen under the right overhang the deck, which suffered numerous breakdowns as a result of the weight of the iced water remained housed inside).

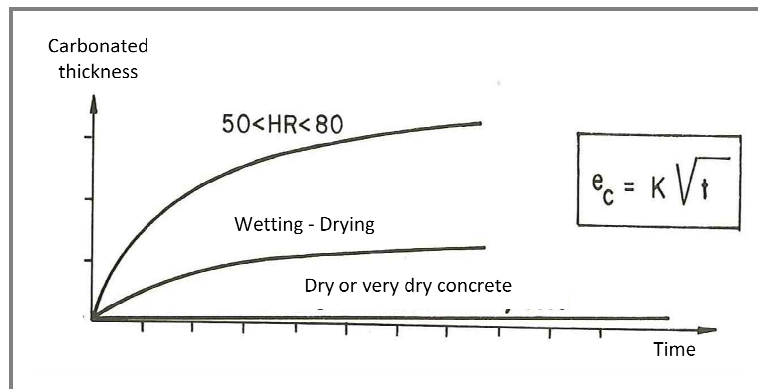
Figure nº 16. Advance of carbonation front versus time

The data obtained indicate that the carbonation is negligible in all sides of the shafts, so this data extrapolated to the rest of the structure, is considered that the carbonation is not the trigger of corrosion processes logged.
