# **The influence of anti-freezing agents on the deck of highway bridge, and its countermeasures**

Nasu administration office, East Nippon Expressway Company Limited, Japan

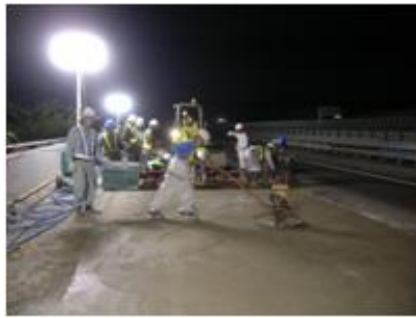
Picture 11-The punching out part on the base plate

deck. But in this construction, we tried to unite the decks by chipping the top 30mm with water jet to remove the weakened and damaged part. Also, we conducted a replacement in the area in which a high salinity in the deck was recognized in the horizontal crack and salinity measurement research, including the established deck (283 m<sup>2</sup>). Concerning the punching out part, after cutting the pavement with a cutting machine, we conducted chipping with water jet in the 200mm range of the punching out part so as not to create micro cracks in the structurally sound established deck. Concerning the punching out in the deck area, after pouring super rapid hardening concrete, we inserted the joint glue and positioned SF concrete to pave it. (Picture 3 – 14). Also, as the results mentioned in 4.3.3 above shows, since there was the possibility of water effusion from curbstones to the deck, we set-up an edge water conveyance in the curbstone part, after we fixed the deck and pavement. (Figure 9) The water which dispersed to the edge will be guided to the catch basin of the bridge, through the edge water conveyance. Picture 15-17 are photographs of the construction.
